Challenges of Urban Drainage System in the Emerging Towns of Ethiopia: The Case Study of Assosa Town

Kokeb Zena Besha

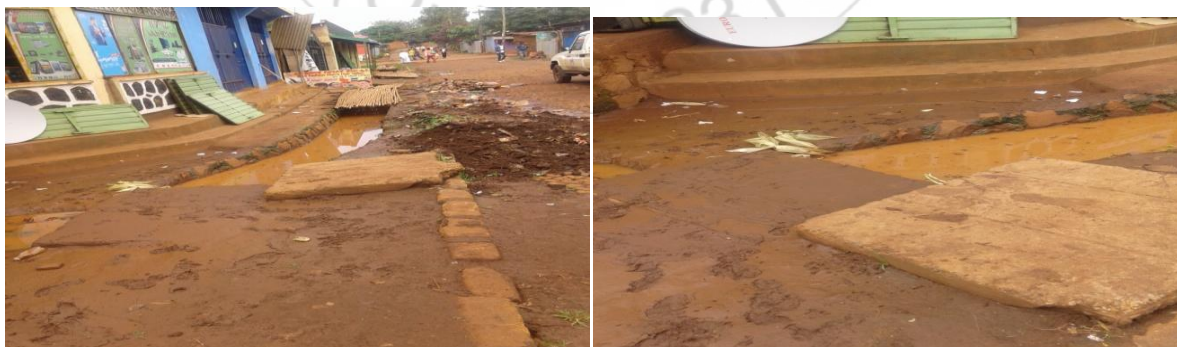
Figure 2: Rectangular Open Drains with poorly defined outlet

As shown in figure 2, a photo was taken by the researcher in May, 2016 during the field work shows that due to poorly defined inlets & outlets stagnant water is formed in the open drains.

terms of operation and maintenance as well as physical condition as evidenced from figures 2, 3, 4, 5 and 6.

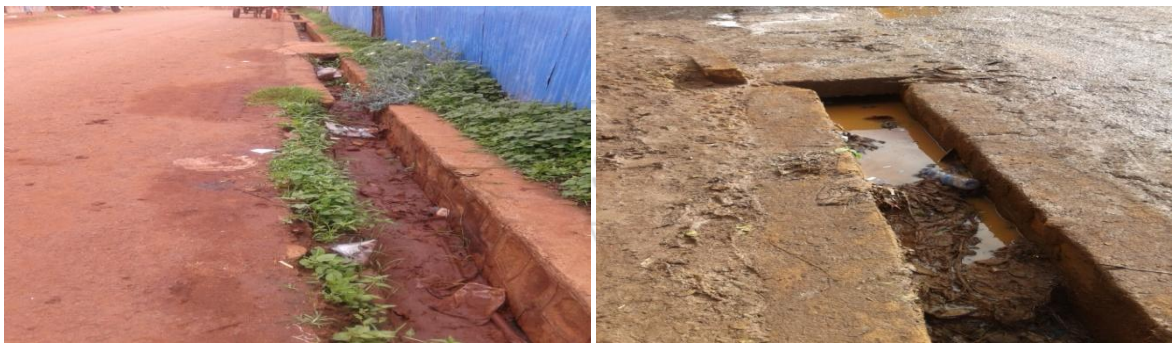
Figure 4: Failed & blocked Side drains

In figure 4, the side drains are failed & blocked by silt sediments due to poor maintenance & lack of timely supervisions by the concerned bodies.

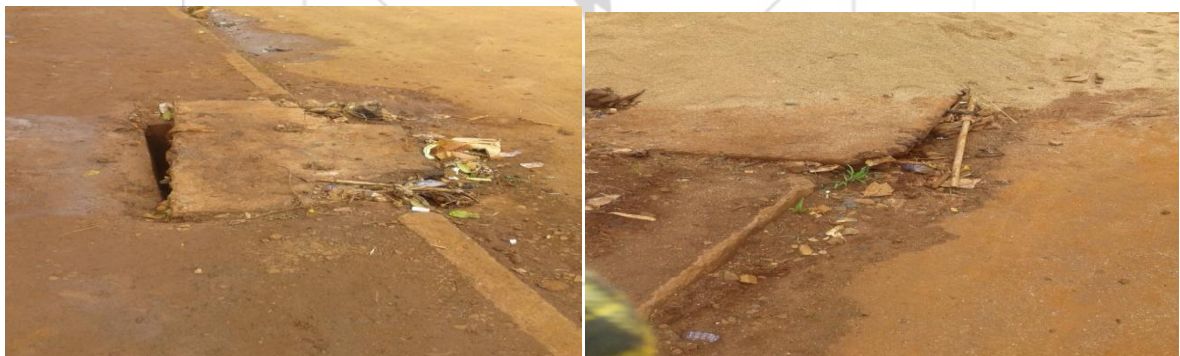
Figure 5: Poorly Executed Manholes

In figure 5, the manhole cover is not properly done and maintained as well due to lack of technical skill & poor supervision during construction time.

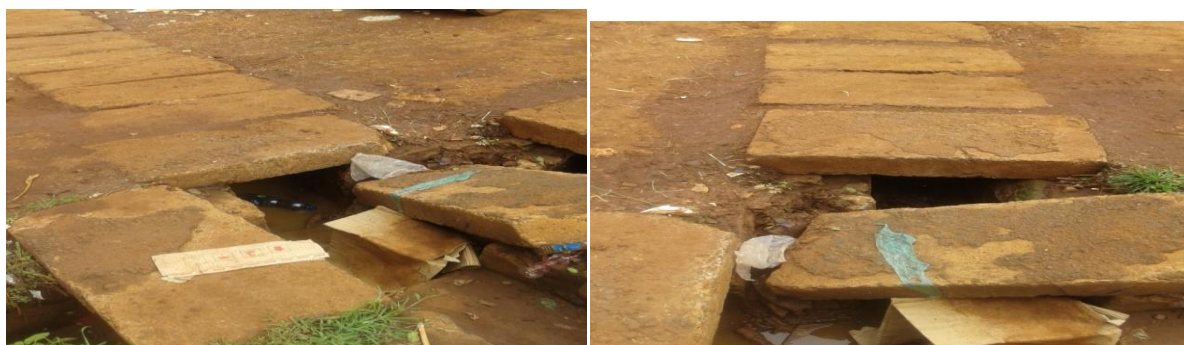
Figure 6: Poorly Covered open drains

Considering figure 6, the concrete block which is used as a cover for open drains is not properly executed; such types of problems are seen here and there at the study area. In general, it is reflected that drainage condition is poor in
