Case Report: Overhanging Fillings in Restorative Dental Treatments and Endodontics

Caner Selami Güner¹, Pınar Yılmaz Atal², Faik Bülent Topbaşı³

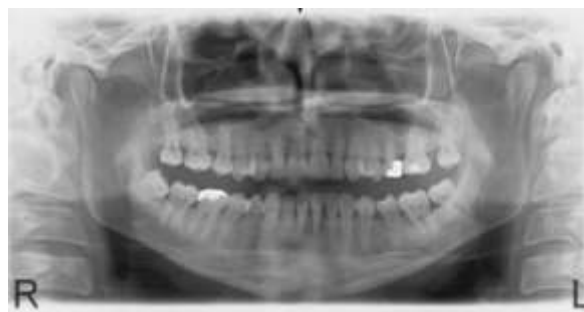
A 30-year-old female patient presented to our clinic with complaints including local pain, bleeding diathesis, and halitosis. Her intraoral and radiographic examinations revealed that the cause of her complaints was the OD amalgam restoration with overhanging contours in her upper left second premolar tooth (Figure 1).

Figure 1: Initial panoramic graphy to oral diagnosis

The overhanging amalgam restoration, which was not in alignment with the natural contours of the tooth and the periodontal tissues in the interproximal region, was thought

to result in periodontal complaints by causing plaque retention and foreign body reaction.

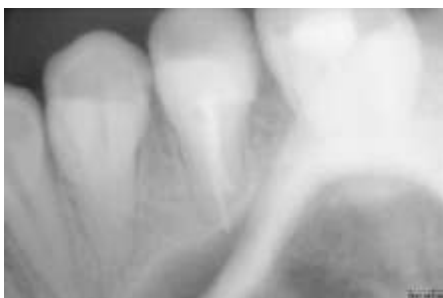
As a treatment approach, we decided to replace the overhanging contoured OD restoration with a composite restoration that is in alignment with the periodontal structures and has natural contours. While replacing the filling, pulp perforation occurred and its endodontic treatment was completed in the same session (Figure 2). The restoration above the canal was completed with a composite material (Spectrum TPH3, Dentsply Maillefer, Ballaigues, Switzerland) and a total-etch adhesive system (Prime & Bond NT, Dentsply Maillefer, Ballaigues, Switzerland). The polishing (OptiDisc, Kerr, Canada) procedure was completed in the same session (Figure 3).

Figure 2: Root Canal Treated Number 25

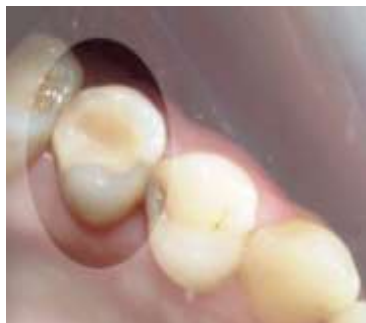
During the 3-month follow-up of the patient, the composite restoration in alignment with the periodontal tissues was observed to enable protection of the patient's oral hygiene, resulting in the elimination of local periodontal complaints (Figure 4).

Figure 4: Occlusal View of The Coronal Restoration

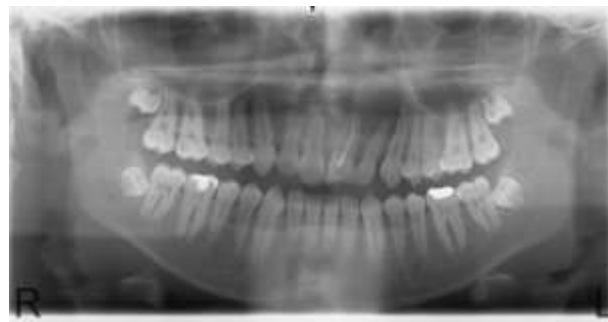
The anamnesis of a 15-year-old male patient who presented to the clinic complaining about a swelling at his left anterior maxillary region revealed that a swelling occurred at his left anterior maxillary region 3 years after he had suffered a trauma at the age of 9. He consulted a dentist due to this swelling and the dentist administered a canal treatment to his left maxillary central tooth. The radiological and clinical examinations we carried out in our clinic showed that there was an overhanging gutta-percha in his left maxillary central tooth and a radicular cyst affecting his central, lateral and canine tooth (Figure 5).

Figure 5: Initial Panoramic Radiography

Considering the etiology of the occurrence of a radicular cyst, we can hold responsible the assessment of post-traumatic symptoms without taking radiography and the overhanging canal filling material used in the treatment.

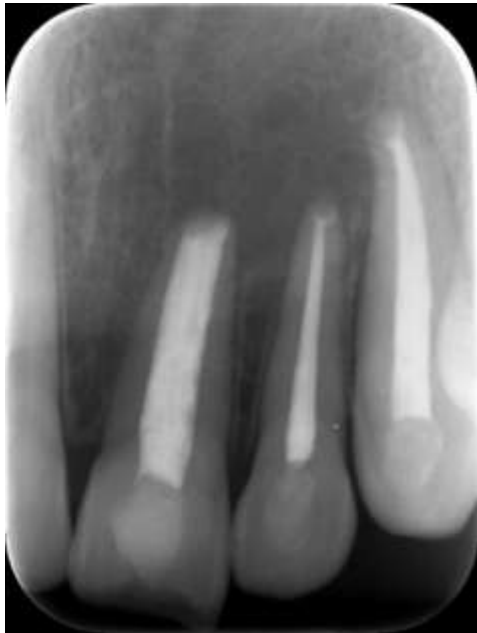
During the 3-month follow-up after the operation, a reduction in the extraoral swelling of the patient and an increase in opacity indicating osseous recovery in the radiolucent area in the radiography were observed showing both clinical and radiographic remission (Figure 7).

Figure 7: Three-month Follow-up X-ray
