# Intraradicular Splinting of a Coronal Horizontal Root Fracture with Surgical Repositioning of the Fractured Crown in a Permanent Maxillary Lateral Incisor: A Case Report

Dr Ajay Singh Rao<sup>1</sup>, Dr Archana<sup>2</sup>, Dr Supriya Patil<sup>3</sup>, Dr Meetu Mathur<sup>4</sup>

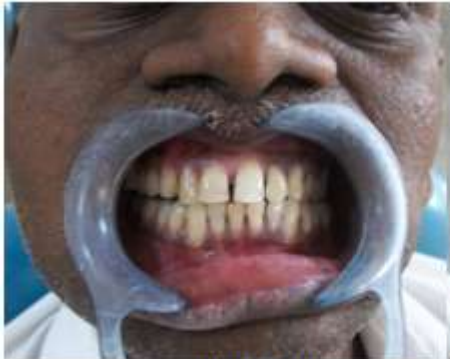
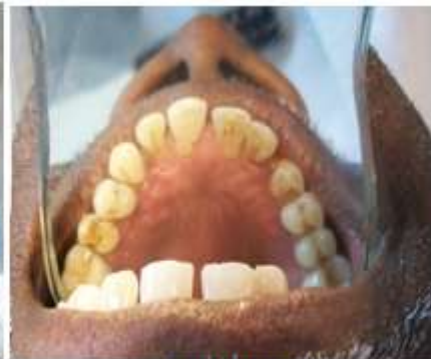
Figure 1 (a)

A 45 year old male visited the department of Conservative Dentistry & Endodontics with the complaint of loose tooth in the upper front region. He had suffered a dental injury in the upper anterior teeth biting on a hard object the previous night. He had no other major injuries and his medical history was uneventful. The clinical examination revealed Ellis Type III fracture of the upper right lateral incisor. Discomfort was noted during percussion and palpation. Tooth had grade III mobility. The crown was simply attached with the help of the gingival fibers (fig.1a & 1b). The Radiographic examination revealed crown fracture of the horizontal fracture in the coronal third of the root on the upper right lateral incisor, separating the Coronal and Radicular fragments from each other (fig.2)

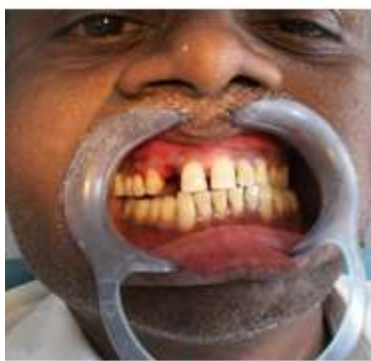
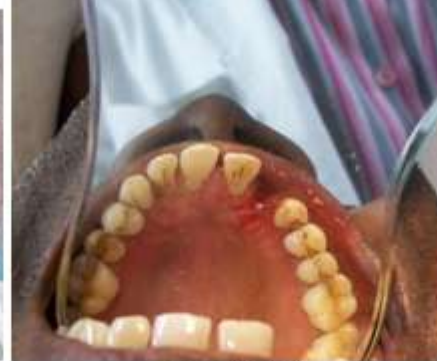
Figure 3 (a)

The crown was gently extracted with forceps under local anesthesia 2% lignocaine hydrochloride with 1:80000 adrenaline (fig.3a & 3b). It was stored in saline to prevent dehydration. Working length was established by radiographic method (fig.4) and the radicular part of the tooth was cleaned and shaped using Protaper rotary NiTi files while 3% sodium hypochlorite was used as an irrigant (fig.5). Lateral condensation technique with AH plus sealer was used for obturation. Post space was prepared using G.G. drill no.5 and confirmed with a radiograph (fig. 6a & 6b). An appropriate size fiber reinforced composite post (*Rebuilda post* with diameter 1.2 mm) was selected. It was checked for its fitting by taking an intraoral periapical radiograph and was cut to the desired length with the help of a diamond cutting disc (fig.7a & 7b). Now the Mucoperiosteal flap was raised using the crestal incision with vertical releasing incisions (fig. 8). The margins of the radicular part of the tooth were exposed (fig.9). The canal was dried using paper points. A Dual cure resin cement (*RelyX unicemTM, 3M*) carried into the canal and the post was inserted and cured for 40 seconds (fig.10). The fiber post was pre-treated with 24% hydrogen peroxide for better bonding with the resin cement. An "Anti rotational groove" was prepared on the palatal side of the crown (fig.11). Now the crown fragment was checked for its fitting by inserting it on the post in the canal passively (fig.12). Once confirmed,

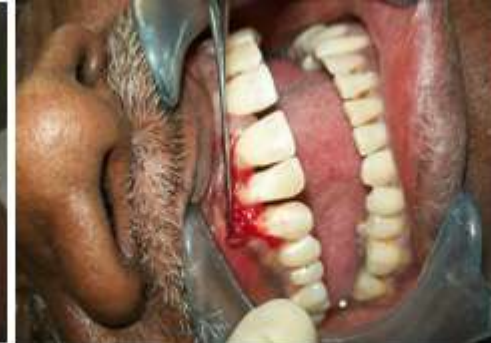
Figure 13

the crown was repositioned on the post using the same dual cure resin (*RelyX unicem, 3M*) and light cured (fig.13). Flap was repositioned and sutures were given (fig.14a, 14b & 14c). Patient was recalled one week later for sutures removal. Marginal gingival showed proper healing .After 12

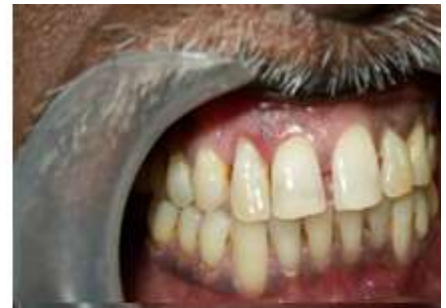
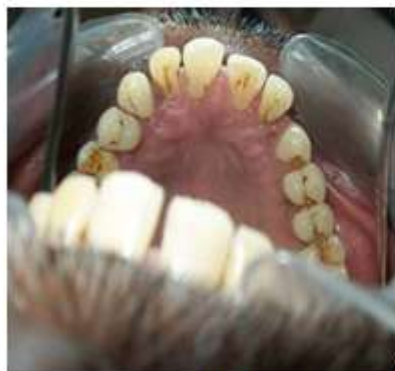
Figure 15 (a)

months follow up the tooth and the associated gingiva were healthy asymptomatic clinically (fig.15a & 15b) as well as radiographically (fig.16).
