Case Study on Cracks in Public Buildings and their Remedies

Abstract: Cracks are inherent and detrimental elements of building detailed investigation should be carried out regularly to ensure the assessability and serviceability of the building. For rehabilitation of cracks it is important to understand the causes and the types of cracks appeared in the structure. This paper shortly describes the causes and types of cracks and their remedial measures. Non destructive testing methods are used to access the strength of the structure at a first instance to know the actual state of the structure whether it will be serviceable/workable or to be demolished. Few case studies were conducted at different public buildings at Gwalior M.P. Political science, economic and archaeological blocks of Jiwaji University. Moti Mahal building. NITM (Nagaji institute of Technology and Management building. Which were reported cracks and they were in suspension to whether it will work or should be demolished. The purpose of this study is to determine the position of structure whether it is further serviceable or not and secondly, if we use the same building how it will be repaired.

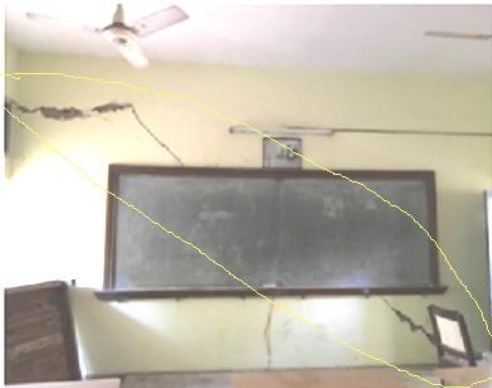
Figure 1: Short wall of classroom 16 (political block)
 Width- above 2mm
 Type- Wide (Non-structure)
 Shape- Diagonal, Horizontal crack
 Cause- settlement of foundation

Minor cracks found in the building may be repaired using a Epoxy polymer with the cement mixes used to reduce the temperatures stresses as well as to avoid the present cracks of the building as well as to avoid further formation of cracks in future years to come.

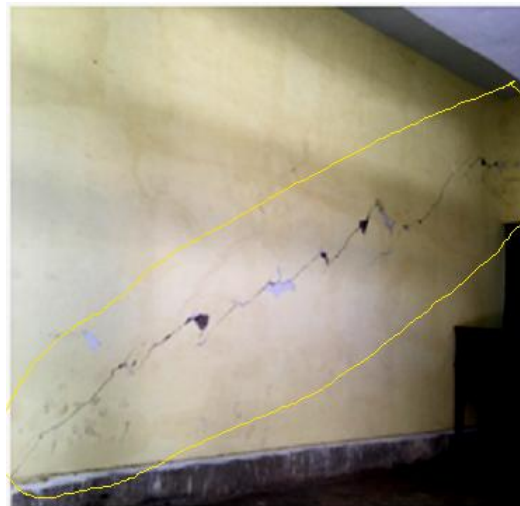
Figure 4: Wall in archaeological block
 Width- 1 to 2 mm
 Type- medium, non-structural crack
 Shape- diagonal
 Cause- settlement of foundation

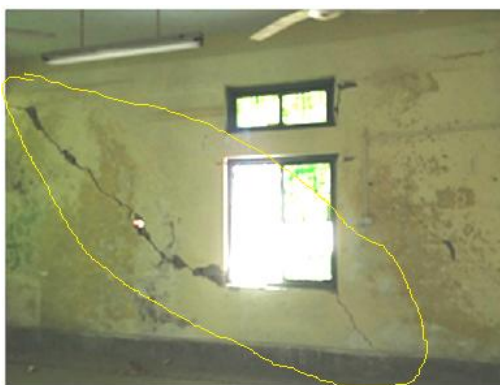
Figure 2: Long Wall of Sir Alexander Cunningham hall (political block)
 Width- above 2mm
 Type- Wide (Non-structural crack)
 Shape- Stair step crack
 Cause- settlement of foundation.

With clear cover of 40mm of concrete and **Case study 2 (moti mahal)** have severe cracks and structural failure therefore it needs to be demolished and rebuilt to ensure the stability of the structure.

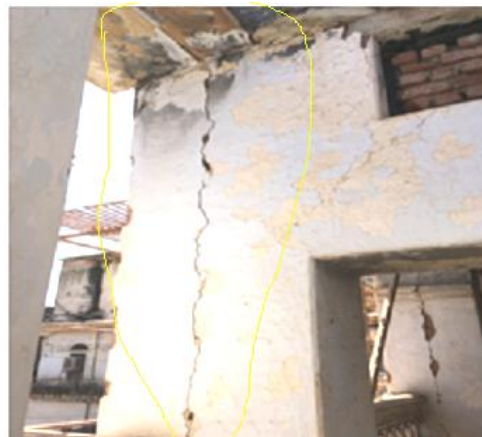
Figure 1: Column at industrial court
 Width- 2mm
 Type- Major structure Crack
 Shape- vertical crack
 Cause-thermal variation, due to joint

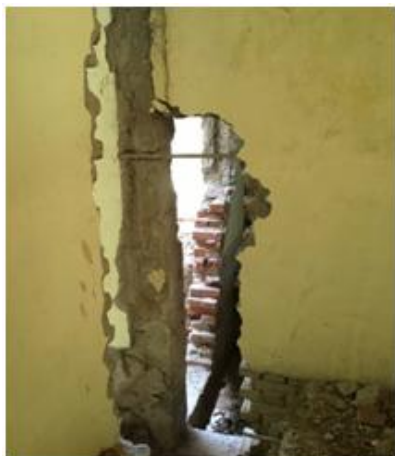
Figure 3: Rear column
 Type- Major Structural crack.
 Cause- settlement of foundation.

Columns should be provided with 4 nos 16mm dia bars as vertical reinforcement along with the tie bars of 6mm dia bars at 300mm spacing.

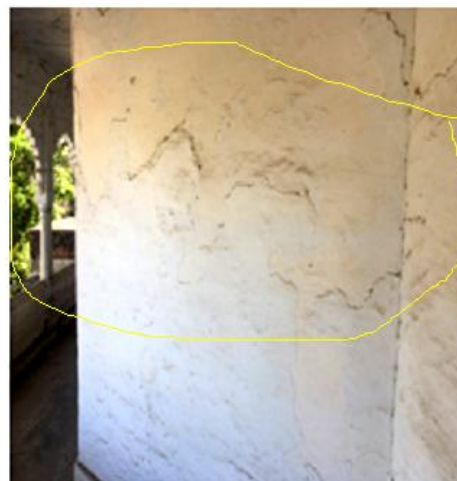
Figure 2: Wall of labour court
 Width- 1mm
 Type- Medium (Non-structural crack)

Shape- Random pattern
 cause- Temperature variation, Shrinkage.

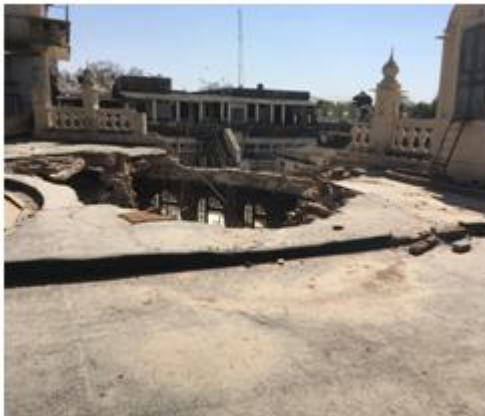
Figure 1: Roof of commissioner hall

Failure of slab
 Type- Major structure Crack
 Cause- due to Fire

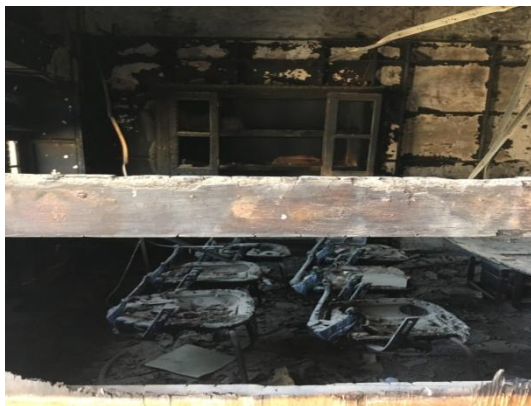
Figure 2: Transportation block

Width-varying from 1mm to 2mm.
 Type- Medium (structural crack)
 Cause- due to Fire

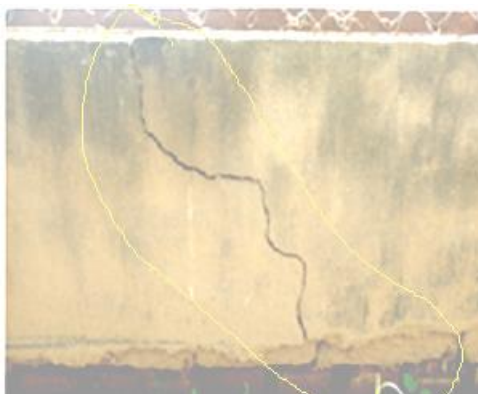
Figure 1: Exterior wall of hostel building

Width – 1 to 2mm
 Type – medium, non-structure.
 Cause – improper construction practice And maintenance
