Case Study on Cracks in Public Buildings and their Remedies

Abstract: Cracks are inherent and detrimental elements of building detailed investigation should be carried out regularly to ensure the assessability and serviceability of the building. For rehabilitation of cracks it is important to understand the causes and the types of cracks appeared in the structure. This paper shortly describes the causes and types of cracks and their remedial measures. Non destructive testing methods are used to access the strength of the structure at a first instance to know the actual state of the structure whether it will be serviceable/workable or to be demolished. Few case studies were conducted at different public buildings at Gwalior M.P. Political science, economic and archaeological blocks of Jiwaji University. Moti Mahal building. NITM (Nagaji institute of Technology and Management building. Which were reported cracks and they were in suspension to whether it will work or should be demolished. The purpose of this study is to determine the position of structure whether it is further serviceable or not and secondly, if we use the same building how it will be repaired.

Case Study 1: Politic

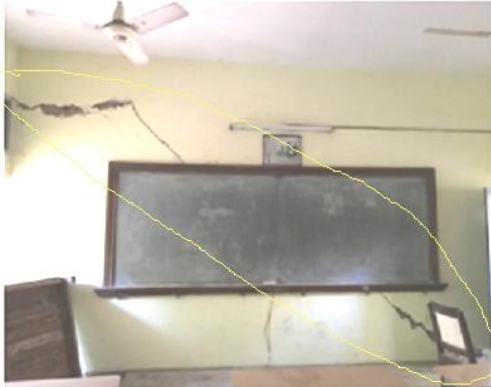
Figure 1: Short wall of classroom16 (political block)
 Width- above 2mm
 Type- Wide (Non- structure)
 Shape- Diagonal, Horizontal crack
 Cause- settlement of foundation

Case study 1(Jiwaji university) and case study 3 (NITM) requires following rehabilitation work:

1) Minor Cracks:

Minor cracks found in the building may be repaired using a Epoxy polymer with the cement mixes used to reduce the temperatures stresses as well as to avoid the present cracks of the building as well as to avoid further formation of cracks in future years to come.

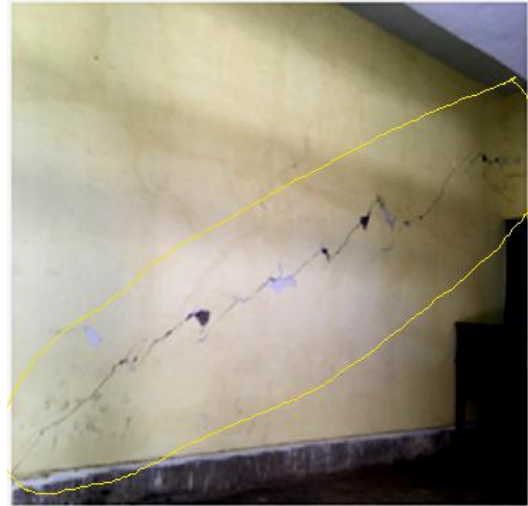
Figure 4: Wall in archaeological block
 Width- 1to 2 mm
 Type- medium, non-structural crack
 Shape- diagonal
 Cause- settlement of foundation

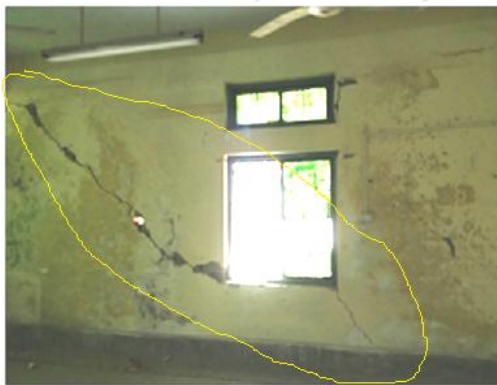
Figure 2: Long Wall of Sir Alexander Cunningham hall (political block)
 Width- above 2mm
 Type- Wide (Non-structural crack)
 Shape- Stair step crack
 Cause- settlement of foundation.

2) Major Cracks

- a) Major cracks found in the building shall be repaired by placing 2 Nos of 8 mm dia M.S bars at every third course of brick masonry followed by the epoxy resin cement mix. Along with the ties of 6mm dia bars to tie the two 8 mm bars.
- b) Walls with the major cracks should be provided with 2 Nos 8 mm dia M.S bars at the joint of wall and the column to check the shear cracks.

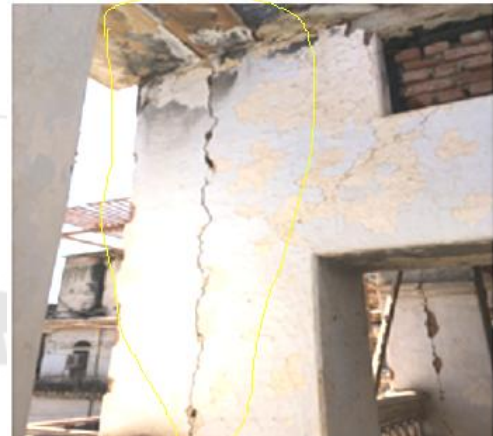
Figure 1: Column at industrial court
 Width- 2mm
 Type- Major structure Crack
 Shape- vertical crack
 Cause-thermal variation, due to joint

With clear cover of 40mm of concrete and **Case study 2 (moti mahal)** have severe cracks and structural failure therefore it needs to be demolished and rebuilt to ensure the stability of the structure.

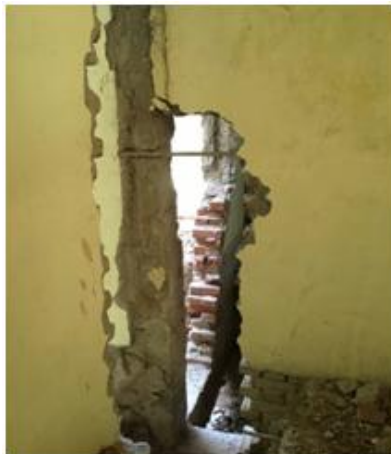
Figure 3: Rear column
 Type- Major Structural crack.
 Cause- settlement of foundation.

3) Rehabilitation of columns:

Columns should be provided with 4 nos 16mm dia bars as vertical reinforcement along with the tie bars of 6mm dia bars at 300mm spacing.

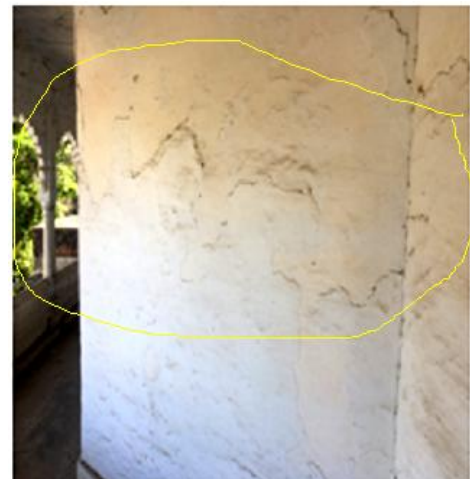
Figure 2: Wall of labour court
 Width- 1mm
 Type- Medium (Non-structural crack)

Shape- Random pattern
 cause- Temperature variation, Shrinkage.

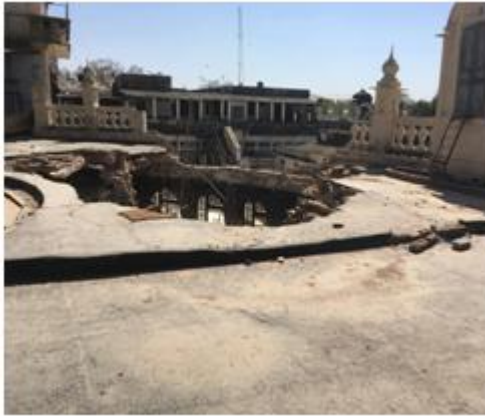
Figure 1: Roof of commissioner hall

Failure of slab
 Type- Major structure Crack
 Cause- due to Fire

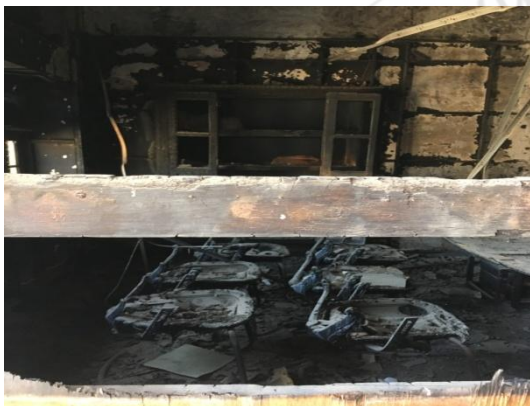
Figure 2: Transportation block

Width-varying from 1mm to 2mm.
 Type- Medium (structural crack)
 Cause- due to Fire

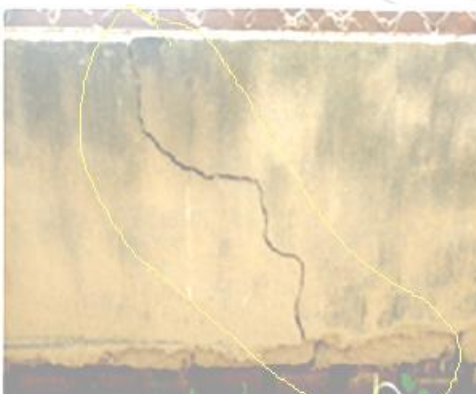
Figure 1: Exterior wall of hostel building

Width – 1 to 2mm
 Type – medium, non-structure.
 Cause – improper construction practice And maintenance
