# An Evaluation Study of Problems and Practices of Shallow Foundations for Combined Flood, Earthquake and Settlement Prone Areas

Ajai Kumar Rai<sup>1</sup>, Brajesh Mishra<sup>2</sup>

**Abstract:** *The development of cities along the bank of river is the common characteristics of all Indian cities developed in the past. Earthquakes are quite common in cities located at the foothills of a hill/mountain range due to its location near the hill/mountain. Settlement and development of cracks in buildings and foundations is the symptom left behind by the earthquake/flood. The low lying areas near the water body are also settlement prone as the construction of foundation of buildings takes place on filled up/unstable or weak soil. The combined effect of flood, earthquake & settlement makes extremely difficult to adopt the techniques of either flood resistant buildings or earthquake resistant buildings. Though all the problems cannot be solved but the life threatening collapses can be prevented and damage limited to repairable proportions can be achieved by adopting the proper remedial measures. In this paper through the evaluation study of Gorakhpur city located at the foothill of Hima

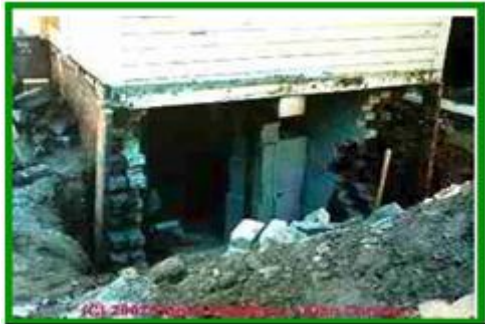
**Figure 1:** Damage of Brick Foundation Due to Wet Soil / Drainage Problem

The moisture absorption of the most porous building material i.e. bricks leads to the, as frost damage materializes by ex-foliation or splitting of the surface ultimately resulting the

salt washing, deterioration or total destruction of bricks. The various factors affecting the brick resistance against frost includes material properties i.e. pore distribution, water absorption, moisture, number of freeze-thaw cycle, freezing speed and climate.

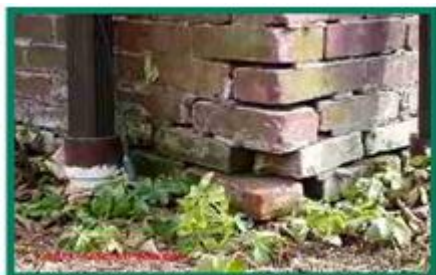
**Figure 2 :** Brick Foundation Damages Showing the mortar damages due to flood

The damage of wood due to thriving of nutrients found in woods by fungus, fungus rot is the most common reason for the deterioration of wooden member. For fungus to grow the essential requirements are availability of oxygen, presence of at least 20 percent water of the dry wet of wood and temperature range 0-40 °C. When the water table is at the top of the foundations, the fungus rot is observed in case of pile & raft foundation. Boring beetles and carpenter ants are the insects that do most damages on wooden foundation above ground level and foundations subjected to rotting defect. Old building foundations generally in low lying areas lies higher than the original terrain and surrounded by filled up soil or waste suffers from the adverse effect of moisture/flood damages. The flood water/moisture penetrates up or out through the foundation walls can freeze and breaking/deterioration of the old mortar takes place either by crumbling of old mortar or by losing of old mortar binding ability. The complete mortar damage / tearing into pieces are possible in case of cores of the box wall foundations. Traveling moisture in foundation wall can carry soluble salts of the mortar and foundation materials at the outer surface where the water evaporates and salt crystallizes. These salt build up can flake off the mortar or surface of the bricks and other building materials used in foundations.

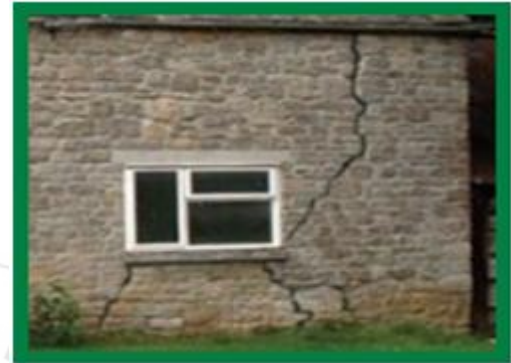
**Figure 3:** Development of cracks in Buildings Due to differential Settlement of Foundations

Ground water table depression may be due to ice static rebound, de-watering of ground water, existing ditches and pipes below the ground water level, construction of new buildings with deep foundation and basement, built up area

having covered surface with asphalt roads and parking areas, reaching of much smaller portion of rainfall as ground water and pulling of ground water by deciduous trees with large & deep root system. Ground with limited bearing capacity can start to settle even in the construction phase which can be observed by the settlement of the foundation or development of cracks in the foundation walls. Differential settlements occur due to uneven depth of the bed rock, excavations under foundations, poor backfill, high loads and unfavorable ground conditions i.e. just excavating down foundation level.

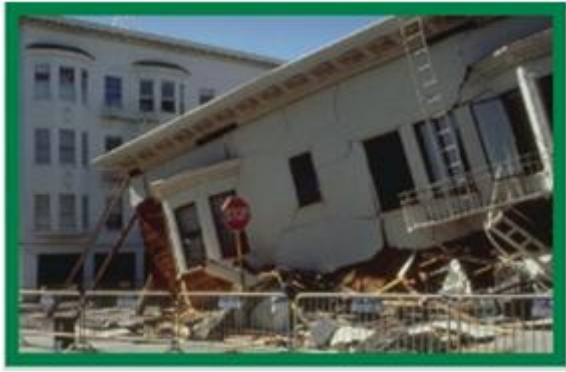
**Figure 4:** Damages of Building/ Foundation Due to Earthquake /Liquefaction

The horizontal acceleration developed in a potentially sliding mass such as steep/unstable slopes, slopes on weak and weathered layer and filled slopes during earthquake tends to increase the driving force and decrease the soil resistance thus decreases the safety factor against sliding as the existing

slope maintains its stability through the greater value of soil resistance than the driving force.

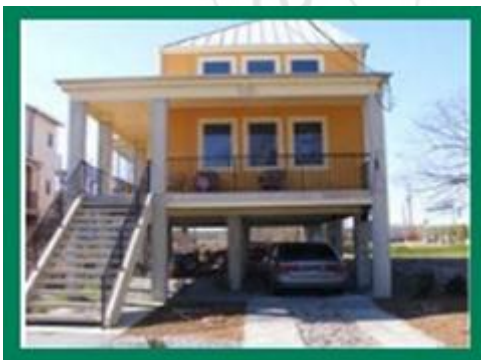
**Figure 5:** Building/ Foundation Design Suiting To Flood prone Area

All building foundations in flood prone areas must be constructed with flood damage resistant materials and these foundations must elevate the building above basic flood level. The foundation should be designed considering flood event and safety against flotation, collapse and lateral movement of the buildings resulting from the flood.

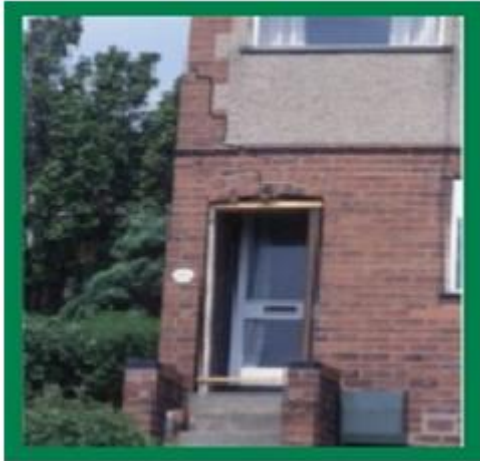
**Figure 6:** Differential Settlement Due to Influence of Trees

Removing of large deciduous trees existing near the foundation wall in case of lowering of water table may enable to control the water table as the roots of such type of trees absorb the water which have the significance effect. Surface infiltration by connecting shallow wells or pipes to the water bearing layer and deep infiltration through shafts in rocks or through pipes extending down to the actual depth of the water table is done.

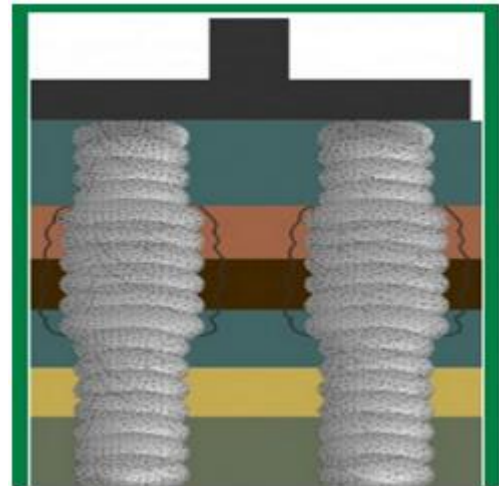
**Figure 7:** Geo-pier Rigid Inclusion Support System

- a) Increasing the safe bearing capacity of soils by soil stabilization techniques such as dynamic compaction, dynamic replacement.
- b) Forming a stiffened mat beneath concrete footings
- c) Providing the tolerance for unforeseen underlying soil conditions
- d) Transferring the load by providing a stone/RCC platform/beam over anchor piles or vi-bro-concrete columns or stone columns used for improving the soil load bearing characteristics.
- e) (e) Providing Geo or rammed aggregate pier support system

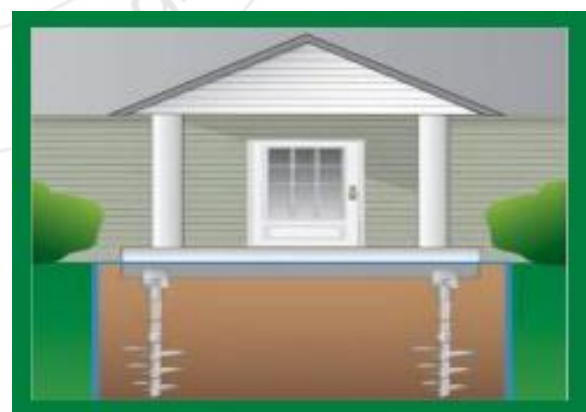
**Figure 8:** Ground Anchoring of the soil underneath foundation

All the new construction in earthquake prone area wooden framed structure with concrete must be affixed to their bases by anchor bolts of diameter 1/2 inches to 5/8 inches 10 inch long and 7 inches or more embedded into the foundation all along the perimeter at spacing of not more than 6 feet with a projected bolt above the mortar or concrete. The bottommost i.e. horizontal wooden member of framed structure are drilled and are set at the foundation flush and nuts are tightened down on the wood. In these areas buildings /foundations can be constructed on firm soil and soft soil after proper design considering the soil characteristics but on weak soils i.e. soils having large differential settlement or liquefying potential. It must be avoided or compacted to improve them so as to qualify as firm or soft soil. Improvement in the soil properties by adopting the stone column ,sand piling ,ground anchoring or dynamic compaction, vibrio-flotation, dynamic replacement suiting the requirement at site for weak or expansive /collapsible must be ensured before the construction of the foundation

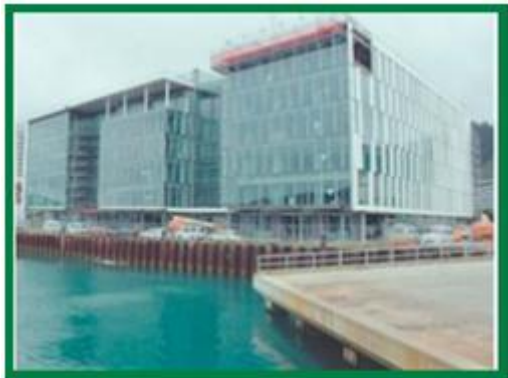
**Figure 9:** Separate Blocks Capable of Moving Independently during earthquake event

The length /width ratio of a block must be less than 3 as the torsional or shear effect of ground motions during earthquakes are pronounced in long narrow rectangular blocks. If longer length of the block is required , it should be break up in two blocks after providing a sufficient spacing between blocks. Each block must have symmetry and

regularity. Large cornices, horizontal or vertical cantilever projections & fascia stones must be reinforced with the main structure if necessary otherwise it should be avoided. In other words preferring simplicity over ornamentation is the best approach.

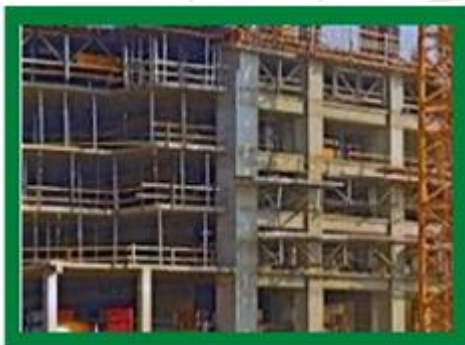
**Figure 10:** An Earthquake Resistant RCC Framed Structure

Where it is possible the area around the buildings should be enclosed with interconnected long walls with transverse walls. Framed structure is preferred over bearing wall construction due to benefits of using greater number of storeys, better control in context to ductility & strength and no effect of number & size of the openings on the strength.

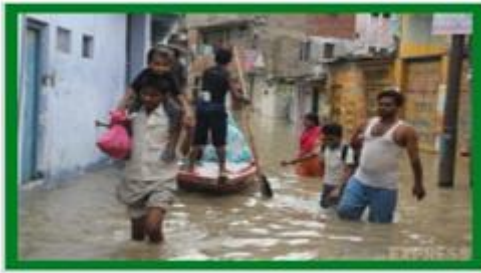
**Figure 11:** 1998 Flood Situation in Gorakhpur

The causes of the occurrence of the flood in Gorakhpur, which has become a major problem due to the water logging during rainy season in many parts of the city are as follows:

- (a) Changing Trend of Climate
- (b) The bowl shape topography of the city
- (c) Release of water from Nepal into rivers
- (d) Gentle topographic slope
- (e) Irregular & unplanned development
- (f) Poor infrastructure & sewerage system
- (g) Haphazard way solid waste disposal

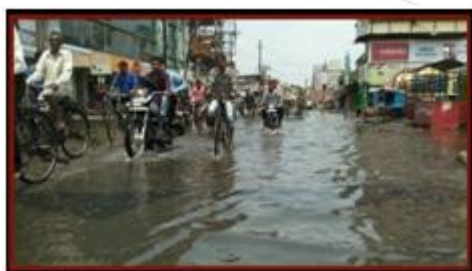
**Figure 12:** Continuous Water logging in Gorakhpur

The Gorakhpur city has experienced rapid and unexpected climate change along with speedy population increase and growth rate in recent years unlike pleasant climate of the past. The average maximum and minimum temperatures of the city were 26 degree and 20 degree respectively in the past has been adversely affected and recent average temperature variation lies between 38-25 degree. The fluctuation in temperature and its effect on the precipitation has resulted the poor sewerage, solid waste disposal, infrastructure, water management and increased water and vector borne diseases due to continuous water logging in the lower areas of the city. The average annual rainfall of the city is 1200mm which is playing an important role in the climate change by increased quantity of rainfall in reduced number of days and uncertainty in the rainfall pattern as compared to the past. Though the high ground water table in the city appears to be boon but total contamination of two layers of ground water as a result of poor water logging, solid waste dumping in haphazard way and poor sanitation/drainage has severely affected the only ground water source of drinking water.

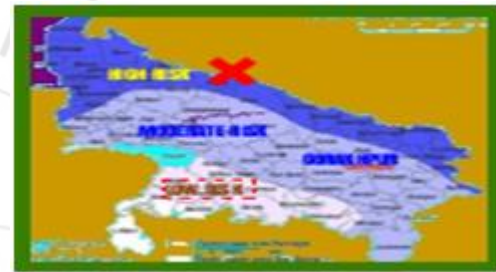
**Figure 13:** Uttar Pradesh Earthquake Zones

Gorakhpur falls in the region of moderate seismic hazard and have experienced seismic activity in the magnitude of 3.18-5.5.as shown in figure3 .Nepal is the major source of earthquake in Gorakhpur where earthquakes are quite common and frequency of earthquake shows rising trends in last five years. The adoption of earthquake resistance techniques in civil engineering structures is the need of today to avoid the problem of tomorrow or near future due to growth rate of the city in context to construction of civil engineering structures and possible liquefaction of soil in case of earthquake event due to presence of Ramgarh Tal/lake covering an area of 723 hectares with a circumference of 18 km. The decrease in the area of Ramgarh lake is the cntiuous process due to utilization of banks of Ramgarh as dump site and colonial development in these areas are taking place in recent years.
