Failure Analysis of Some Aerospace Components through Microscopic Examinations

Abstract: *Microscopic fracture analysis techniques have been used to find out causes of failure of given aerospace materials. The mode of their fracture and various microscopic and macroscopic features has been thoroughly examined before concluding the actual story of failure.*

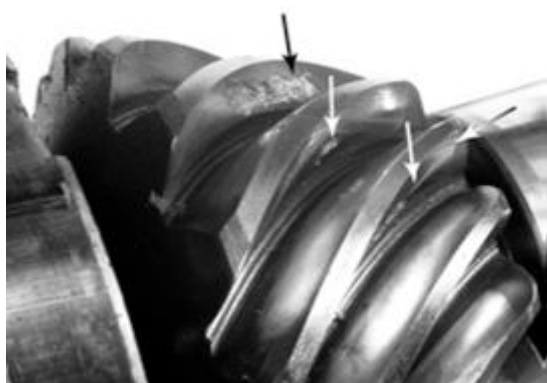
Figure 1: Observed fractures in one of the parts

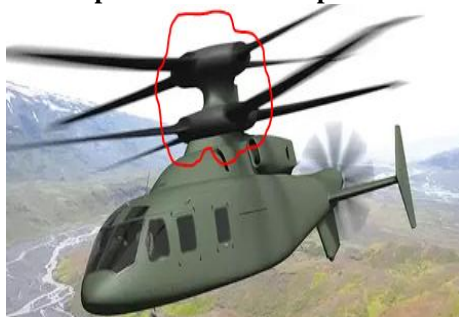
Figure 3: Figure showing location of wheel hub

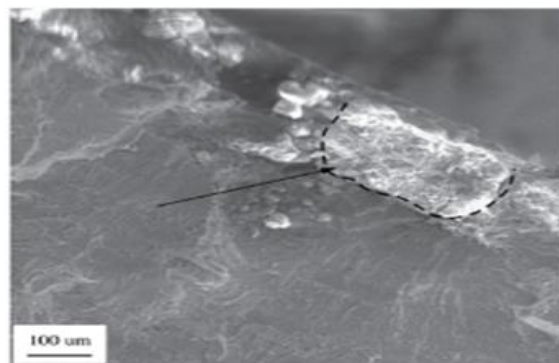
- 1) **Crack initiation:** In the case of wheel hub, the crack initiation was associated with corrosion pit on the surface at the fillet region.

Figure 4: fatigue crack nucleation site from corrosion pit at the specimen surface (marked with black)

Pitting corrosion, or pitting, is a form of extremely localized corrosion that leads to the creation of small holes in the metal. The driving power for pitting corrosion is the depassivation of a small area, which becomes anodic while an unknown but potentially vast area becomes cathodic, leading to very localized galvanic corrosion. The corrosion penetrates the mass of the metal, with a limited diffusion of ions

Saline environment (after further chemical tests)

Since the helicopter to which sample belonged was a naval helicopter so continuous exposure to saline environment of sea may have initiated pits on its surface causing its failure.

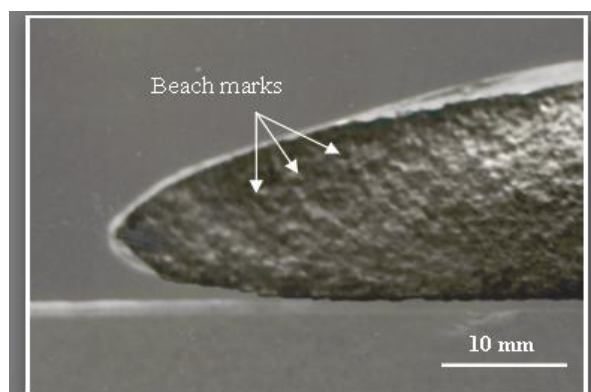
- 1) **Crack initiation:** In the case of turbine blade the beach marks were observed to be initiated from leading edge.

Figure 5: Beach marks seen on the sample

Beach marks are macroscopic progression marks on a fatigue fracture or stress-corrosion cracking (SCC) surface that indicate successive positions of the advancing crack front. They take the form of crescent-shaped macroscopic marks on fatigue fractures representing positions of the crack propagation, radiating outward from one or more origins.

Due to high number of cycles crack initiated from leading end of blade from multiple points which propagated further leading to fracture. By tracing back the beach marks, the origin of crack initiation were identified.

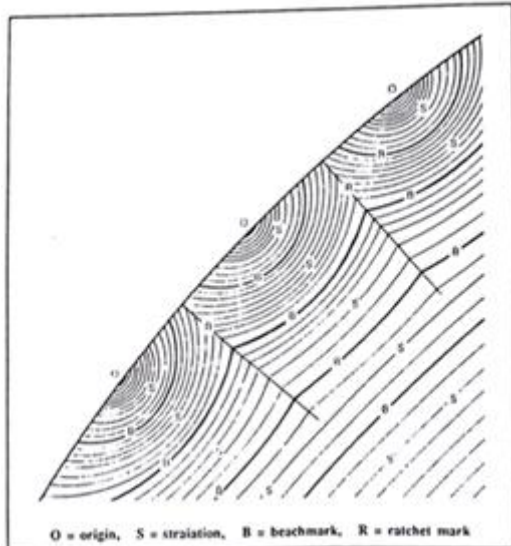
Fatigue striations are microscopic features on a fatigue fracture surface that identify one propagation cycle of a fatigue crack. They are not always present and can only be seen under a scanning electron microscope shown in figure 6

In figure 6, **Ratchet Marks** can also be seen, which are actually traces of vertical planes separating fatigue fractures originating from multiple initiation points.

Figure 6: various features seen on given sample
