Behaviour of Reinforcement in RCC Structure when Subjected to Fire

Abstract: As we all aware that hazards of major fires and fire mishaps are increasing day by day in structures. Therefore evaluation, rehabilitation and repair of structures damaged by fire have become a newsworthy. Effect of fire is most serious potential risk to most of RCC STRUCTURE. In today's world concrete is most widely used in construction field. So, for researchers to make concrete fire resistant has become tropical interest. In many country's several researchers did researches on this topic. In this area Research and developmental efforts are continuously being carried out and other disciplines are also trying to research on this topic. The reality of actual life issue are expressed which gives us real feeling in this topic. From this research we would be familiar on the absolute approach for the rehabilitation of structure damaged due to fire. Also express a particular evaluation and procedures by conducting some techniques known as NDT, and recovering method. To find out the effect of the fire on reinforcement steel bars we performed some experiment on 6 samples, each bar heated to 150°, 350°, 650°, 950

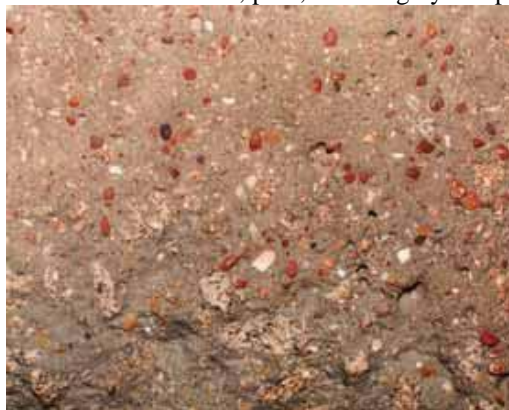
Due to fire discoloration takes place and the possible change in concrete is normal, pink, whitish grey and puff.

Figure 1.1: Color change in the concrete due to elevated temperature

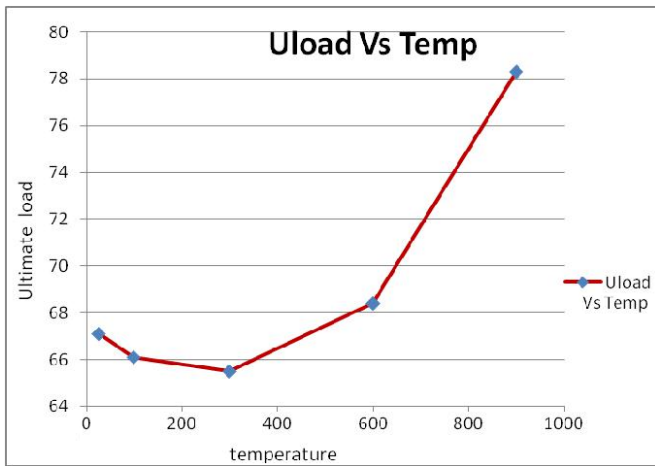
Sr. No.	Temperature in °C	Load (KN)	Ult stress	Yield stress	Max Extn
1	27	66.8	0.58	0.462	1.63
2	150	65.8	0.58	0.472	1.65
3	350	65.1	0.58	0.449	1.44
4	650	68.0	0.68	0.456	0.96
5	950	79.1	0.79	0.479	0.21

Figure 4.1: Unload vs Temp Curve

- 2) Observed the characteristic changes in the mechanical properties of the bars by Tensile strength testing using Universal Testing Machine shows that the increase in ultimate load and decrease in percentage elongation of the specimen which mean that there is significant decrease in ductility of the specimen.
- 3) Study of micro structure of the bars using Scanning Electron Microscope (SEM) also shows that the microstructure of highly heated specimens varies without varying the chemical composition which would have negative impact on the structure.
