Periprosthetic Tibia Fracture after Total Knee Arthroplasty: A Case Report

Abstract: Peri-prosthetic tibia fracture after knee arthroplasty is not a very common complication in the arthroplasty population. We came across one such fracture in our patient who was under follow up in OPD for last six years post arthroplasty. We treated the fracture with locking plate. The patient is faring well in short term follow up, however a long term follow up is needed to know the clinical, radiological and functional outcome as well as to know the complications like implant failure, non-union or re-fracture.

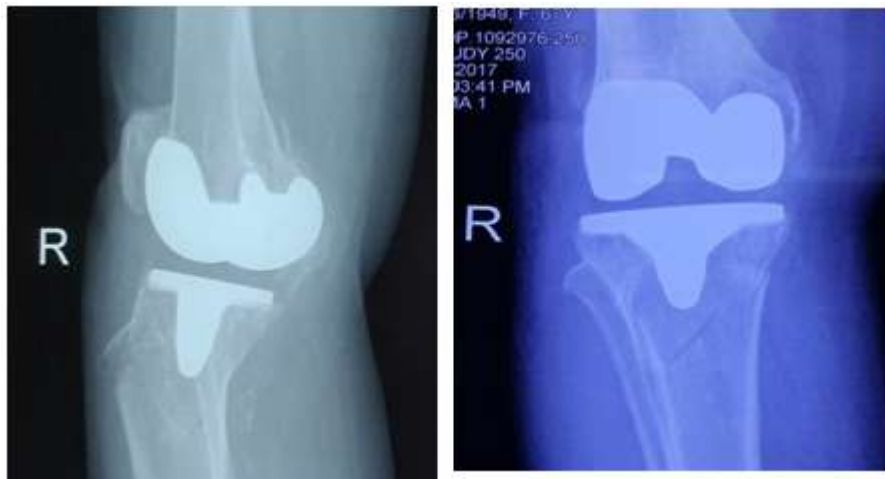
Figure 1: Pre-operative Radiograph Felix Type III-A

We classified the fracture in our patient as Type III subtype A of Felix classification system which includes a fracture distal to the prosthetic stem (**Fig**) and the prosthesis is stable or well fixed. The fracture was fixed with locking plate (**Fig**).

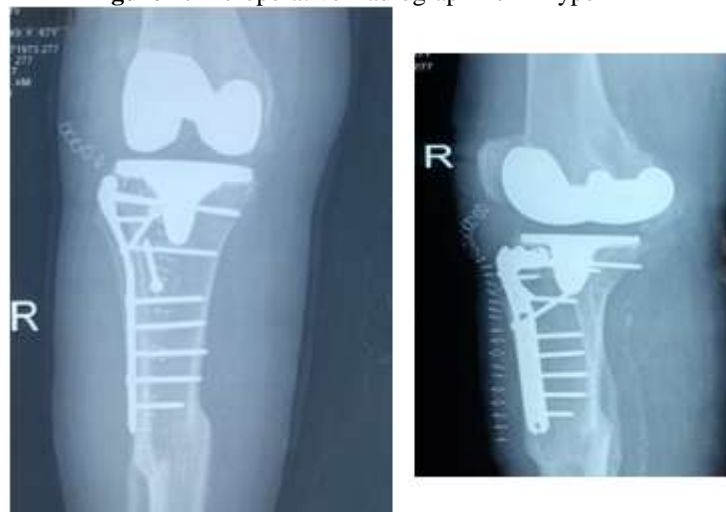
Figure 2: Pos-operative Radiograph

Once declared fit for anaesthesia the patient underwent surgical intervention. Lateral approach to the proximal tibia used and fracture fixed with two inter-fragmentary screws and proximal tibia locking plate. Now patient is under post-operative rehabilitation.
