# Periprosthetic Tibia Fracture after Total Knee Arthroplasty: A Case Report

**Abstract:** Peri-prosthetic tibia fracture after knee arthroplasty is not a very common complication in the arthroplasty population. We came across one such fracture in our patient who was under follow up in OPD for last six years post arthroplasty. We treated the fracture with locking plate. The patient is faring well in short term follow up, however a long term follow up is needed to know the clinical, radiological and functional outcome as well as to know the complications like implant failure, non-union or re-fracture.

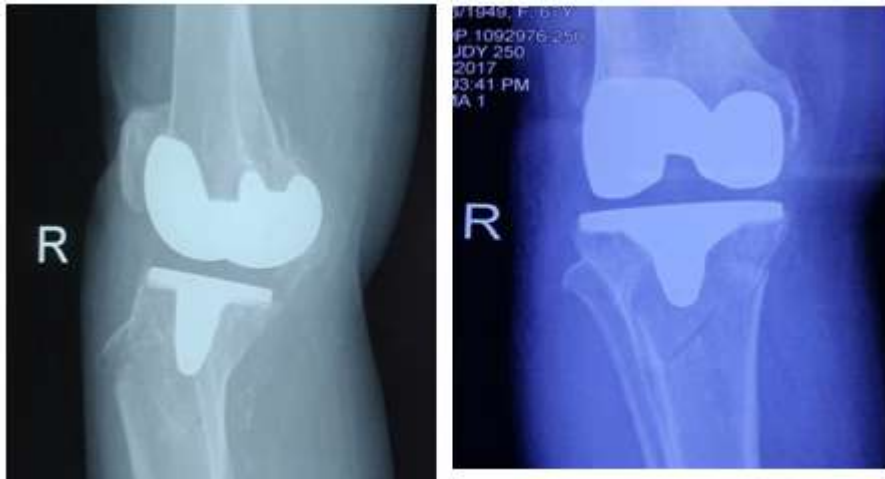
Figure 1: Pre-operative Radiograph Felix Type III-A

We classified the fracture in our patient as Type III subtype A of Felix classification system which includes a fracture distal to the prosthetic stem (**Fig**) and the prosthesis is stable or well fixed. The fracture was fixed with locking plate (**Fig**).

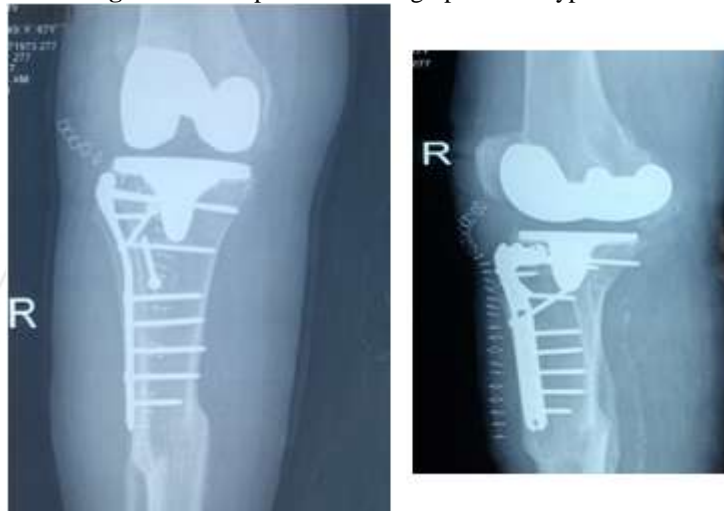
Figure 2: Pos-operative Radiograph

Once declared fit for anaesthesia the patient underwent surgical intervention. Lateral approach to the proximal tibia used and fracture fixed with two inter-fragmentary screws and proximal tibia locking plate. Now patient is under post-operative rehabilitation.
