# Study of an Accident Case through Scientific Observation and Forensic Science Techniques

**Abstract:** *In Haryana, India in the winter season, three persons of same village, under the influence of liquor, travelling in a car collided with a tree during the night. The car was brought to the village by towing but the rope was broken when they reached the village. All three get out of the car for their respective houses; whereas one was found dead lying in the street near the car in the morning. The parents of the deceased alleged that their son was murdered and his dead body was thrown in the village. Scene of crime team rushed to crime spot. Based on observations, photographs and scientific reconstruction of the incident (i.e. influence of liquor, speeding car, foggy night time, bad road conditions, unclear and raised soiled brim of the road, it appears that the driver of the car lost control at the spot and applied brakes but due to speed of car and road conditions; the car went skidding and consequently the front middle portion of the car banged into the giant tree receiving damages in the front side matching in height with damages on the bark of tree and resulting into the fa

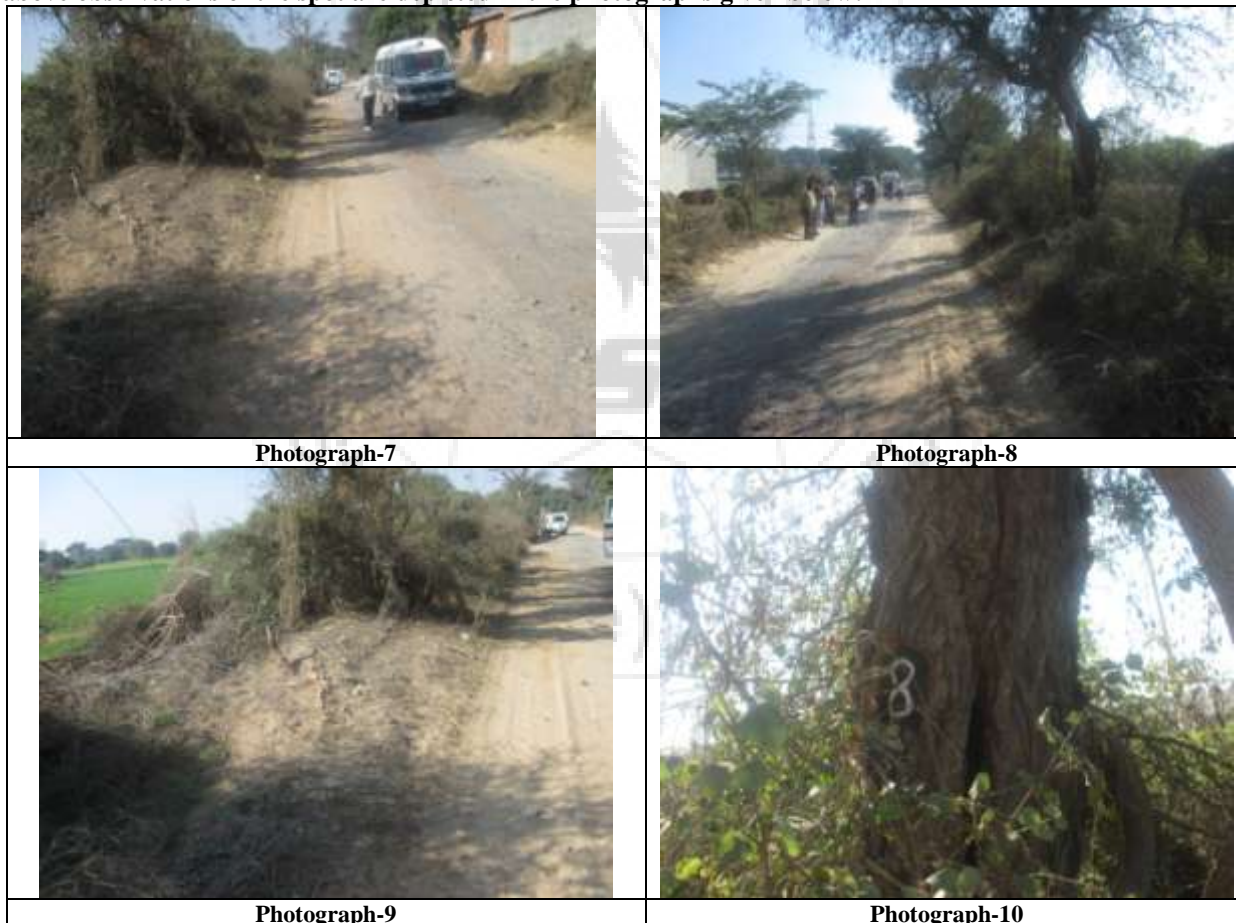
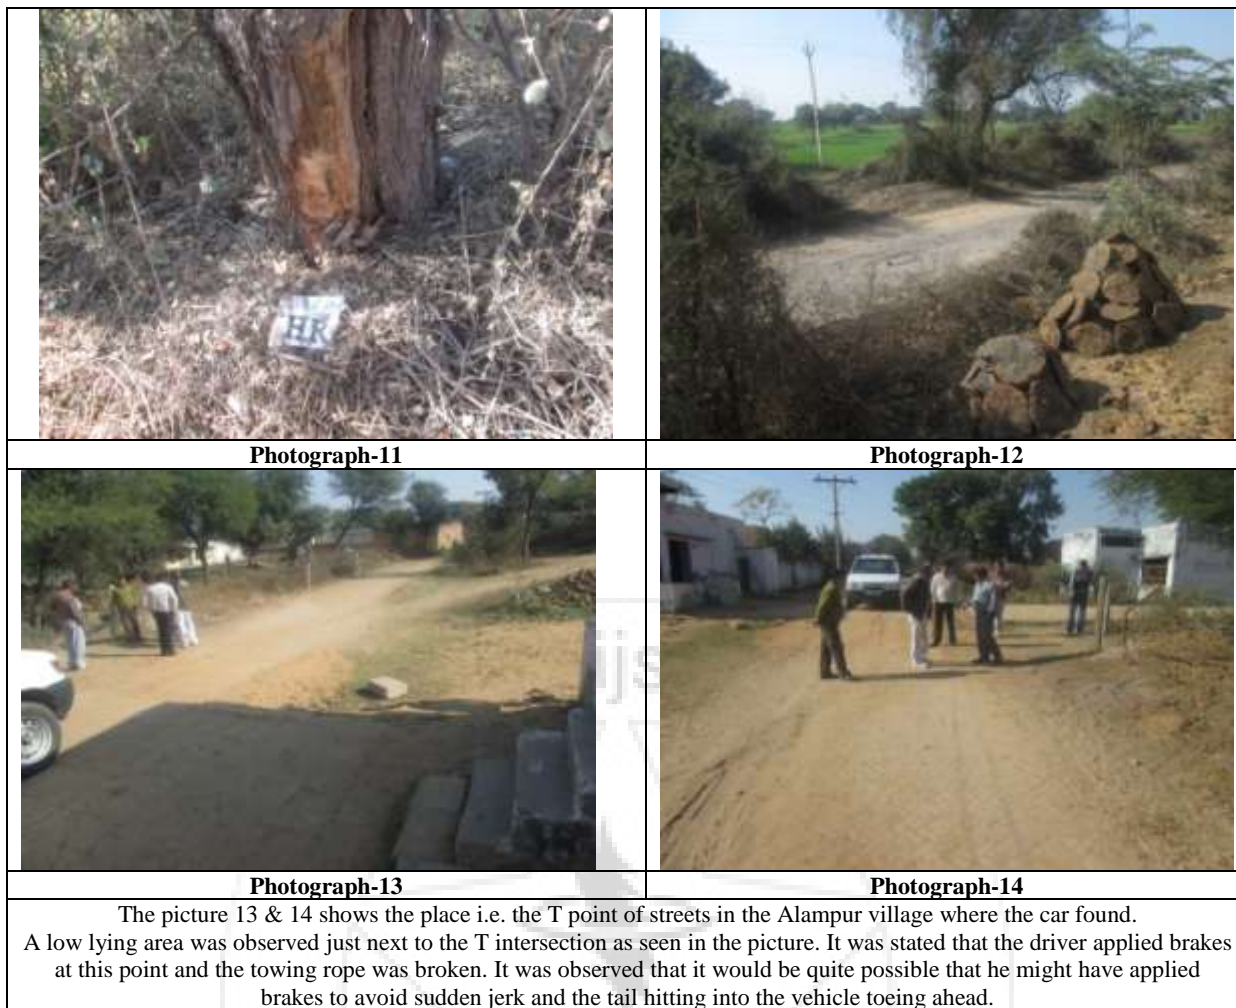
The place of accident was a metalled road approx. 18 feet wide. The following observations were made to describe the road conditions and also depicted in the photographs given below:

- On western side of the spot on the road there were agricultural fields and on the eastern side one house was observed.
- The road was not maintained and carpeted as lot of potholes along with lot of loose gravel and sand noticed on the road. In case of braking of any vehicle the tyres would not grip properly the road because of the mentioned road condition.
- Soiled Brim of road having margin approx. 6' wide was made on both side of the road and it was noticed to be not maintained as a number of bushes/shrubs along with other wild vegetation of considerable height were grown upto the border of metalled road.
- The metalled road was observed to be having no curve at the spot therefore the view of both side upto long distances was very clear.

- The spot was observed at a distance approx. 200 meters in the southern direction from the T junction on the road of village named Thillod.
- Skid mark of length approx. 40 feet were observed along the westernside of the road upto a giant tree grown approx. 7 feet away from the western border of the road. The skid mark began from the edge of the western border of the road and observed to be ended just infront of the mentioned giant tree. The shrubs and vegetation were observed to be uprooted upto the giant tree.

- The approximate circumference of the giant tree was 21 inches. The bark of the tree infront of skid mark was observed to be missing between heights 8 inches and 20 inches from the ground level. One broken piece of front registration number plate was found lying near the base of the tree. Pieces of bark and shrubs were observed to be entangled in the front damaged portion of the car.

- The western side soiled brim of the road was elevated and having a slope towards the border of the road.

The above observations of the spot are depicted in the photographs given below:

On the basis of above scientific observations, photographs and reconstruction of the incident (i.e. influence of liquor, speeding car, foggy night time, bad road conditions, unclear and raised soiled brim), it appears that the driver of the car lost control at the spot and applied brakes but due to speed of car and road conditions; the car went skidding and consequently the front middle portion of the car banged into

the giant tree receiving damages in the front side matching in height with damages on the bark of tree and resulting into the fatal accident. In the reconstruction, it was observed that when the car went skidding on the raised soiled brim of the road the car was tilted on right side as driver side of the car would be on low lying area and the person on left front seat might also tilted towards driver side over the gear lever and when the car banged into the tree the person seated behind might have bounced on the left seat with great pressure and might have struck to the person seating on the left front seat through the gap between the two front seats; in this process the back support of left front side seat was bent forward and the deceased received the injuries mentioned in the PMR.
