# Study of an Accident Case through Scientific Observation and Forensic Science Techniques

**Abstract:** *In Haryana, India in the winter season, three persons of same village, under the influence of liquor, travelling in a car collided with a tree during the night. The car was brought to the village by towing but the rope was broken when they reached the village. All three get out of the car for their respective houses; whereas one was found dead lying in the street near the car in the morning. The parents of the deceased alleged that their son was murdered and his dead body was thrown in the village. Scene of crime team rushed to crime spot. Based on observations, photographs and scientific reconstruction of the incident (i.e. influence of liquor, speeding car, foggy night time, bad road conditions, unclear and raised soiled brim of the road, it appears that the driver of the car lost control at the spot and applied brakes but due to speed of car and road conditions; the car went skidding and consequently the front middle portion of the car banged into the giant tree receiving damages in the front side matching in height with damages on the bark of tree and resulting into the fa

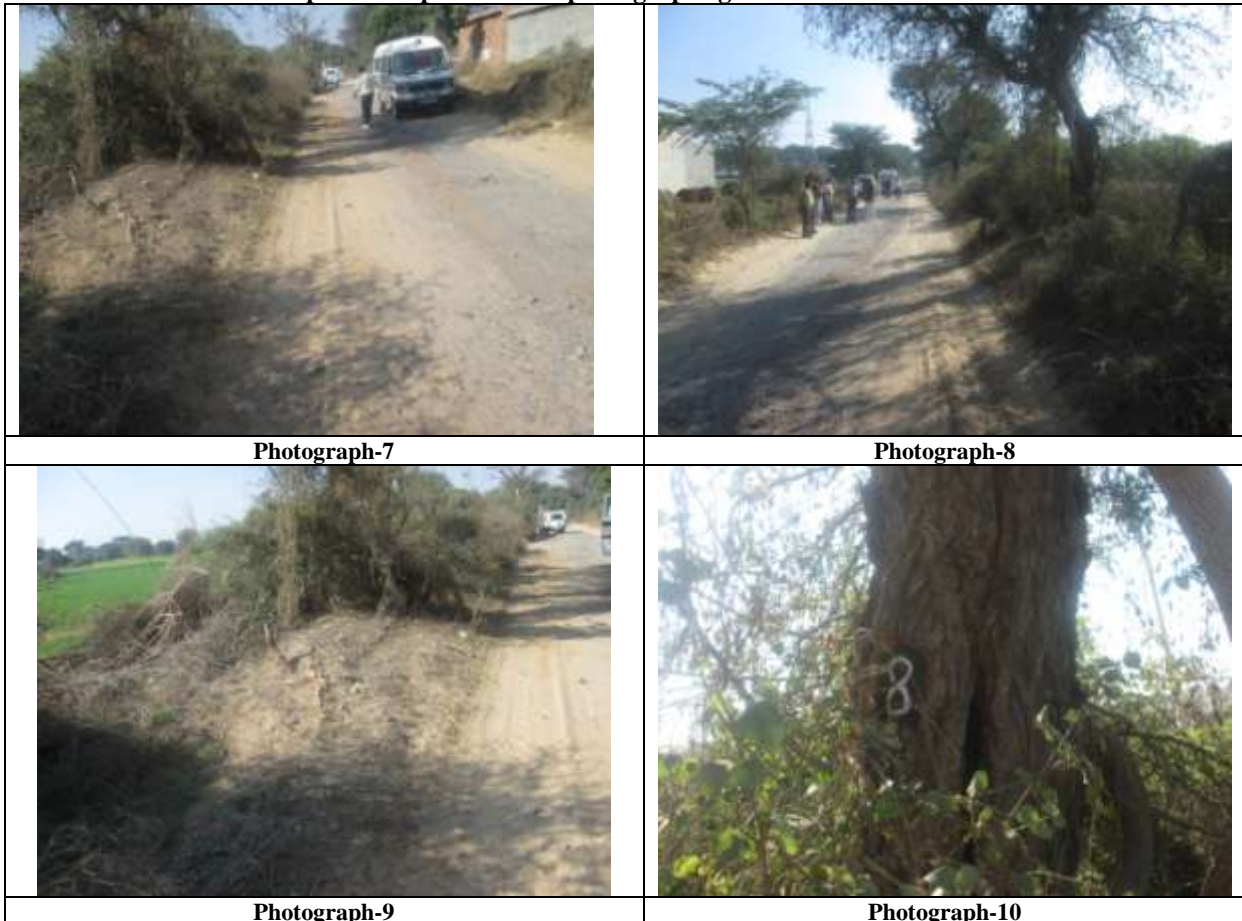
The place of accident was a metalled road approx. 18 feet wide. The following observations were made to describe the road conditions and also depicted in the photographs given below:

- On western side of the spot on the road there were agricultural fields and on the eastern side one house was observed.
- The road was not maintained and carpeted as lot of potholes along with lot of loose gravel and sand noticed on the road. In case of braking of any vehicle the tyres would not grip properly the road because of the mentioned road condition.
- Soiled Brim of road having margin approx. 6' wide was made on both side of the road and it was noticed to be not maintained as a number of bushes/shrubs along with other wild vegetation of considerable height were grown upto the border of metalled road.
- The metalled road was observed to be having no curve at the spot therefore the view of both side upto long distances was very clear.

- The spot was observed at a distance approx. 200 meters in the southern direction from the T junction on the road of village named Thillod.
- Skid mark of length approx. 40 feet were observed along the westernside of the road upto a giant tree grown approx. 7 feet away from the western border of the road. The skid mark began from the edge of the western border of the road and observed to be ended just in front of the mentioned giant tree. The shrubs and vegetation were observed to be uprooted upto the giant tree.

- The approximate circumference of the giant tree was 21 inches. The bark of the tree in front of skid mark was observed to be missing between heights 8 inches and 20 inches from the ground level. One broken piece of front registration number plate was found lying near the base of the tree. Pieces of bark and shrubs were observed to be entangled in the front damaged portion of the car.

- The western side soiled brim of the road was elevated and having a slope towards the border of the road.

On the basis of above scientific observations, photographs and reconstruction of the incident (i.e. influence of liquor, speeding car, foggy night time, bad road conditions, unclear and raised soiled brim), it appears that the driver of the car lost control at the spot and applied brakes but due to speed of car and road conditions; the car went skidding and consequently the front middle portion of the car banged into

the giant tree receiving damages in the front side matching in height with damages on the bark of tree and resulting into the fatal accident. In the reconstruction, it was observed that when the car went skidding on the raised soiled brim of the road the car was tilted on right side as driver side of the car would be on low lying area and the person on left front seat might also tilted towards driver side over the gear lever and when the car banged into the tree the person seated behind might have bounced on the left seat with great pressure and might have struck to the person seating on the left front seat through the gap between the two front seats; in this process the back support of left front side seat was bent forward and the deceased received the injuries mentioned in the PMR.

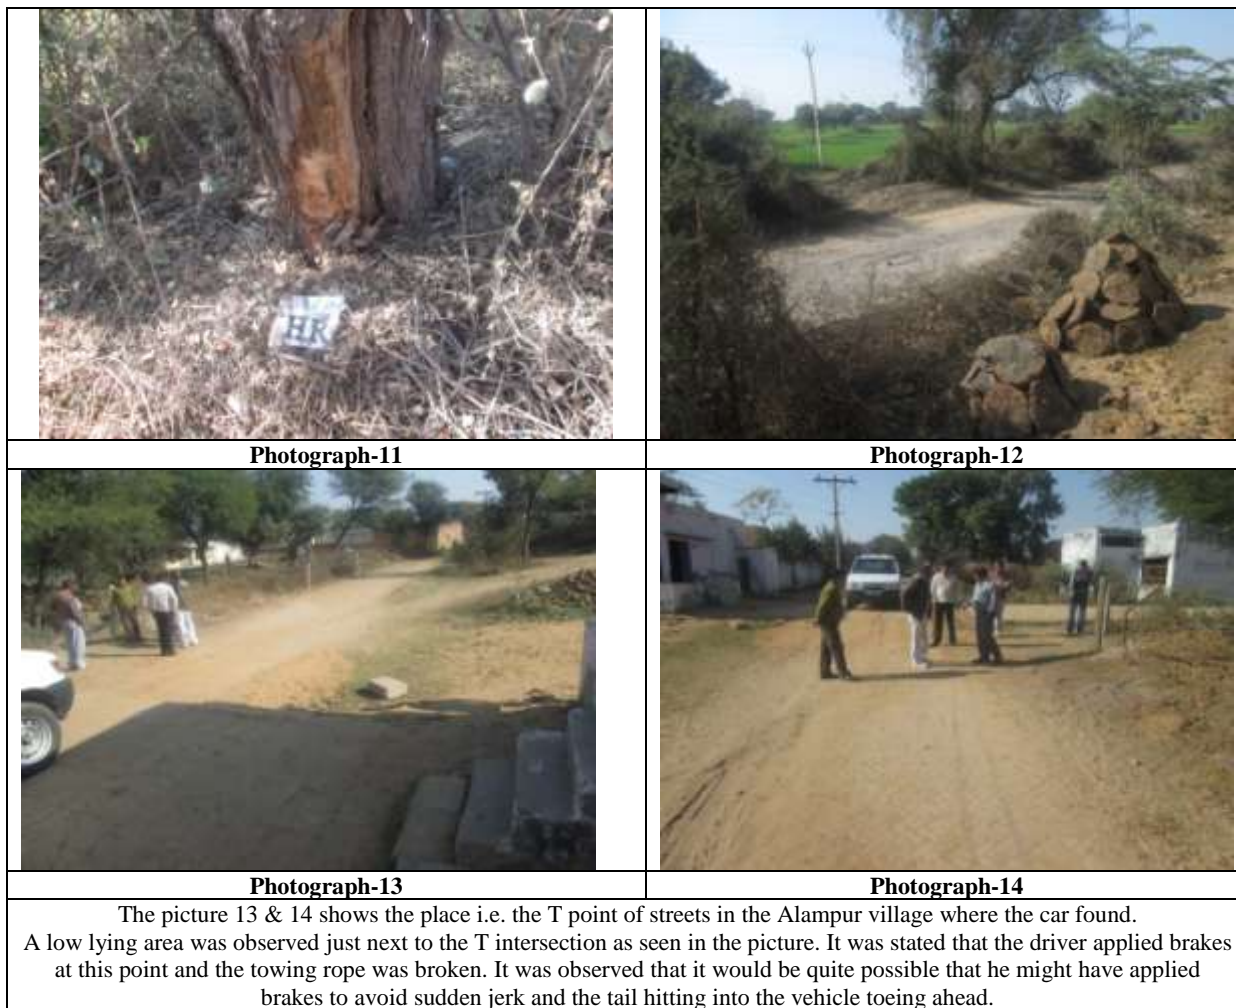
The above observations of the spot are depicted in the photographs given below:
