Coastal Erosion and Land Degradation - A Study at Navaladi, Batticaloa, Sri Lanka

Rajaretnam Kiruparajah

Department of Geography, Eastern University, Sri Lanka

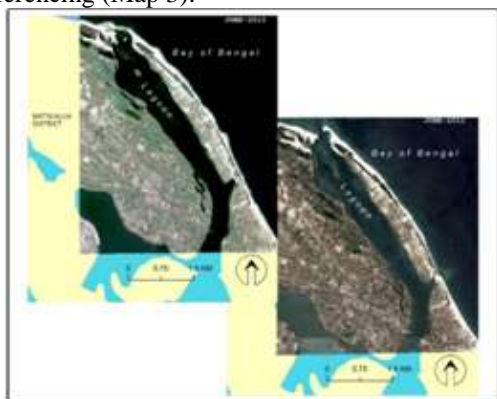
Map 3: The prime data sets acquired from Google earth dated June 2010 (Left) and June 2011 (Right) of the study area

Satellite imagery is the prime datasource for this study. Many recognized websites provide satellite data free of cost to promote research by the use of remotely sensed data. However, some remotely sensed data have certain limitations in resolutions to obtain recent or current data. There is some possibilities of getting the latest and high resolution satellite imagery having spatial resolution less than or equal to 1m, from US based satellites like Worldview-2 or Quickbird, etc., but more expensive. An alternative solution is to download satellite images from Google Earth¹. In recent years, most popular image processing and GIS software like ERDAS IMAGINE, ENVI, ArcGIS, etc. have provided tools to visualize and import Google earth images (Malarvizhi et. al. 2016). The Advantage of Google earth is that it provides the latest satellite imagery having spatial resolution in very high, clear view of features such as buildings, roads, and coast, etc., further Google earth provides temporal data which will be very useful for land use mapping and coastal change detection studies of the region of interest. The only limitation of Google earth is that it may not be possible to obtain the original multispectral band data. The present study is an attempt in this direction, in which 48 individual tiles of Google earth images covering Navaladi area in Batticaloa district, Sri Lanka were extracted using Terra Incognita for GPS mapping and management open source software. The advantage of Terra Incognita for GPS mapping and management software is that it downloads the images along with the coordinated information from Google earth. And these downloaded images can be directly utilized in GIS environment for spatial analysis without the need for geo-referencing (Map 3).

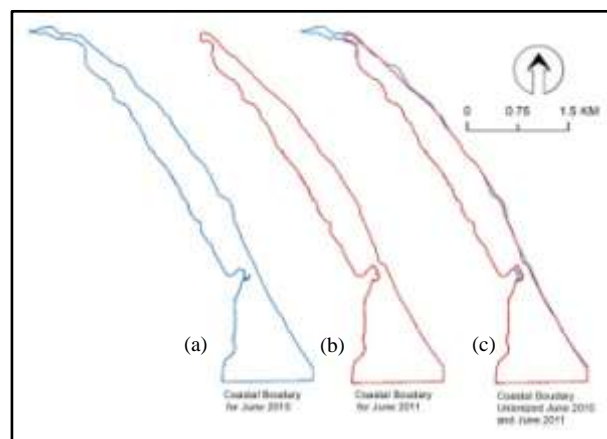
Map 4: The overlay of two different polygons in two periods of time. (a) The boundary represents study area in 2010, (b) Another boundary for 2011 and (c) An overlaying both periods of 2010 and 2011 coastal boundaries.

But, some other images and maps were converted from geographic coordinate system (latitude/longitude) to projected coordinate system (northing/easting) using UTM² projection in Arc GIS 10.5. Two sets of cloud free satellite images were acquired for this study, and every set contains 48 images. One set (dated June 8, 2010) and another set (dated June 17, 2011) of images were collected from historical site in Google earth. The boundary of the study area as seen in Map 1 is digitized as polygon and has been converted from ArcGIS shape file format (.shp)³. There are two polygons 2010 and 2011 digitized separately for the boundary of the study areas from satellite images, each polygon representing those coastlines in respective years. The polygons processed to overlay operation, for detect eroded and deposited areas along the coast of study area, and then geo-processing tool used for union function and geometric calculation effectively (Map 4).

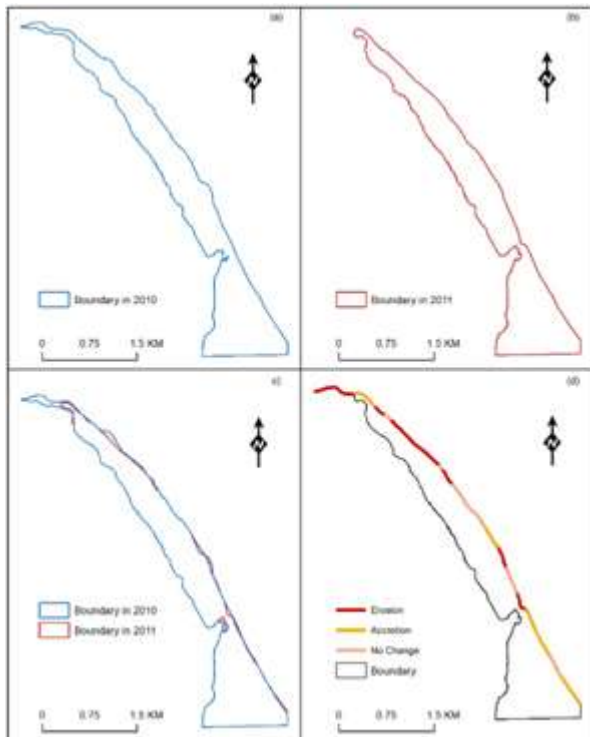
Map 5: The condition of the coastline in study area. Map (a) boundary in 2010, (b) boundary in 2011, (c) An overlapped

map both 2010 and 2011, and (d) Coastal condition in lengthwise

When comparing the boundaries for two different periods of time, obviously understands the differences of changes on the coastline. According to this, coastline was subjected to severe erosion in several locations, and accretion was happened in a few areas. Based on different action, the coastline categorized into 3 type of coastlinessuch as erosional coastline, depositional coastline and stable coastline. Erosion process happened in 2828.42 meters long, accretion in 2207.59 meters long and unchanged 1907.48 meters of the shoreline out 6943.5 meters in total length.

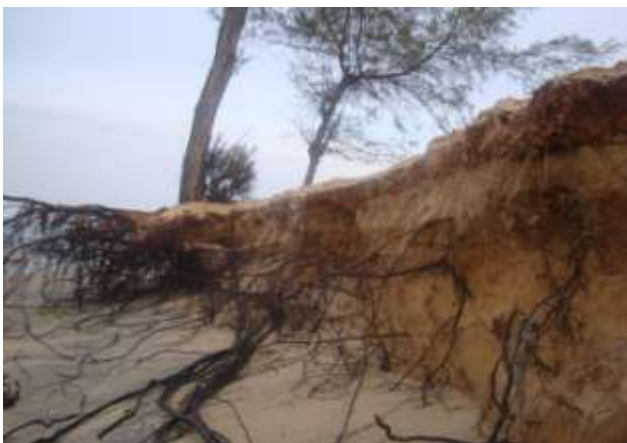
Plate 1: A severe wave action observed along the coast due to the sudden change of beach profile as steeper

The photograph (Plate 1) below, a great example to severe erosion on coast in Navaladi.

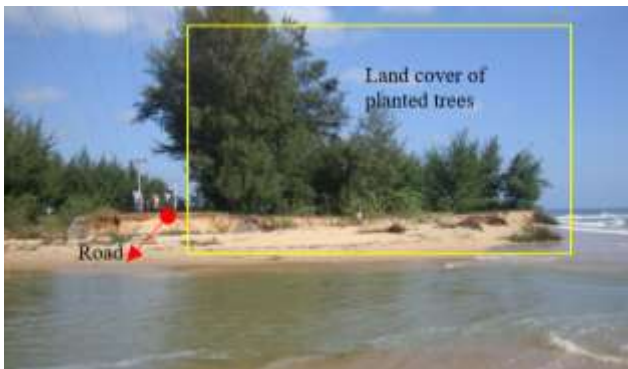
Plate 2: Water discharge toward sea via opened new mouth of lagoon (Photograph dated on Feb 12, 2011)

image shows the same direction as 93 meter the length between lagoon and sea reduced by 107 meter. Based on the scenario, there have been a change to land that will be broken as two parts and a small new island will form in future. In addition to that, the photographs are representing as plate 2 and 3 for same place but photographs were taken in two different time of study area. These are the evidences for land degradation due to the human activity in this site. When comparing with 2010 land use map with 2011, some of the land use portions are disappeared, in a few portion of land use changed from one to another, the sea water entered into land, someone reduced in their scale and some land use extended from previous scale.

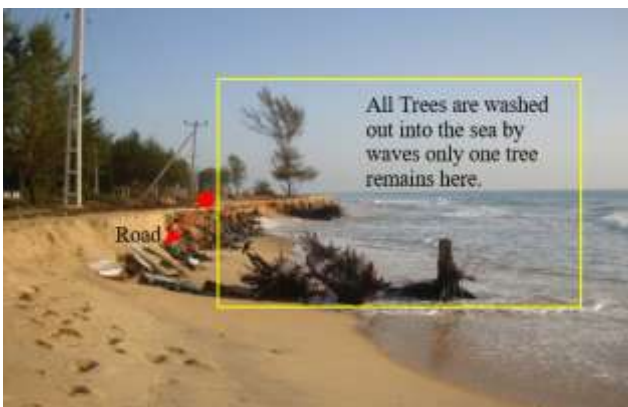
Plate 3: Coastal land degradation by wave and running water. (Photograph dated on July 2, 2011).

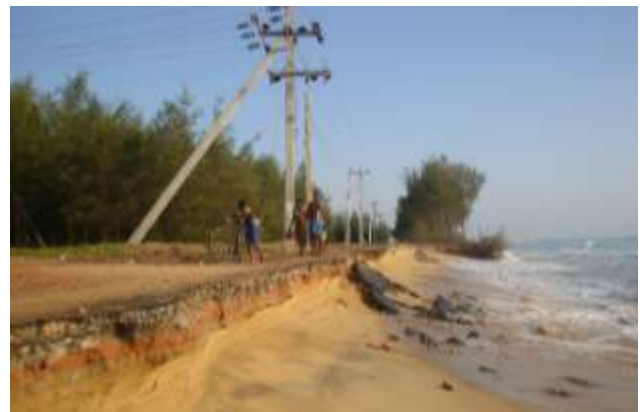
Plate 4: The Main access along the coast of Navaladi was severely affected.

These are exactly, 1.73 hectares of trees are lost, 0.55 hectare of wetland destroyed and it became permanent water body now, bare land reduced by 0.33 hectare in this highlighted study area. It is representing percentage of degradation 66%, 21%, and 13% respectively in amount of total degradation land. The road access in this area altogether was 25,920 meters in 2010. In 2010, it was reduced by 230 meter and damaged 425 meters in long, these are the main access connected to Navaladi and Batticaloa city (Plate 4).

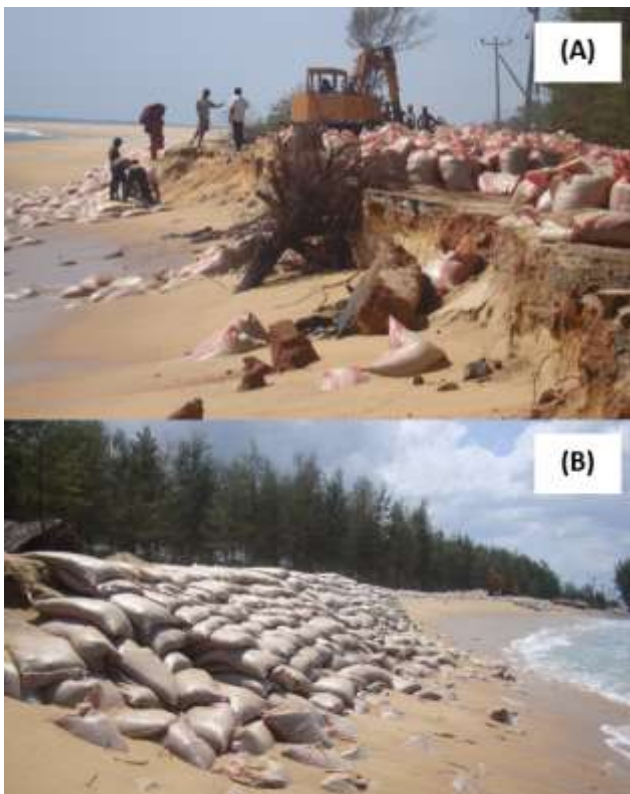
Plate 5: There are two photographs, prevention measure for coastal erosion by government authority. Photograph (A)

sand bags arranged with heavy machinery, and photograph (B) completion of prevention works in study area.

The Coastal Conservation Department of Sri Lanka made steps to inhibit the coastal erosion in the study area. For an example, the Government representatives in different levels came with heavy machinery, laborers and other accessories at right time to the spot, and they were preparing thousands of sand bags to place in identified coastline to prevent the erosion. Few days after, most of the sand bags were transported from onshore to offshore by waves. Because, at the moment beach profile was steeper and the wave action was very aggressive, the inhibiting force for coastal erosion had beyond their management. However, few days later they achieved their task in certain coast lines (photograph (B)).

Nowadays, the respected authority shows good sign (Plate 5) specially the Coastal Conservation Department of the country aware regarding this issues and attempting several steps to inhibiting coastal erosion temporarily. The setback system in the coastal defense and management shall be improved by the Government authority in regional level.
