Research on Study of the Investigation of mass Movement along Malshej Ghat

Prof. P. D. Sabale¹, Prof. S. J. Yadav², S. G. Admuth³, H. R. Ambavane⁴, V. R. Athawale⁵,
N. C. Chavan⁶, P. B. Govekar⁷

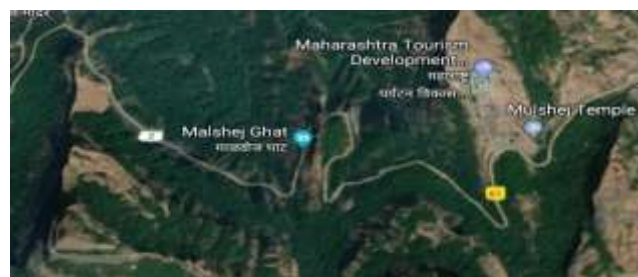
Image 2: Satellite image of malshej ghat

We select investigation territory is Malshej Ghat which is goes under western ghat go in the thane and pune region of Maharashtra province of India The scope and longitude of malshej ghat is 19°20'26.25"N and 73°46'28.39"E individually, rise of Malshej Ghat is 588.29m the geomorphology is likewise extraordinary at different area the profoundly weathered, respectably weathered, minimized basalt are exist at different spot.
