A Case Study of Existing Institutional Building for Assessment and Repair

Domain: Smt. S. R. Patel Engineering College, Dabhi, Patan-Unjha Road, Gujarat, India. This is G+1 structure which is 10 years old. In this building Ground floor is having JV001 to JV014 and First floor is having JV101 to JV114.

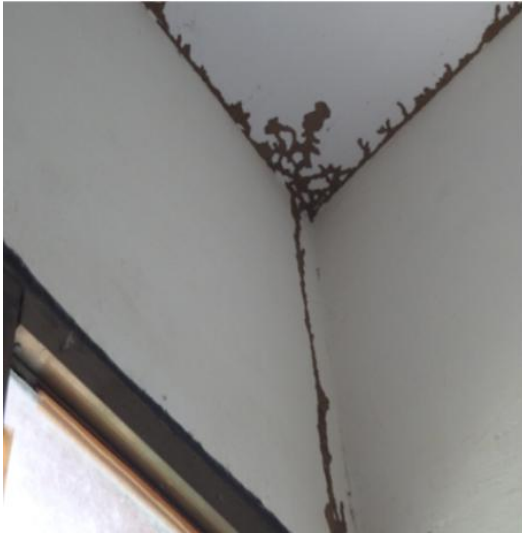
Photograph 1: Termite

Mainly the problem of termite is observed everywhere in the building. The main reason for this is that it is agricultural land and termite is found in mostly agricultural land. Chemical test analysis classified the test results of carbonation test, sulfate test and chlorination test, the initial corrosion of reinforcement in beam, column and slab is being observed. It can be seen that detailed visual inspection and Non Destructive Testing (NDT) play an important role in condition assessment of existing buildings. Level of distress can be determined using suitable NDT test along with detailed observation and with proper restoration methods the life period of structure can be enhanced.

For Termite treatment first of all, holes are drilled at 30cm c/c at a downward angle of 45° from both the sides of the external wall at plinth level and the chemical emulsion is pumped in these holes under pressure. Chemicals used for termite treatment are Aldrin, Heptachlor and Chlordane.

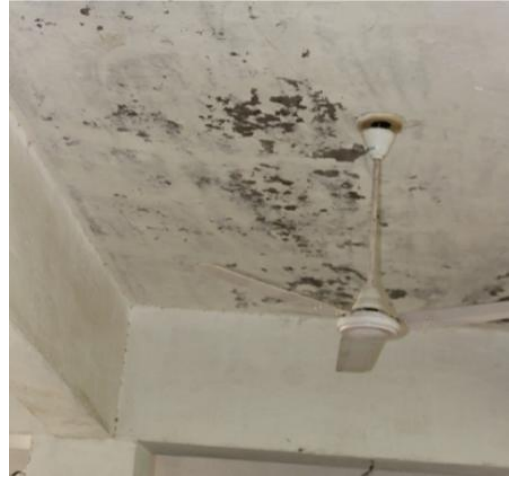
Photograph 4: Leakage and Dampness

For internal wall bituminous emulsions painting, water proofing solution painting and applying cement wash. For external wall remove vegetation near building, coating with boiled linseed oil as well as use bituminous painting, cement wash and also such type of solutions used for water proofing for external side of building.

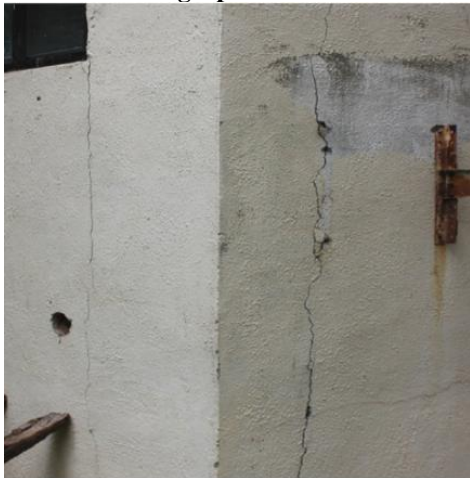
Photograph 2: Vertical crack (Wide crack)
Due to Thermal stress

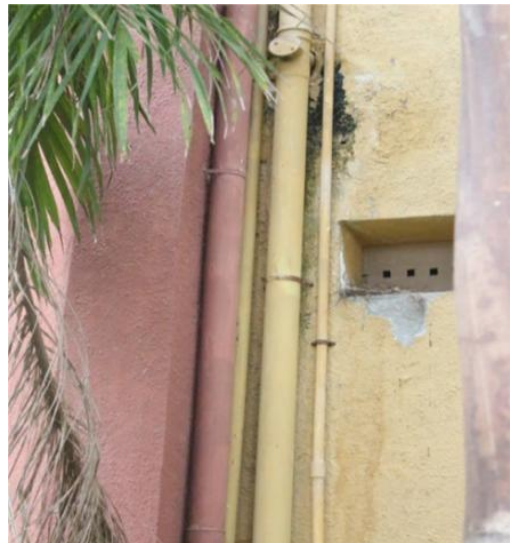
Photograph 5: - Improper/poor drainage pipe

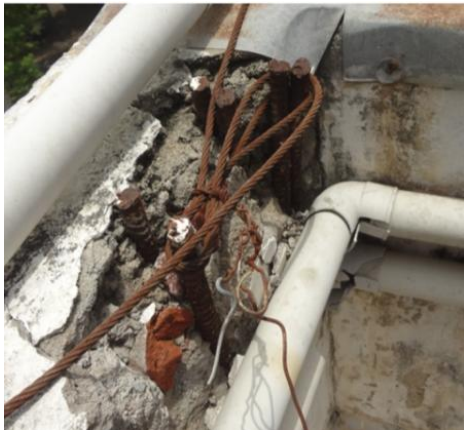
Photograph 3: Open reinforcement and
Environmental Effect

Prepare fresh concrete and fill all column open reinforcement and also bar should be properly adjusted and placed for future expansion of building.

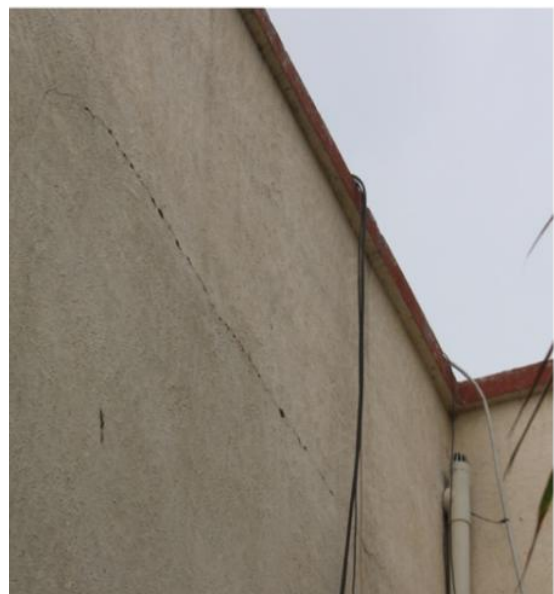
Photograph 6: Horizontal crack due to shrinkage

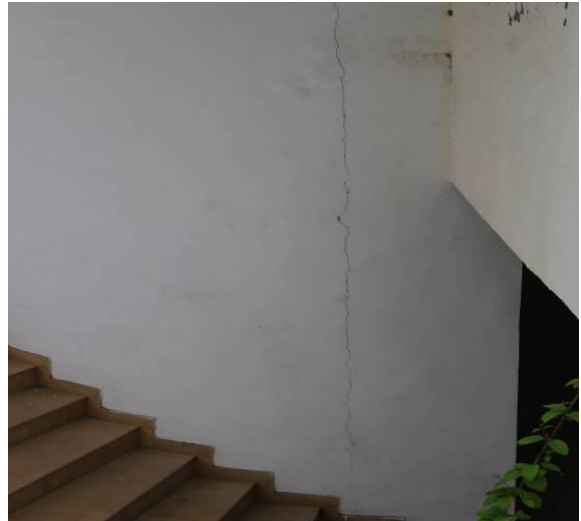
Photograph 10: Beam-wall / Vertical crack (Expansion joint)

In view of leakages from the expansion joint, it is recommended to clean the joint and fill it with Polyurethane sealant and redo the portion as per IS 5256-1992 provisions.

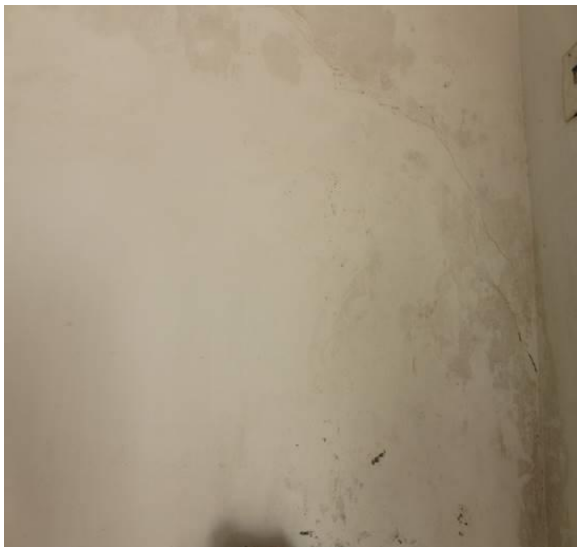
Photograph 8: Near vegetation (Diagonal cracks)

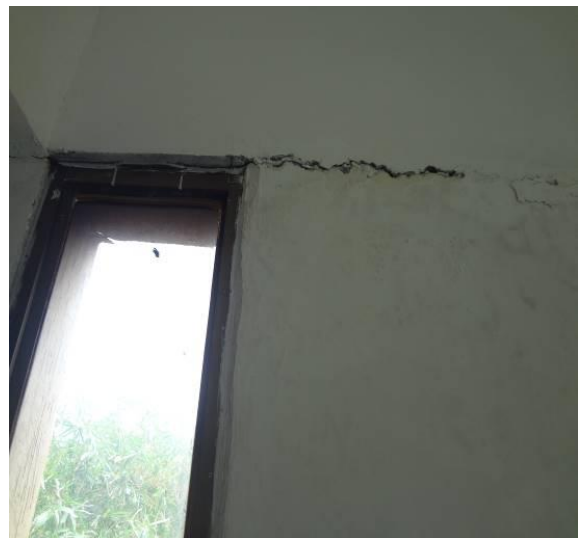
Photograph 11: Beam-wall (Horizontal crack)

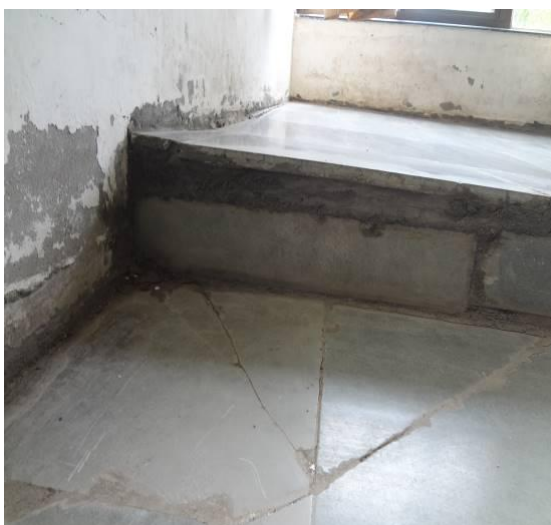
Photograph 9: Flooring/ Improper leveling

and vegetation in the foundation and also due to the expansion of brickwork and flooring settlement is everywhere at all floor in college building, it is caused during thermal expansion. It is also caused due to less compaction of materials below the floor.

The damaged tiles are removed and the flooring was compacted properly to remove air voids then new tiles were laid in level with cement paste. The popping up of terrace flooring cannot be repaired .It has to be removed and replace

by another flooring and by sealing the joints to make it water proof. So, that moisture or damp air cannot be infiltrate inside the flooring.

In Cement paste add waterproofing admixtures like waterproofing adhesive, its brand name Zentrival PL and Zentrival HS. It is polymer based water proof tile adhesives used for better bond, adhesion, strength, faster work and good waterproofing quality [IS : 2645-1975].

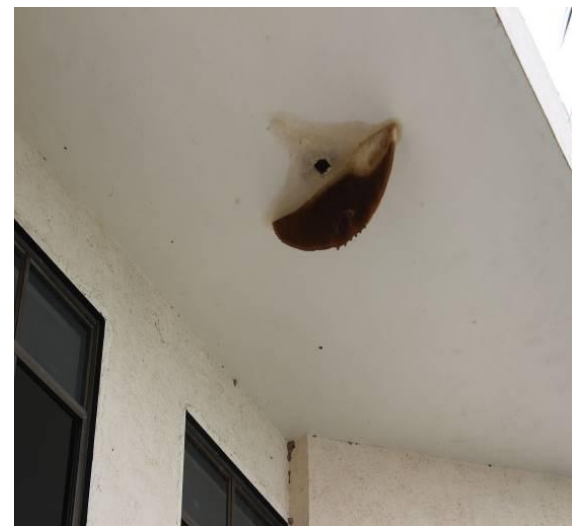
Photograph 12: Lack of maintenance

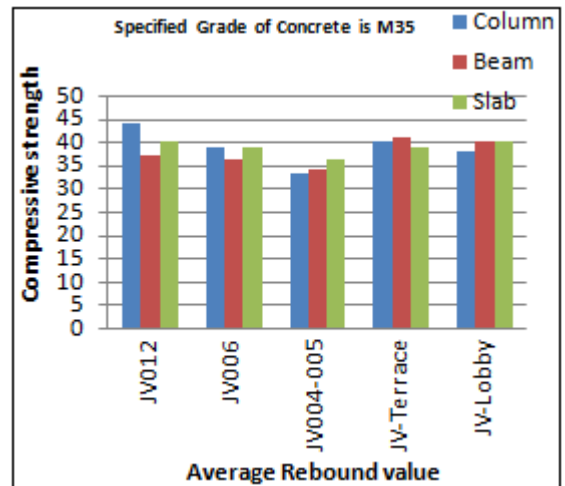
Figure 4: Graph of Rebound number v/s Compressive strength

The Bar chart (Figure: - 4) was prepared based on the results obtained from the Rebound Hammer Test conducted on selected structural members of the building and a few locations of Beam, Column and Slab. The results were concluded in reference to Calibration graph (Figure: - 3).

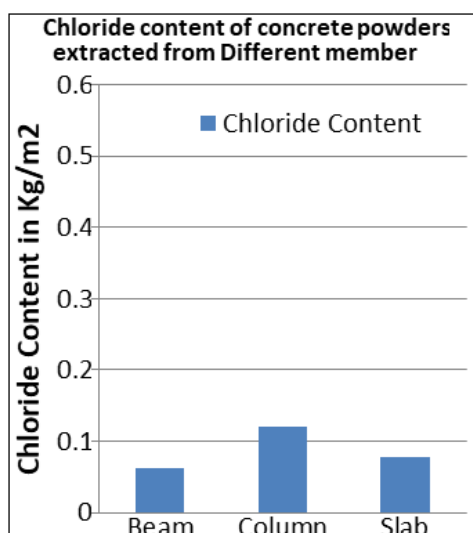
Figure 6: Chloride content of concrete (Taken average value of beam, column and slab)

The test results obtained after chloride content test are within considerable limits so that chloride was not the reason for corrosion. The values of test result are shown in Figure: - 6.
