State-of-the-Art Review on Masonry Structure: Identification Behaviour and Seismic Retrofitting Techniques for Structures

Abhishek Ghimire

District Support Engineer, Earthquake Housing Reconstruction Project (EHRP), National Reconstruction Authority, Nepal

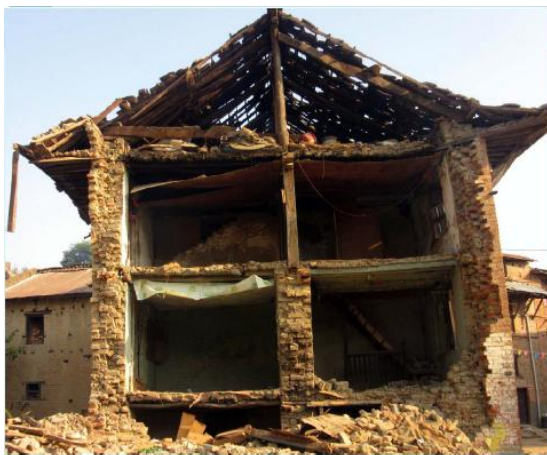
Figure 1: Failure of exterior walls on Masonry building [6]

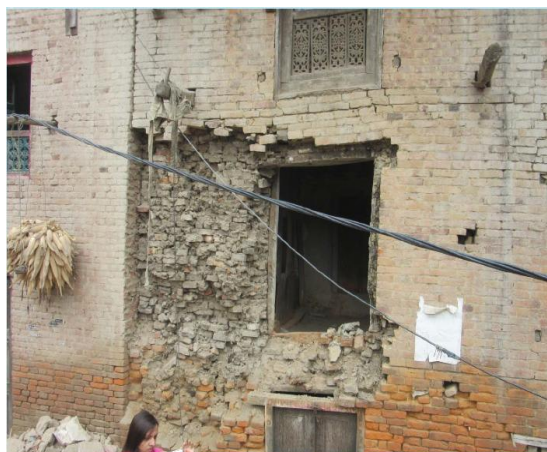
Figure 2: Delamination on masonry building [6]

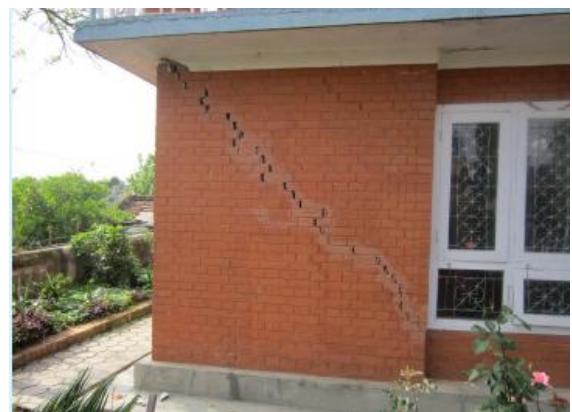
In-plane lateral loads induce shear deformation in masonry wall. These type of deformation elongates one diagonal with tension and shorten the others with compression perpendicular to the tension. Since, masonry structure have lower strength in tension, in-plane lateral forces typically induce diagonal cracking perpendicular to the tension axis. It is very common crack in the masonry structure.

Figure 4: Diagonal Cracks on Masonry wall (NSET, Nepal)[6]

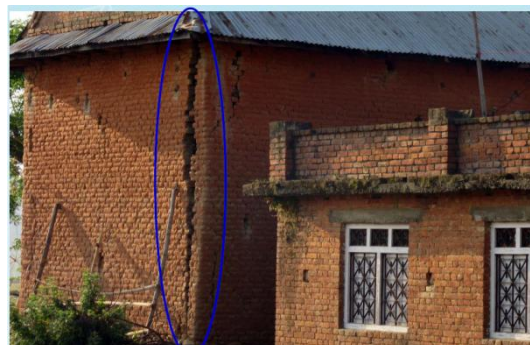
Figure 8: Connection Failure[8]

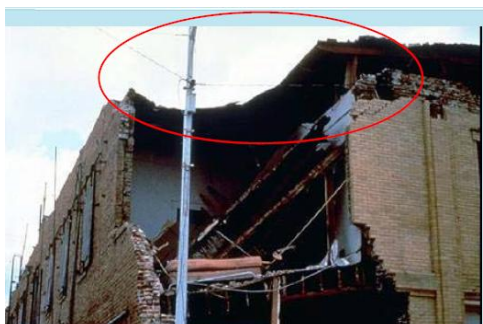
Figure 6: Weak Floor-Roof connection [6]

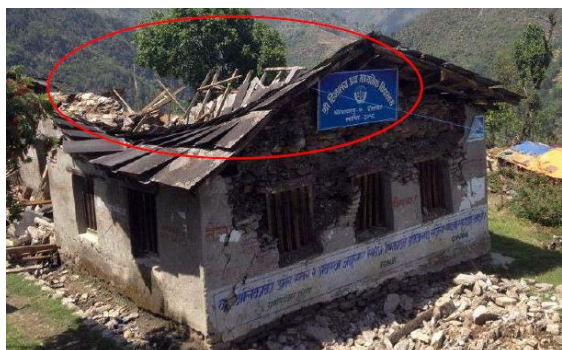
Figure 7: Weak Floor-Roof Connection [6]

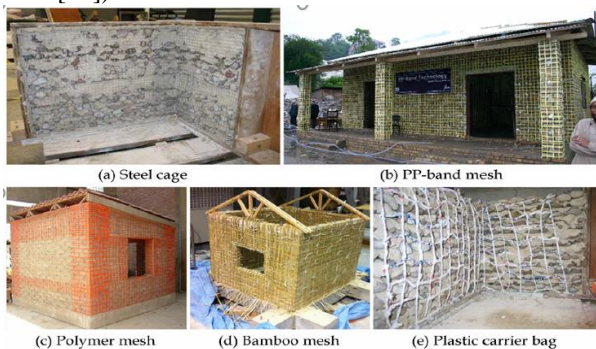
The main objective of mesh type retrofitting is to hold the masonry components into a single unit and prevent the collapse of masonry buildings. These type of retrofitting can be made of any ductile material which may be used steel cage, polymer, polypropylene band, bamboo meshes and plastic carrier bag as shown in figure (Meguro et al., 2012[8]; Sathiparan et al., 2012[9]; Tetley & Madabhushi, 2007[10]).

Figure 6: Various mesh type retrofitting techniques used for masonry structures.

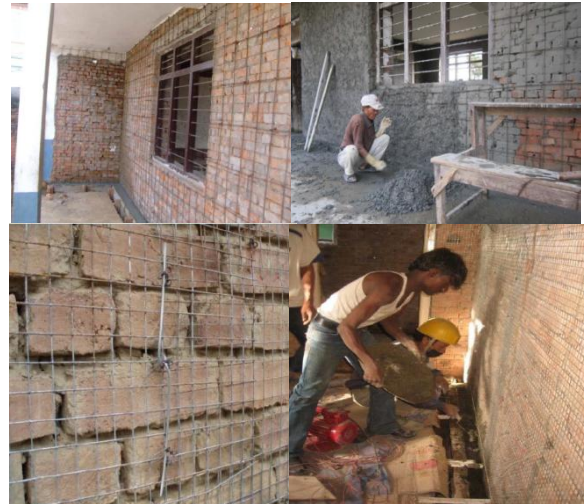
Steel cage of reinforcement or G. I wire mesh are placed in horizontal and vertical strips nailed with metal bottle caps to the walls and it is covered with a thick cement and sand mortar, see in figure 10. After placing mesh from both side and connected with each other, then it holds the masonry component in to single unit and prevent from the collapse of building which is also shown in different shaking table test where model suffered damage but did not collapse.

Figure 7: Steel Cage and G.I. wire mesh on masonry wall
