# Post-Disaster Activity of Controlled Blasting of a Massive Rock at Gagribal Detached from the Takht-I-Sulaiman Hill, Srinagar

**Abstract:** *The District Magistrate Srinagar granted permission for carrying out blasting of a massive rock which had skidded as a result of a rock fall into the house of Mr. Muhammad Ashraf Lone of Gagribal (Srinagar). The massive rock has a size of an apartment building which had fallen off the famous Takht-i-Sulaiman hill. Many perched boulders, massive rock cliffs are critically balanced on the slope with repose angle more than 70°. The controlled blasting operation was carried out under the prescribed norms and rules. All precautionary measures were taken into considerations to ensure that no damage is caused to the adjacent houses in the neighborhoods. This paper discusses the management issues involved as a post disaster management activity for relieving the public grievance and discomfort as a result of the said rock fall.*

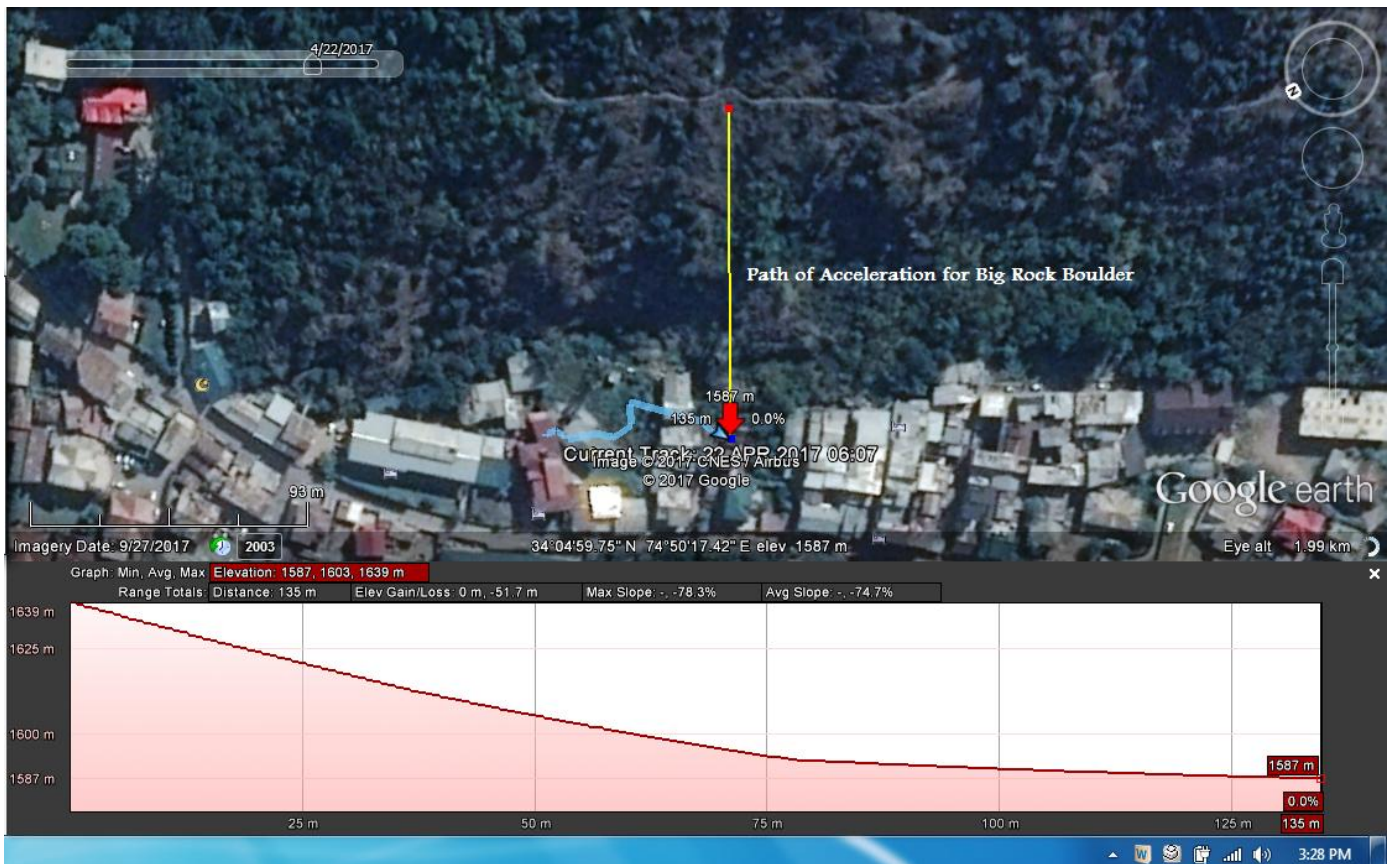
Longitudinal profile/Run out of Big Rock Boulder (Picture-01)

The Takht-i-Sulaiman hill (Picture-01) is located in the heart of the famous Srinagar city. The Hill spreads over an area of approx. 1.6 Square kilometers that extends from Sonwar Bagh South to Gagribal North. Geologically, the Takht-i-Sulaiman hill is composed of Panjal Volcanic Group of Early Permian age with unconsolidated terrigenous clay and boulders. It is pertinent to mention here that many perched boulders and massive rocks cliffs are critically balanced on the slope with repose angle more than Seventy degrees ( $> 70^\circ$ ). The Big Rock Boulder (Picture 02) "the size of an apartment building" has fallen off the famous Takht-i-Sulaiman hill on the north western side detached from the source caused the triggering mechanism. It has been observed that a combination of meteorological and attitude of rock has generated the rock fall during the intervening night of April 6, 2017 that has caused permanent damage to the house.

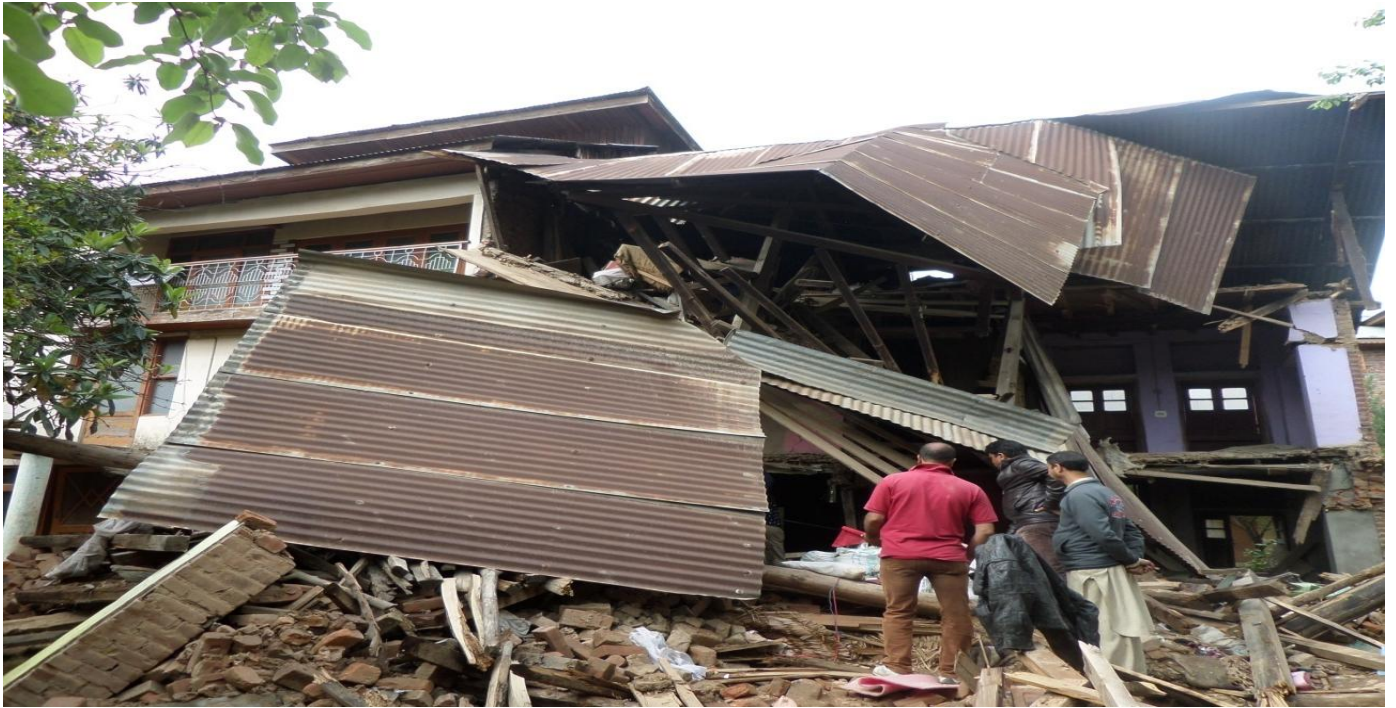
View of damaged house of Muhammad Ashraf Lone at Dal Lake Gagribal, Big Rock boulder is not visible as the roof has coved it

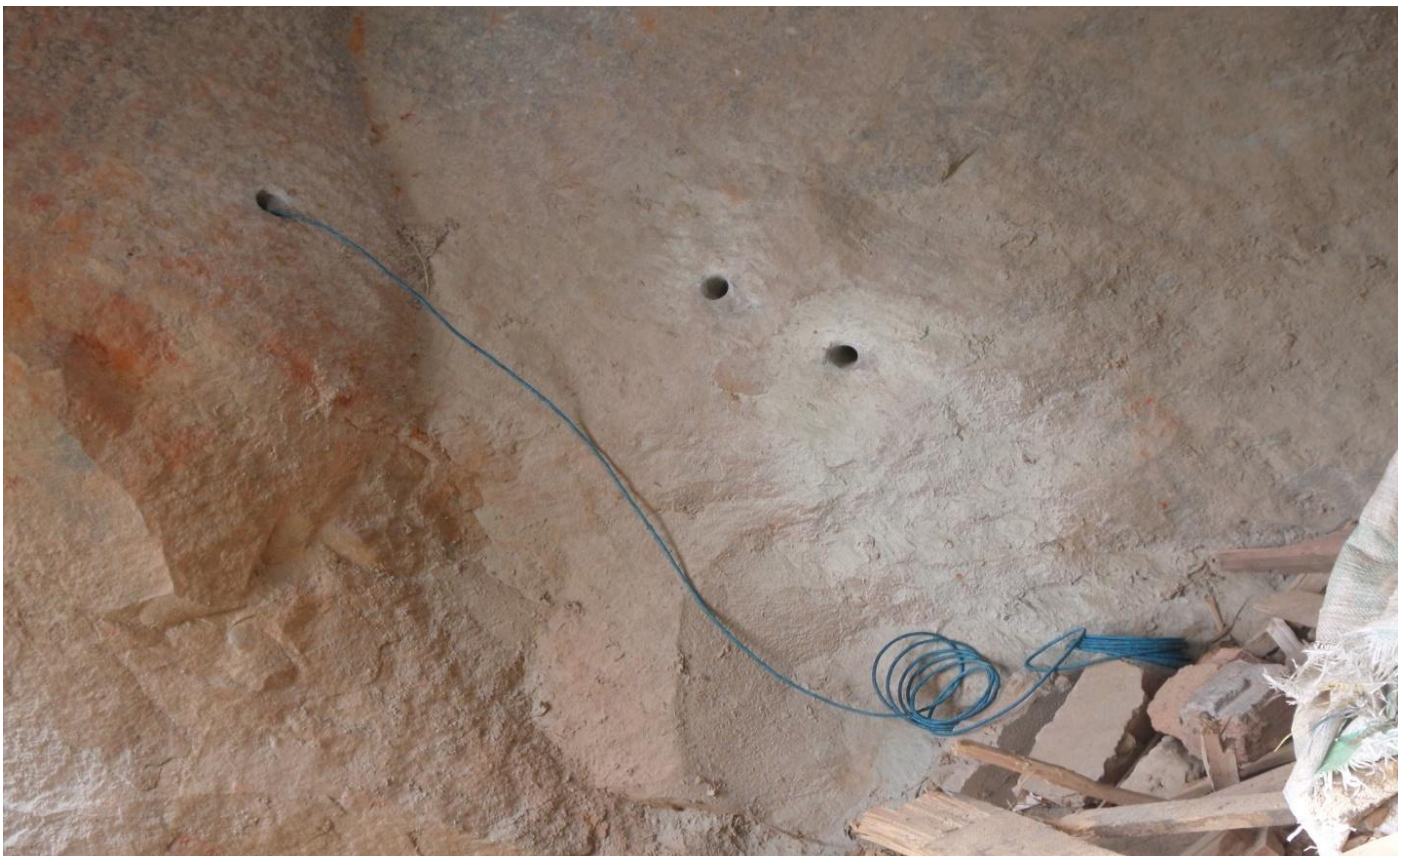
Charging of drilled holes at Gagribal Dal Lake Srinagar (Picture 02)

In the presence of Tehsildar Khanyar and Sub-Divisional Police Officer Nehru Park four (4) drilled holes were charged out of five (5). One drilled hole was kept free of charge for controlling the large number of shooting stones and fly rocks due to the impact of blasting. The four holes were loaded with the seven (7) Special Gelatine 9-inch size (weight SG 125gms/cartridge) with four hole detonators and safety fuse at 3:15 P.M. the blasting took place at 4:05 P.M.
