Rockfall Hazard Analysis of Ellora Cave, Aurangabad, Maharashtra, India

This paper deals with the possible damage of the Nandi Mandapa situated within Kailashnath temple (cave-16) due to the probability of falling blocks from the top of the Kailashnath temple (Figure 3a) and its remedial measures. Rocfall 4.0 program has been used for the analysis and an extensive fieldwork has been conducted for identification of launching features of rockfall (Figure 3b).

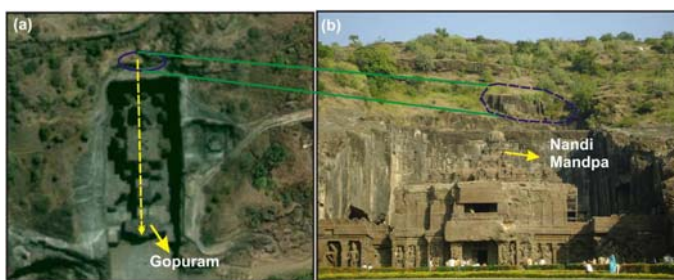
Figure 3 (a) Plan of the Kailashnath temple with profile marked as yellow dotted line used for rockfall analysis. (b) Shows possible location of rockfall blocks and also frontal portion of Nandi Mandapa. (Source: http://en.wikipedia.org/wiki/Kailashnath_Temple,_Ellora).

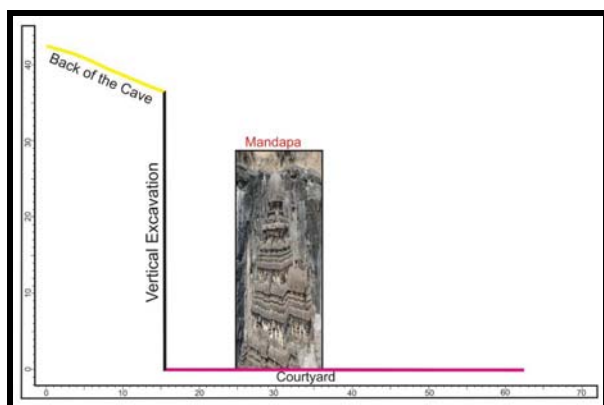
The rockfall analysis has been performed at the back of the Kailashnath temple and slope geometry are given in Figure 5. The impact of the falling blocks on the Nandi Mandapa has been calculated using Mandapa as a barrier location in the path of the rockfall. The typical rockfall trajectory is shown in Figure 6. The kinetic energy and velocity of the impacted rock blocks on the Mandapa and its impacted locations were determined by rockfall analyses (Figure 7). The impacted maximum total kinetic energy found as 64.4 kJ for 2000 kg blocks and the value for maximum velocity is equal to 10.9 ms^{-1} for 1500 kg blocks. It was also observed that the impacted energy increases rapidly from 18.7 kJ for 500 kg to 56.5 kJ for 1000 kg. However, 1500 kg to 2000 kg does not involve a sharp increase. Moreover, it has been observed that most of the rock blocks hit the Mandapa but direct impact has not been observed. The results of the rockfall analysis using different size of rock blocks are mentioned in Table-2.

Figure 5: Typical profile for the rockfall analysis. Also showing position of Nandi Mandapa.

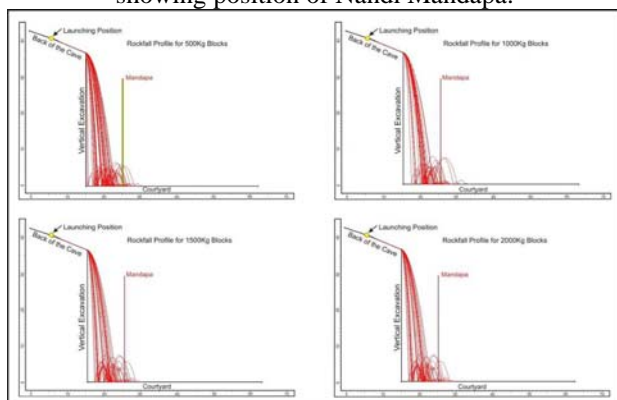
**Figure 6:** Rockfall trajectories for different sizes of the falling blocks.

2) Two-dimensional rockfall analyses have been performed with varying size of the falling blocks i.e. ranging from 500 kg to 2000 kg.
3) The results of the rockfall analyses revealed that fallen blocks will have high impact velocity and energy on the temple and will cause temple to the structure. The maximum impacted kinetic energy and velocity are found as 64.4 kJ and 10.9 m/s. These values indicate a highly dangerous situation for the Nandi Mandapa.

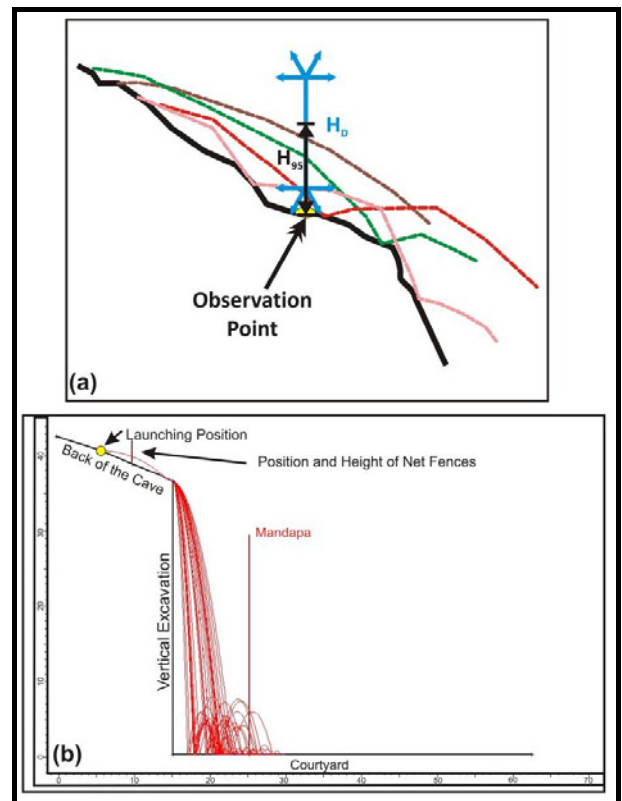
Figure 7: (a) Schematic diagram for the design height of net fences (b) location and height of proposed net fences at Kailashnath temple.

The schematic diagram for the net fences is shown in figure 7a and the data for the analysis is mentioned in Table-3. Also location of the net fences is shown in figure 7b and using the method proposed by Peila and Ronco [28], height of the net fences has been identified and mentioned in Table-3. The value of height of the net fences is found to be 1.49 m to protect the miss-happening at the site.

4) There are various rockfall hazard mitigation measures available but due to aesthetical problems only net fences is applicable for the protection of fallen rock blocks. The height of the net fences has been calculated using the equation proposed by Peila and Ronco (2009) and it is found to be 1.49 m.
