Failure Analysis for High Speed Gears

Abstract: *In this paper, the failure analysis of high speed gears driving air blowers in starch manufacturing processes was investigated in order to find the failure reasons and so over coming them in the future. The gear velocity was 21000 rpm and manufactured from carburized steel (18CrNiMo7-6) DIN No. (1.6587). The gear module was 2 mm and number of teeth was 23 teeth. The gear has failed within 3 weeks of first time operation. Visual investigation has carried out and a set of photos was taken. The teeth of the gear have undergone a bending deflection accompanied with surface wear. The operating conditions (environmental effects, lubrication, loads, assembly and alignment) were revised. The design data was reviewed according to the standard gear design recommendations and also the manufacturing data were checked according to the design data. Additionally, the material analysis; micro hardness measurements and micro structure were investigated. A set of errors were found. The analysis showed that the gear material selection was wrong because the carburization is not suitable for small gear modules. Also, the carburizing depth is not suitabl

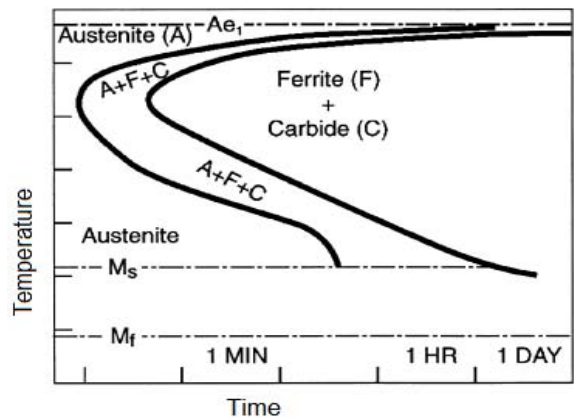
Figure 8: Time, Temperature, Transformation Curve

The presence of Bainite which decreases the fatigue strength, especially contact fatigue strength, where (the ideal structure of the case would be fine tempered martensite with very little or no presence of other transformation products. The presence of the excessive retained austenite (figures 3, 4) due to incorrect quenching after the carburizing process, as shown in figure (8), where (retained austenite is more critical with steel containing increased Nickel and chromium).
