Failure Analysis for High Speed Gears

Abstract: *In this paper, the failure analysis of high speed gears driving air blowers in starch manufacturing processes was investigated in order to find the failure reasons and so over coming them in the future. The gear velocity was 21000 rpm and manufactured from carburized steel (18CrNiMo7-6) DIN No. (1.6587). The gear module was 2 mm and number of teeth was 23 teeth. The gear has failed within 3 weeks of first time operation. Visual investigation has carried out and a set of photos was taken. The teeth of the gear have undergone a bending deflection accompanied with surface wear. The operating conditions (environmental effects, lubrication, loads, assembly and alignment) were revised. The design data was reviewed according to the standard gear design recommendations and also the manufacturing data were checked according to the design data. Additionally, the material analysis; micro hardness measurements and micro structure were investigated. A set of errors were found. The analysis showed that the gear material selection was wrong because the carburization is not suitable for small gear modules. Also, the carburizing depth is not suitabl

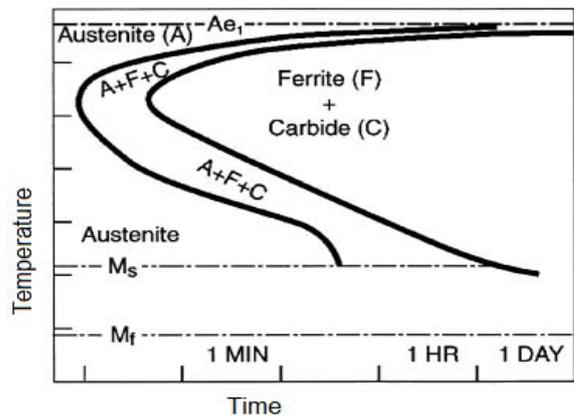
Figure 8: Time, Temperature, Transformation Curve

The presence of Bainite which decreases the fatigue strength, especially contact fatigue strength, where (the ideal structure of the case would be fine tempered martensite with very little or no presence of other transformation products). The presence of the excessive retained austenite (figures 3, 4) due to incorrect quenching after the carburizing process, as shown in figure (8), where (retained austenite is more critical with steel containing increased Nickel and chromium).
