Case Study of Failure of Titanic Ship

Mohd Nazim¹, Dr. Ravi Butola², Dr. JP Kesari³

^{1,2,3}Delhi Technological University, Delhi, India

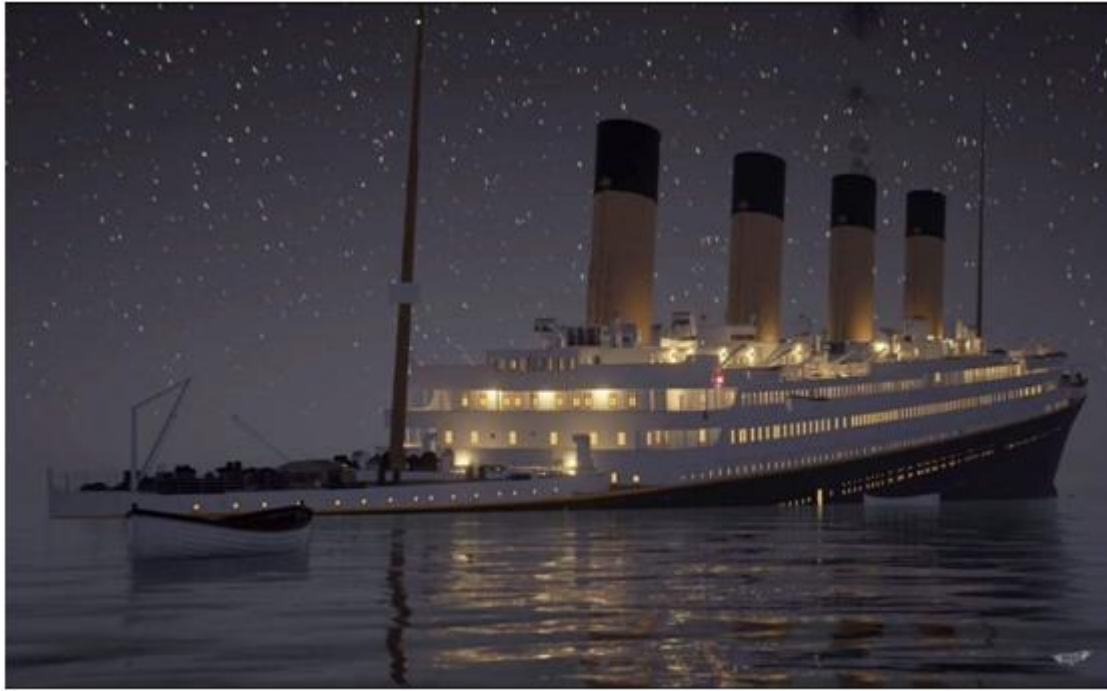
Figure 3: A layout of the watertight compartments and the damage from the collision

The thick black lines below the waterline indicate the approximate locations of the damage to the hull. The watertight compartments were useless to countering the damage done by the collision with the iceberg. Some of the scientists studying the disaster have even concluded that the watertight compartments contributed to the disaster by keeping the flood waters in the bow of the ship. If there had been no compartments at all, the incoming water would have spread out, and the Titanic would have remained horizontal. Eventually, the ship would have sunk, but she would have remained afloat for another six hours before foundering. This amount of time would have been sufficient for nearby ships to reach the Titanic's location so all of her passengers and crew could have been saved.
