Technical Analysis of a Cause of a Vehicle Transfer Case Failure

Abstract: *The article deals with a transfer case failure of Skoda Octavia Combi and a procedure of a technical expert necessary to detect a cause of this failure. During the operation of the vehicle the transfer case and subsequently the gear box started to show a loss of functionality. In order to find out the cause, the damaged aggregates were dismantled from the vehicle in the car service facility in the presence of the technical expert. Based on his instructions, dismantling and disassembly of the aggregates was carried out and the technical analysis performed.*

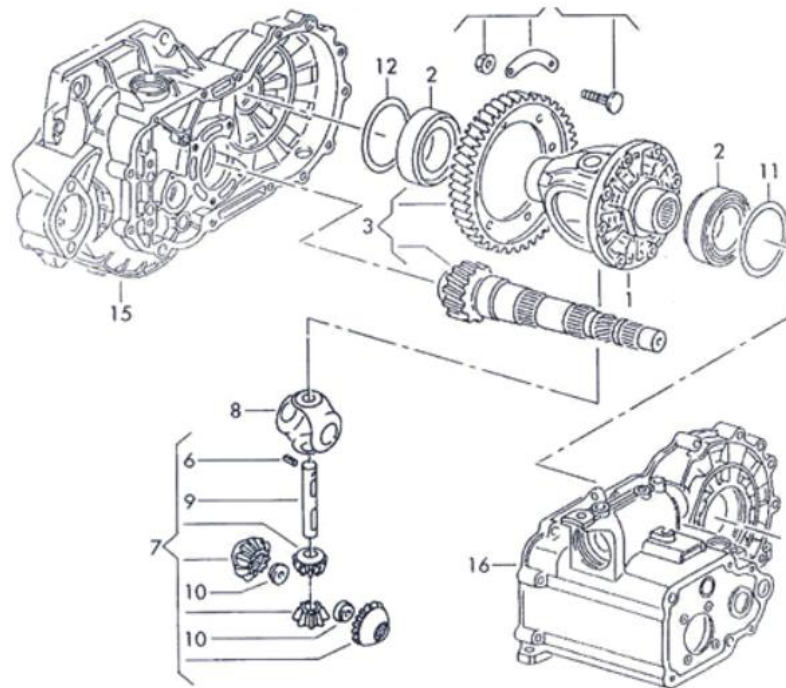
Figure 3: A view of the design of the transfer case and differential

Fig.3 shows the design of the transfer case and the differential in a common housing with the gear box.
