Back Analysis of 1135_1065mRL Slope Failure in Shaba Open PIT

Abstract: *This study is about stability analysis of the Shaba open-pit, the back-analysis of the slope failure on the Eastern wall that ripped the main ramp away. The aim is to replicate the factor of safety and deduct the geotechnical properties before failure in order to estimate appropriate parameters while taking into account the influence of water on the rock mass as well as that of other parameters for the normal and safe continuation of mining activities below the unstable zone. The failure of the Eastern wall slope (1135-1065 mRL) has been caused by many factors. The presence of cracks along the contact zone between many friable lithologies. The failure is associated to the combination of many factors leading to gradual reduction of the rock mass properties and finally to the slope failure. The cumulative effects of surface and underground water as well as the blast vibrations around the failure zone accelerated slope failure. Stability analyses were conducted with Slide and other ancillary softwares GEM4D, Trimble 4D, etc... in order to make the best choice possible of geotechnical parameters for the better co

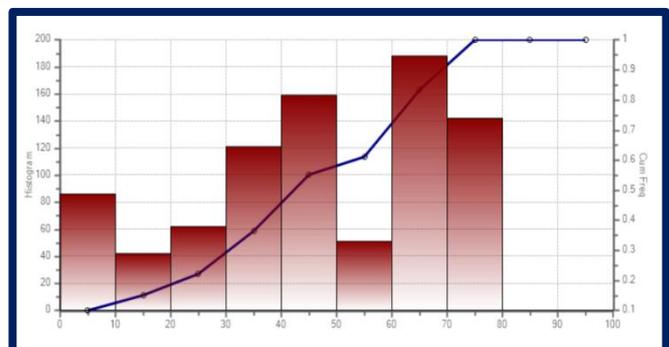
Map below shows measures bench configuration along scan lines. More benches varies between 40-70°.

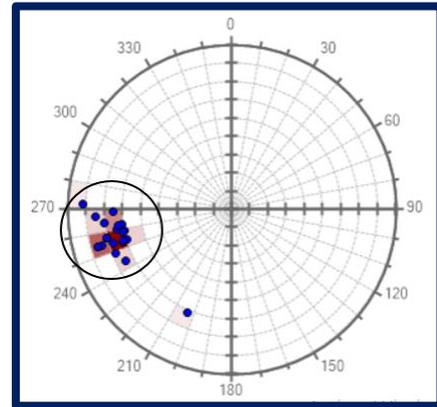
Figure 16: Major structures along the failure zone

The current pit geometry fails along the contact between the black shale lithological unit / Greywacke and Bxc / Bxcg units.

The fracture surface appears to be shallow with respect to the trend and plunge of the prisms shown above and is bounded by structural control along the contact zone between the different geological units.

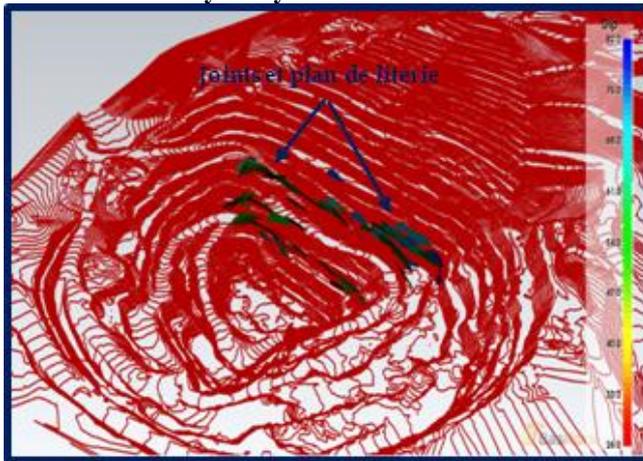
Figure 15: Illustration of the joints and bedding plan in the failure zone

Based on the mapping data collected, the main rupture can be identified as rotational. The potential failure induced is circular.

The existence of this lithology has been confirmed with the block model. Moreover, three dominant structural orientations have been observed, leading to a friable rock mass.
