# An Experimental Study of Microbial Corrosion and Fatigue-Corrosion of HSLA Steel in Seawater

**Abstract:** High strength low alloy steel known as HSLA is widely used in naval construction and ship building due to its capacity to resist to fatigue and corrosion which are considered to be complex phenomena. A study on microbial corrosion in seawater is held on steel plate and compared to specimen removed from a 27-meter naval unit subject to about 37 years of service. Both mechanical properties and microstructural behaviour were studied. The study showed a huge decrease in ductility of steel after exposure to microbial corrosion which is confirmed with Scanning Electron Microscopy (SEM) images. The steel serving for about 37 years showed less decrease in ductility but more in terms of elasticity and this was confirmed with SEM images showing a huge quantity of micro-cracks and corrosion sites. The steel submerged in calm sea water showed a form of pitting corrosion and less fractures.

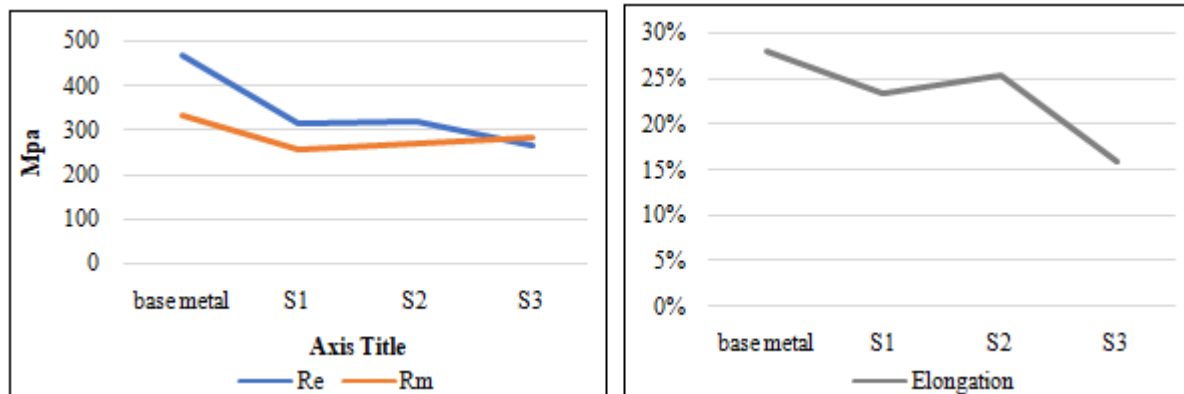
Figure 3: Mechanical properties: yield strength, tensile strength and Elongation

As it is summarised in **table 4**, mechanical properties in both cases are affected. Infact, both yield and tensile strength values have dropped. The yield strength is the lowest in specimen S1 with about 255 Mpa as in **figure 3**. For this specimen taken from the front of the ship, the mass loss is about 48 % as shown **figure4**. The fatigue in this part of the hull is higher than in the middle part while the frequency of waves and hydrodynamic force is elevated. Fatigue associated with corrosion are combined in this case and led to a drop of ductility. The elongation of S1 and S2 is still higher comparing to the specimen S3 put in harbour for 220 days. This is explained by the fact that the steel stayed in

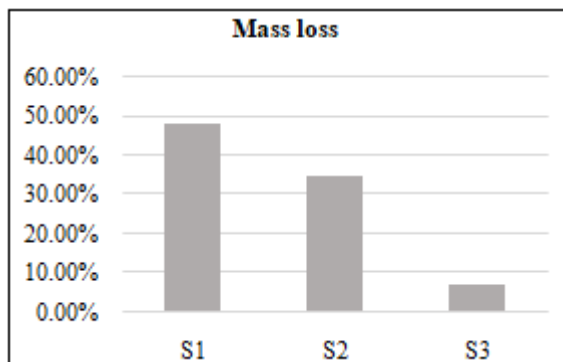
Figure 4: Mass loss of samples S1, S2, S3

calm water conditions and wasn't subjected to cycling loading and wave force. Only corrosion is highlighted in this case and showed a direct impact on mechanical properties. **Figure 5** shows the percentage of mass loss in the considered steel. The highest value is observed in S1 enduring high loading fatigue cycles and corrosion for a very long period.

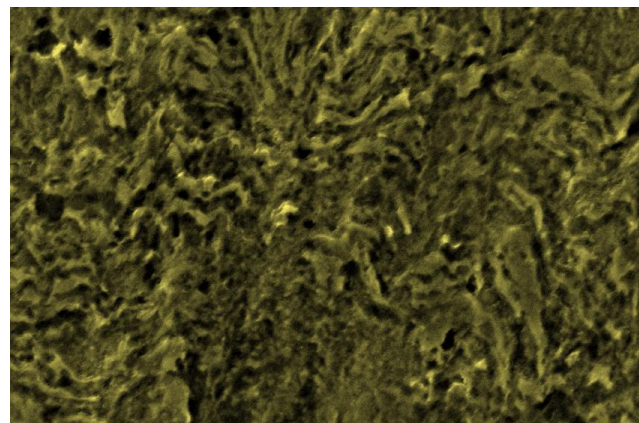
Figure 5: Microstructure of base metal (HSLA steel)

All of the three samples were carefully cleaned, polished and etched with Nital solution (5% nitrate, 95 ethanol) for the SEM. The microstructure of base metal is shown in figure 5. It presents a homogeneous structure of ferrite and pearlite with numerous precipitations of alloy carbides. Figure 6 shows the microstructure evolution of S1. The presence of microcracks is very clear. A significant amount of microcracks is revealed with a perpendicular direction compared to the one of rolling. The cracks spacing is estimated to about 1.3  $\mu\text{m}$  in S1 and about 2.2  $\mu\text{m}$  in S2. Thus, S1 is more solicited than S2. Plastic zones are relevant by SEM images which is the region beyond the rupture zone and host aspects of both effect of cycling loading and fatigue indicators such as the beach marks well expressed in the surface with presence of multiple striation and second of crack propagation and closure phenomena. It is more obvious in sample 1 than 2, so it is considered to be an important parameter in fatigue crack growth.
