Failure Investigation of Tawila Dam in North Darfur, Sudan

Magdi M.E. Zumrawi¹

¹University of Khartoum, Civil Engineering Department, Khartoum, Sudan

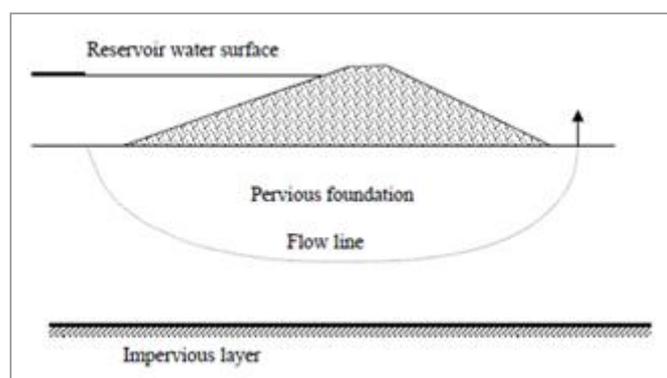
Seepage failure (Figure 1) or foundation failure occurs due to the saturation of the foundation material leading to either washout of the material or a weakening of the rock towards a sliding failure. The flow of water through a pervious foundation produces seepage forces as a result of the friction between the percolating water and the walls of the pores of the soil through which it flows. Figure 1 shows how water flows through the pervious foundation of a dam.

Figure 1: Seepage on the foundation of a dam
