Engine Failure in Road Traffic as the Cause of a Traffic Accident

Abstract: *The article deals with technical analysis of the cause of a technical failure of the Mercedes vehicle, which led to a traffic accident due to the loss of the vehicle's controllability. The methodology and procedures during the inspection of a vehicle as well as the methods applied to process documentation are systematically clarified. Subsequently, the individual findings are presented and evaluated and their technical interpretation is made. The strength calculation of the component (the timing chain) and the calculation of forces exerted on the chain are introduced. In the conclusion, the findings are evaluated with regard to the calculations and technical evaluation of the case is presented.*

In this case, it was a MERCEDES BENZ S 350 L, the year of production: 2006, mileage 271,465 km.

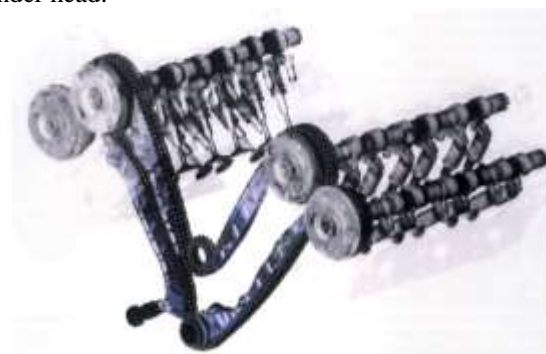
Fig.5 shows the representation of the sprocket gears driving the camshafts of the engine timing mechanism, and Fig. 6 illustrates the mutual engagement of the sprocket gears in a cylinder head.

Figure 5: Engine timing mechanism of MB S 350L

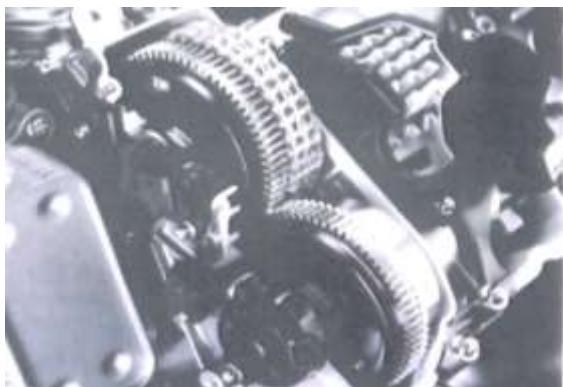
Figure 6: View of the fitting and engaging of the sprocket gears in a cylinder head.

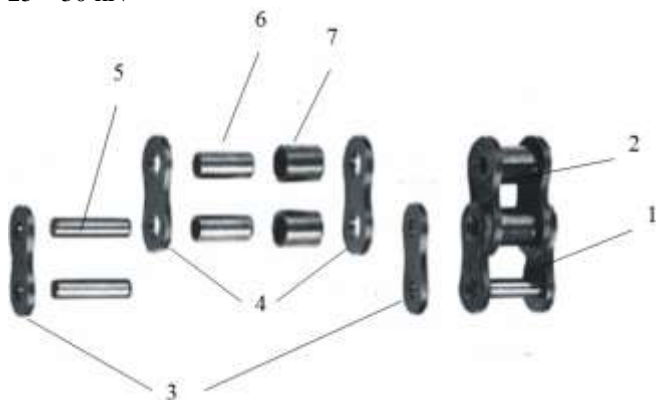
In this case, this is a two-sided roller chain (Duplex), whose outer (1) and inner members (2) consist of:

- outer plates (3)
- inner plates (4)
- pins (5)
- bushings (6)
- rollers (7)

The manufacturer indicates the guaranteed tensile strength: 25 – 30 kN

Figure 7: View of a timing chain member

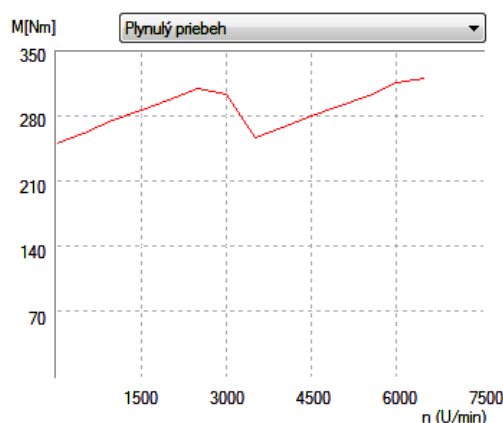
In the normal operation, the engine unit is able to affect a timing chain (if the chain is tensioned due to the timing wheel „jam“) by the force derived from the engine torque of the vehicle MB S 350 L – see Fig.15:

Figure 15: Engine torque flow

If the fracture value declared for a single timing chain – 2 plates is about 25 to 30 kN – the source- a manufacturer's catalogue), it is obvious, that under normal circumstances, the chain cannot get broken during the engine roll due to force common effects.

This value exceeds the limit value for the maximum force needed to break a chain member. On the other hand, technically, it is possible to exclude the force destruction of two chain plates due to material defect in the chain.
