Slurry Pipe Wear detection by Infrared Thermography: Case of Cyclone Underflow Pipe in Kinsevere Process Copper Plant in Democratic Republic of Congo

Mwamba A. Banza¹, Ngoy Y. Mukabi², Kalumbu G. Mutombo³

Abstract: *This article present the slurry pipes wear detection by using infrared image thermography analysis. By determining via the software the temperature difference on one of pipe area, it's possible to determine the wear while the fluid is moving into the pipe. The difference of temperature found on the pipe area makes easily to estimate the wear and suggest the corrective maintenance action. As part of condition monitoring technics, this is helpful to contribute to pipes thickness monitoring.*

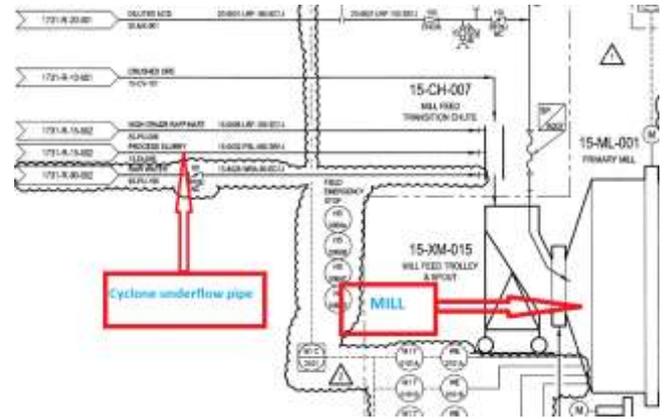
Figure 2: Piping and Instrumentation Diagram extracted and showing the pipe in the circuit [3]

The figure 2 is showing the Piping and Instrumentation Diagram of the under flow pipe in the circuit [3]
