Diagnostics of Iveco Stralis 440ST Truck Tractor Unit Engine and Identification of the Cause of its Malfunction

Abstract: *The article concerns the case of the Iveco Stralis 440St truck tractor unit engine failure and the methodology of the technical expert applied to identify the cause of failure. The engine has repeatedly exhibited failures –leaking crankshaft spring - energised seal and consequent engine oil leak, which has been repeatedly repaired at a car service station. Repeated engine failures resulted in the disputes between a vehicle owner and a car service station, finally leading to an agreement on finding the cause by an invited technical expert. To determine the cause, a vehicle was on the car service station premises, where a technical expert was present and according to his instructions, diagnostic and subsequent disassembly works were done. The outcomes of the investigation proved serious damage to the engine piston unit.*

Make and type: Iveco Stralis truck tractor unit, type 440 ST
Mileage: 173 485 km

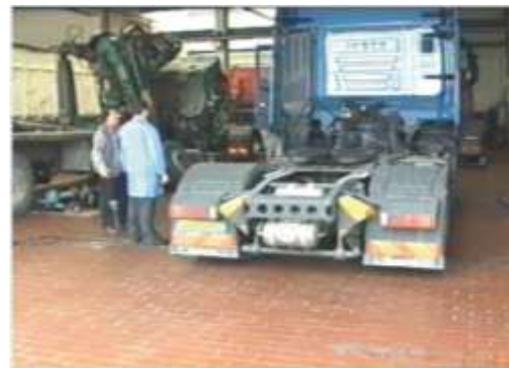
View of NMV, make Iveco Stralis,

A detailed visual inspection of the vehicle and its engine has been carried out. Findings revealed no incompleteness, however there was engine oil found on the front part of gearbox housing – Figure 1.

Figure 1: Vehicle condition detected during a visual inspection

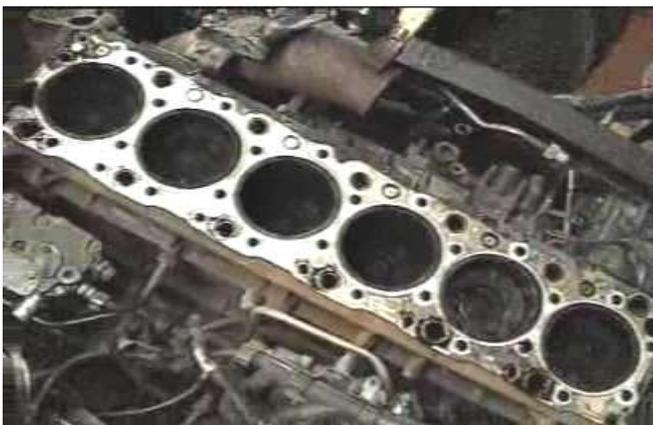
View of the engine block, cylinders and pistons after the disassembly of a cylinder head

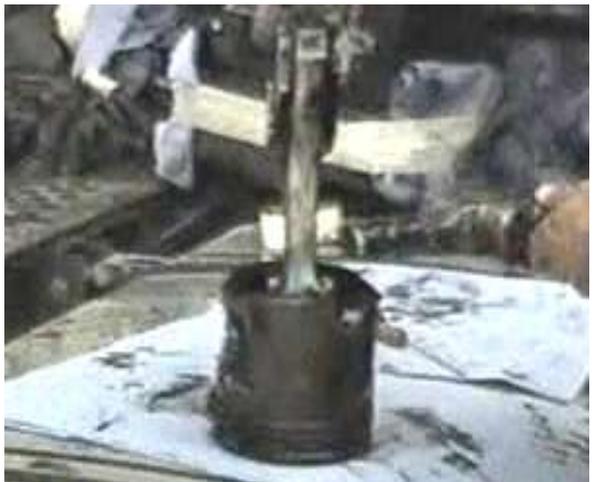
View of the piston and connection rod of the 2nd cylinder after dismantling

- 2nd cylinder piston damaged, broken
- Connecting rod bearings of the 2nd cylinder: damaged
- Connecting rod bearings of 4th cylinder: damaged
- The crankshaft of 2+4 connecting rod: damaged

- During the engine run, a part of the 2nd cylinder piston was broken off from its inner side in the zone of piston

rings due to the fabrication-related defect, or the defect of the piston material of the engine 2nd cylinder

- In the broken part, the burning fuel started to penetrate to the inner zone of an engine and the piston rings started to overheat locally consequently beginning to break
- When the burning fuel was flowing around piston rings, the carbon was deposited significantly on the piston in the piston rings zone
- As a result, we cannot rule out the possibility that a certain amount of fuel entered the engine zone unburned and mixed with engine oil (this can be assumed because the volume of the oil was not reduced)
