Identification of Fabrication Related Defect on the Fiat Ducato Vehicle

Abstract: *The article deals with the case of damage to the Fiat Ducato engine and technical expert's procedure to determine the cause of its failure. The failure occurred in a way that the camshaft and motion adjustment's hydraulic system of the second cylinder intake valve were damaged. The result of technical analysis was the fact that the failure of engine occurred as a result of incorrect assembly in the production. The vehicle has been transported to an authorized service center and after the engine has been removed it has been examined by a technical expert. The article describes procedure of a technical expert and, in conclusion, his findings are presented. In order to find out the cause, the vehicle was inspected by a technical expert in the service station and diagnostic and consequently dismantling works were carried out according to his instructions. The procedure of evaluating the specific properties on the individual parts with their display and the resulting evaluation is described.*

Vehicle: Fiat Ducato 2.8 TDi, OHC

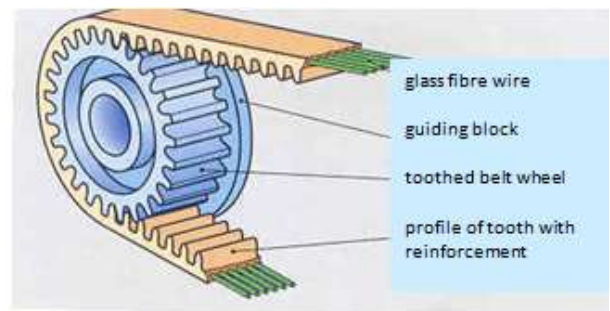
Figure 5: Structure of timing toothed belt

In case of skipping toothed belt of timing, characteristic signs remain, in particular tearing of the teeth at their base and the disturbance of smooth profile of teeth, which skipped over the teeth of the toothed belt.

Since, when checking the toothed belt of timing wheels of engine in question, no specific signs were found suggesting that it would be skipped, I find it technically acceptable that the timing shift of that engine was displaced when assembled.
