Investing the Cause of Premature Tyre Failure of Open Pit Mine Dump Trucks: A Case of ABC Mine, Northeast Africa

Dr. Dyson Galatia, PhD

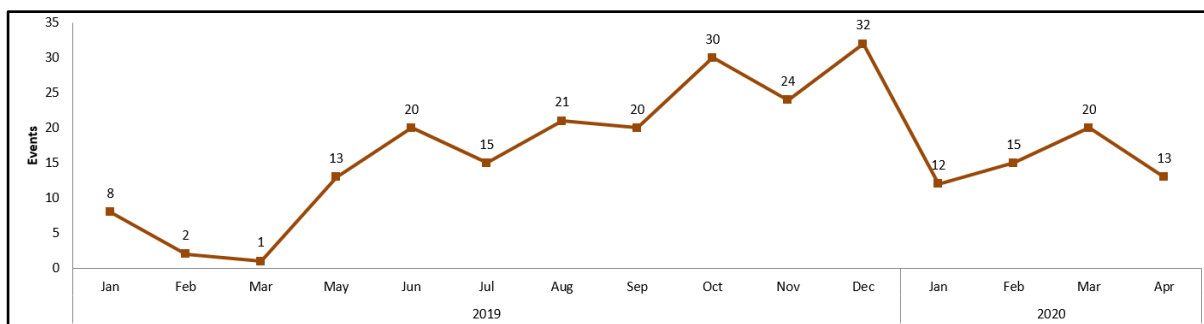
Figure 1: Tyres Replaced Per Month

The data in figure 1 shows the number of tyres replaced per month, the average tyre life for all failed tyres was 1100

hours as opposed to the projected 5000 hours. Figure 2 shows the machine monthly downtime due to tyre failures.

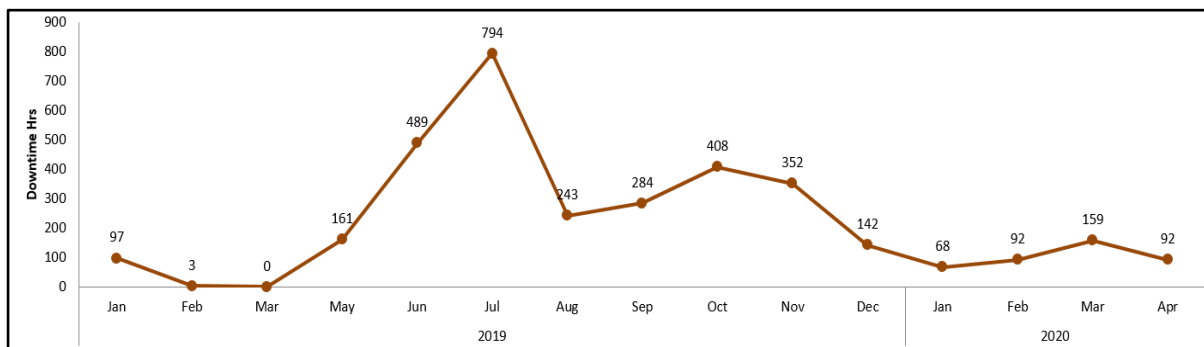
Figure 2: Tyre Downtime

The data in Figure 2 illustrates monthly tyre downtime for the failed tyres, June and July 2019 showed the highest downtime. The explanation to the extended downtime was that, this tyre size was new on the mine and both skills and

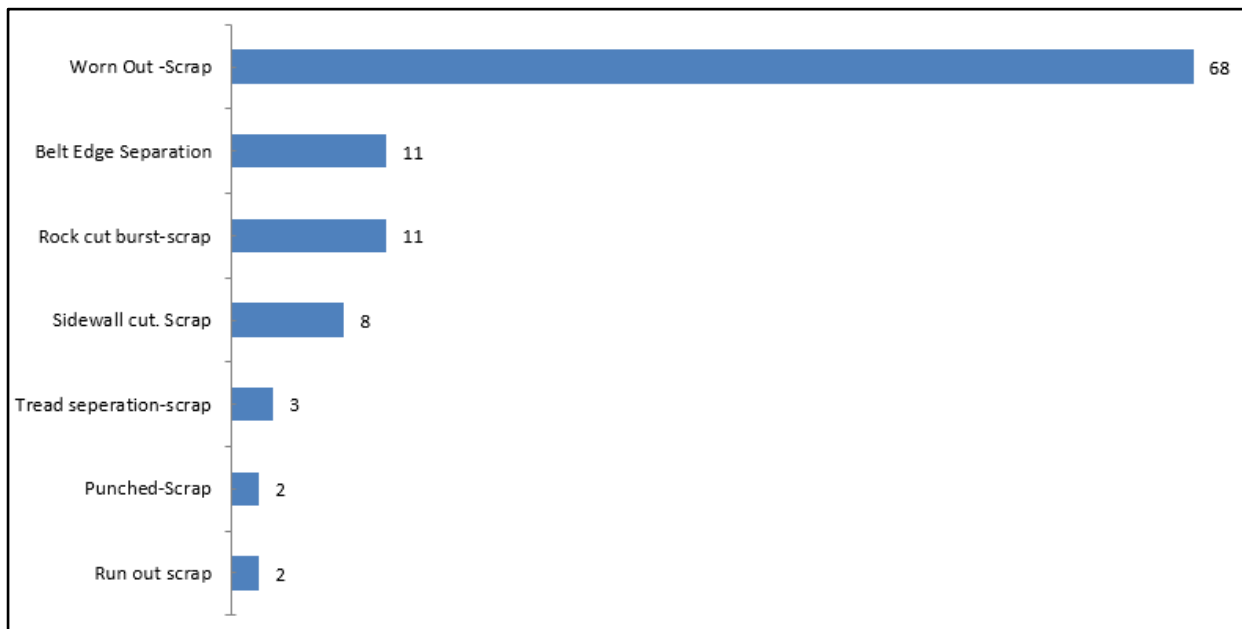
Figure 5: Tyre Failure Mode

Figure 5 shows the failure mode and occurrence, however, all the tyres during the period under review failed before the anticipated time. The average life for the tyres was 1100 hours whereas the projected life was 5000 hours. This implies only 22% of the tyre was used.
