Behavior of Masonry Walls with Respect to Seismic Stress, Analysis and Recommendation

Abstract: Structures with masonry infill panels and reinforced concrete frame are widely used structural systems and by lack of knowledge considered secondary, masonry infill walls are considered until now as non-load-bearing elements, therefore the role of taking and transmitting vertical and horizontal loads (seismic) is ensured only by the reinforced concrete structure. However, experience from past earthquakes around the world has shown that this calculation approach is simplifying and approximate, because we have found during the analysis of earthquake damage that the neglect of masonry walls in calculations can decisively influence and even upset the response of structures to seismic forces. The tests carried out in our research and the numerical modelling carried out on several cases have shown that the effect of shear stress on gantry masonry structures can be taken into account by replacing in the numerical modelling the masonry with equivalent diagonals whose thickness will be calculated according to the physical and mechanical characteristics of the gantry and the masonry.

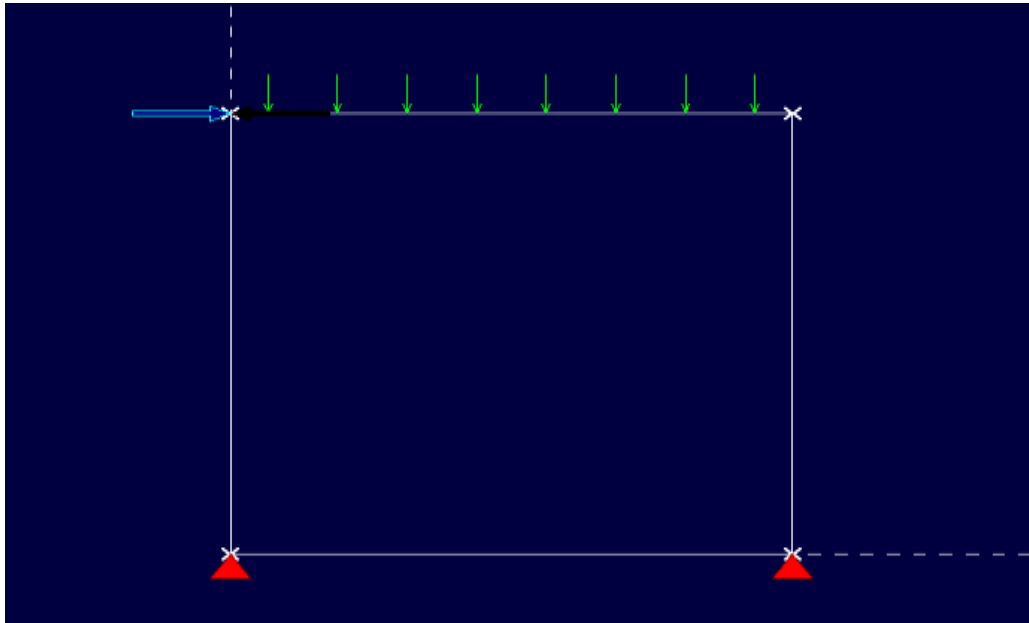
Figure 1: Loading mode

The wall is subjected to a distributed vertical load of value $N=90 \text{ KN/m}$ and a seismic force (horizontal) $V=195 \text{ KN}$.

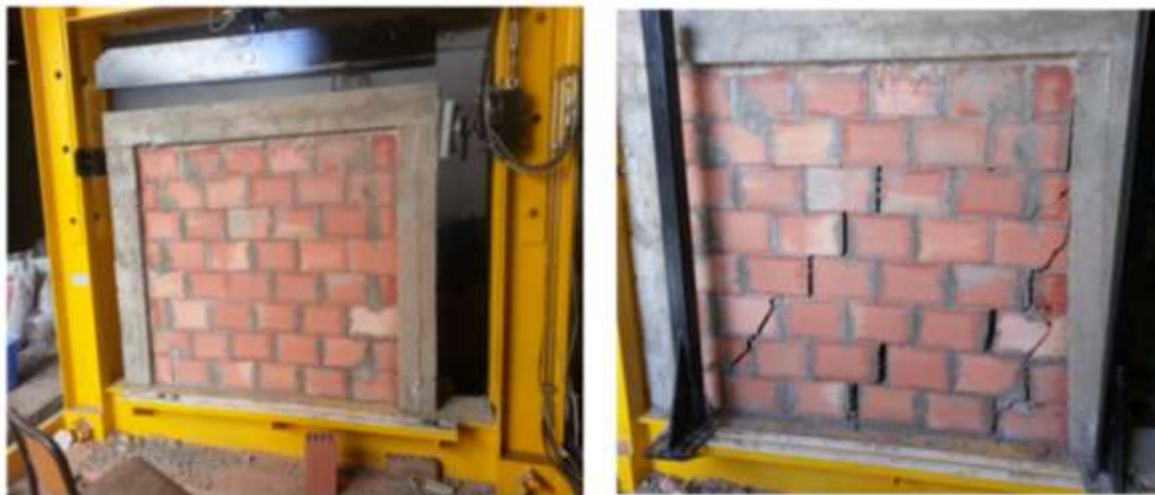
Figure 2: Built Wall

For the comparison between the different models, we made a test on local materials, the results of this test are:

Wall before the test

Wall after the test

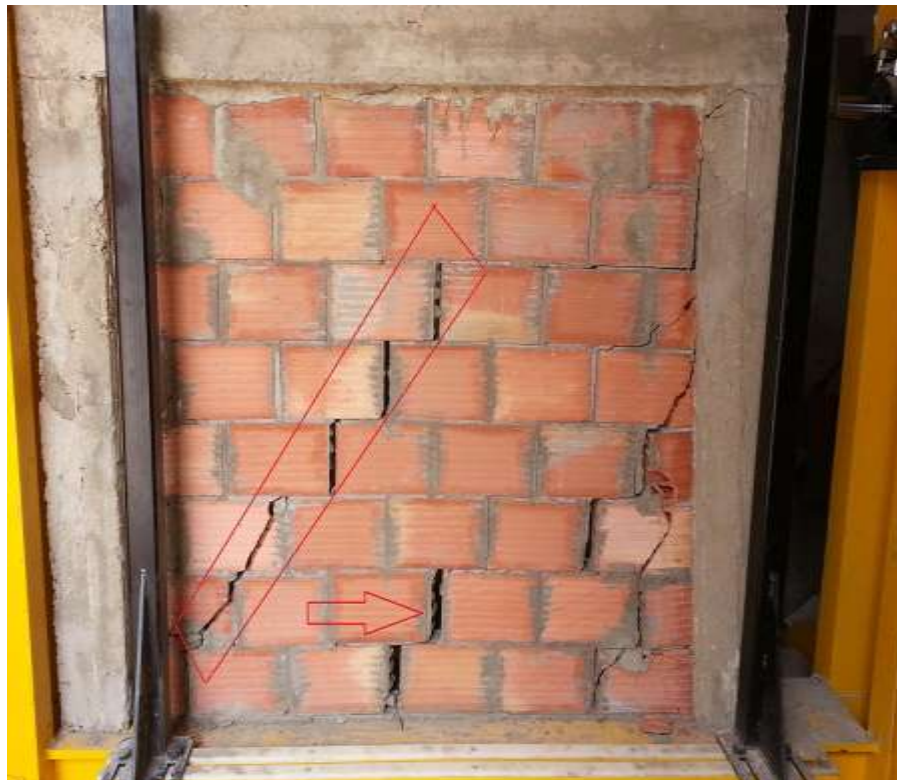
Figure 3: Cracking at the joints

- The diagonal cracking of the infill can be caused by a combined mechanism of failure: bending failure of one column and shear failure of the other.
- Cracking of the panel occurs in the direction of the compressed diagonals along the vertical joints of the mortar.
- The second and third cracks appear in the masonry panel and parallel to the diagonal in compression.
- The wall was built after the realization of the columns and beams, which makes the connection between the different elements strong, so the joints are resistant and can influence the mode of failure.
- This mode of construction prevented the portal-fill detachment found by several researchers.
- As an indication, since the masonry walls are not considered as load-bearing elements, the phase of their

construction in Morocco occurs after that of the columns and beams which makes the connection between these

different elements very weak.
