Case Study of H₂S Exposure & Fatality on External Floating Roof Tank Deck Hydrogen Sulphide Incident at MRPL Refinery

Prepared from OISD Case Study No. OISD/CS/2025-26/P&E/10 Incident Date: 12 July 2025

Abstract: On 12 July 2025, two operators at the Oil Movement and Storage (OM&S) section of a large petroleum refinery in India were fatally overcome by hydrogen sulphide (H₂S) gas while conducting a routine inspection of a floating roof slop tank. This paper presents a systematic analysis of the incident, examining the sequence of events, the physicochemical conditions that led to lethal H₂S accumulation on the floating roof deck, and the compounding failures of procedural compliance, hazard communication, and safety management systems. Post-incident sampling confirmed H₂S concentrations of 890 ppm in the tank and 40 ppm at the top platform 48 hours after the event, concentrations far exceeding the Immediately Dangerous to Life or Health (IDLH) threshold of 100 ppm. The investigation identified multiple latent organisational failures including the absence of confined space entry permits, non-use of personal H₂S detection equipment, solo entry in violation of safe work protocols, a

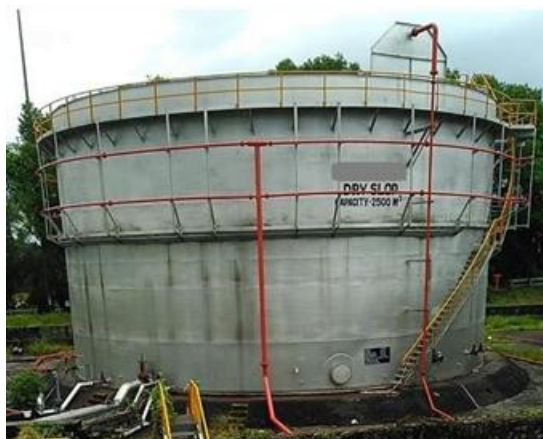
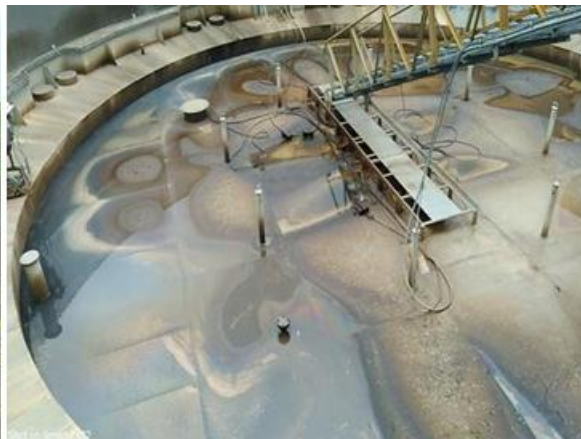
preceding the incident and the morning of the event. The concurrent level rise in Tank, attributed by operations personnel to rainwater accumulation on the floating roof was a primary motivator for the inspection visits that led to the

fatalities. Rainfall is known to suppress gas dispersion above open surfaces, creating a more concentrated and persistent gas layer near the roof level [4].
