Experimental Investigation on the Pulse Behavior of Polymeric Matrix Composites Used in Vehicles

Abstract: *The impact load is defined as the momentary force on the material within a very short period of time. The laminated composite materials can be subjected to many impact loads compared to where they are used. In this study, four different types of oriented carbon fiber materials [0°/0°]s, [0°/90°]s, [±45°]s and [0°/90°/+45°/-45°]s were used. Eight-layers aluminum honeycomb carbon fiber/epoxy composite samples cut of 10 cm x 10 cm were made. Four different samples were tested under 80 joule impact energy. Force-slump curves, force-time curves, absorbed energy-time curves and velocity-time curves were plotted. As a result of the experimental study, puncture damage occurred in all the samples exposed to 80 joule impact energy. The material which had the highest damping capacity and maximum strength against the impact was C₄⁸ composite material with eight-layer [0°/90°/+45°/-45°]s. It was concluded that the carrying capacity and impact strength of the C₄⁸ sample were higher than the samples with different fabric orientations. Crush test applied to the carbon fiber/epoxy composite

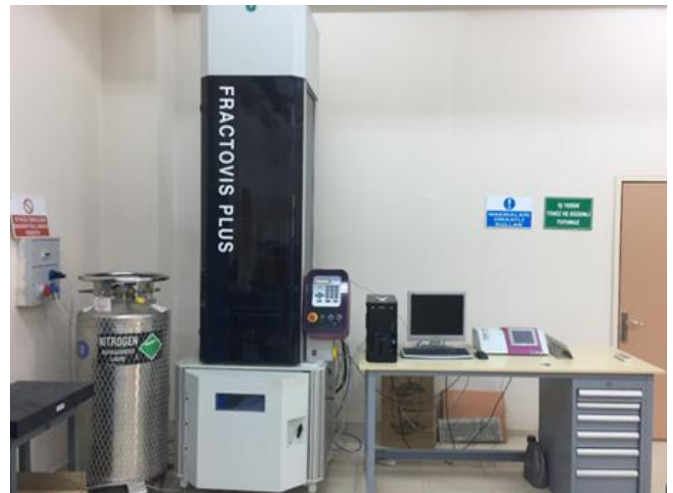
Figure 2: CEAST 9350 (Fractovis Plus) impact tester

The produced slabs were cut into 10 cm x 10 cm size using WMT3020-DL industrial water jet cutting machine. Impact tests were carried out at room temperature using CEAST 9350 Brand Fractovis Plus falling weight impact tester (Fig 2). The impact mass was 4, 926 kg, and a semi-spherical steel impact tip with a diameter of 12.7 mm was used.

The impact test was performed on the samples by means of a pneumatic device in the test device. The samples were exposed to a single energy value of 80 joules. The contact force between the sample and the striker, the amount of sample collapse and the speed of the shooter with time were recorded by Visual impact software. The impact velocity of the striking end of the sample at constant impact energy was C₁⁸, C₂⁸, C₃⁸ and C₄⁸ was 4.98 m/s, 5.44 m/s, 5.37 m/s and 5.20 m/s respectively. Generally three types of damage occur during the impact test; perforation, rebounding and penetration.

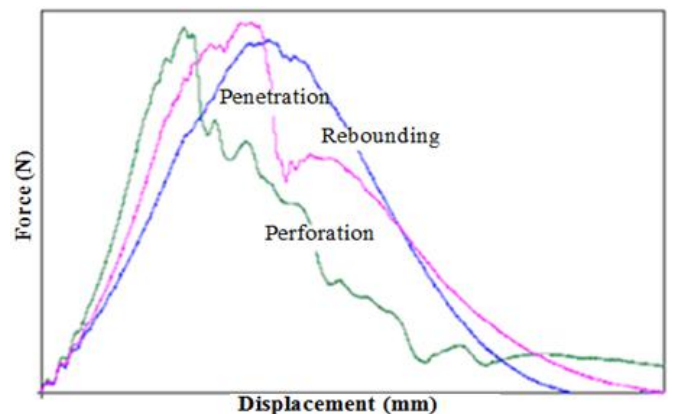
Figure 3: Force - displacement curve [17].

As shown in the Figure 3, the curve has a parabolic shape in low-energy pulses (eg the rebounding curve). The generated force increases by the increase of the impact energy. The maximum forces reach the same value for penetration and perforation curves. In order for the force to be zero, the puncture must occur in the sample. However, the tip of the curve runs parallel to the horizontal axis due to friction between the specimen and the striker.

The curve is divided into open type and closed type curve with the increase of pulse energy. The closed type curve is the curve formed by the back tab of the shooter after the impactor applies a pulse to the test sample. That is, part of the impact energy was absorbed by the sample, and the non-absorbable energy was used for the back tab (Fig 3). With the increase of the impact energy, the closed curve decreases and the collapse increases as the back tab decreases. When the

curve is open, the striker tip is punctured or inserted into the sample. Thus, the striker that enters the specimen moves down the thickness of the sample and the back-tab does not occur. When the energy is increased, the striker tip is inserted into the sample, moves during the thickness of the sample and exits from the bottom by puncturing the sample, ie puncture occurs. The end portions of the curves closing towards the end of the horizontal axis refer to the friction between the impactor and the sample. Thus, increasing the impact energy, it is understood that the composite material will not dampen more impact energy [16, 17].

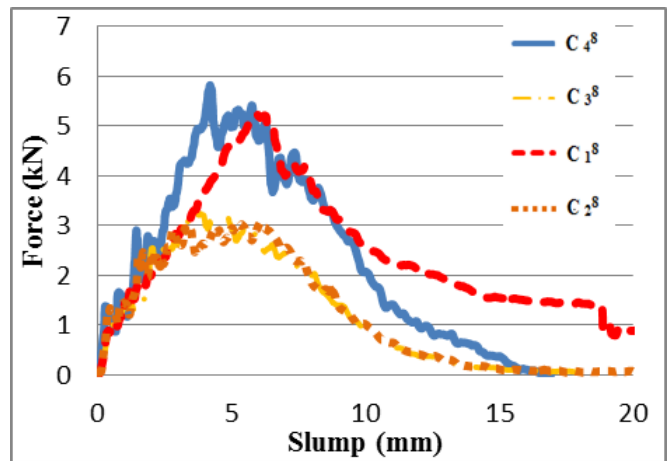
Figure 5: Force-Slump curve of eight-layered composite samples with four different layer sequences

80 joule energy impact tests were performed for eight-layers of composite samples with four different layers. According to the data obtained as a result of the experiments C_1^8 , C_2^8 , C_3^8 and C_4^8 groups were drawn to the strength slump curve (Fig 5).

When the force-slump curve given in Figure 5 is examined, it is seen that the samples of C_1^8 , C_2^8 , C_3^8 and C_4^8 show a similar impact behavior for the 80 joule impact energy value. For each of the four groups, the open curve was formed at 80 joule pulse energy values. The reason for the absence of closed curves was due to the high impact energy value and the failure of the striker. Puncture occurred in samples with an open curve. It is seen in Figure 5 that the C_4^8 group sample having $[0^\circ/90^\circ/+45^\circ/-45^\circ]$ layer sequence for the 80 joule impact energy value across all layer sequences carries more maximum force than the other groups.
