# Carbon Fiber: The Future of Building Materials

Abstract: The need for rehabilitation, repair and strengthening of concrete structure has increased worldwide with a growing number of systems employing concrete jacketing, various retrofitting techniques, externally applied fiber-reinforced polymer (FRP) composites, etc. For applications of structures, an overview of different FRP composites is provided by various polymer composites and in civil structures FRP composites are used for reinstatement or firming up the elemental constituent. In our project we have examined the ability of a woven carbon fiber reinforced fabric wrapping to enhance the strength of various building components. For this purpose few concrete cubes were casted and were carbon wrapped to check the increase in strength. The strengths of cubes with carbon fiber wrapping were compared and the results were observed to have increased in strength for the carbon fiber wrapped cubes. Along with these cubes a column at a building site was also examined whose compressive strength was found to be less than design strength. Non – destructive test of Rebound Hammer was conducted on this column and later it was wrapped with

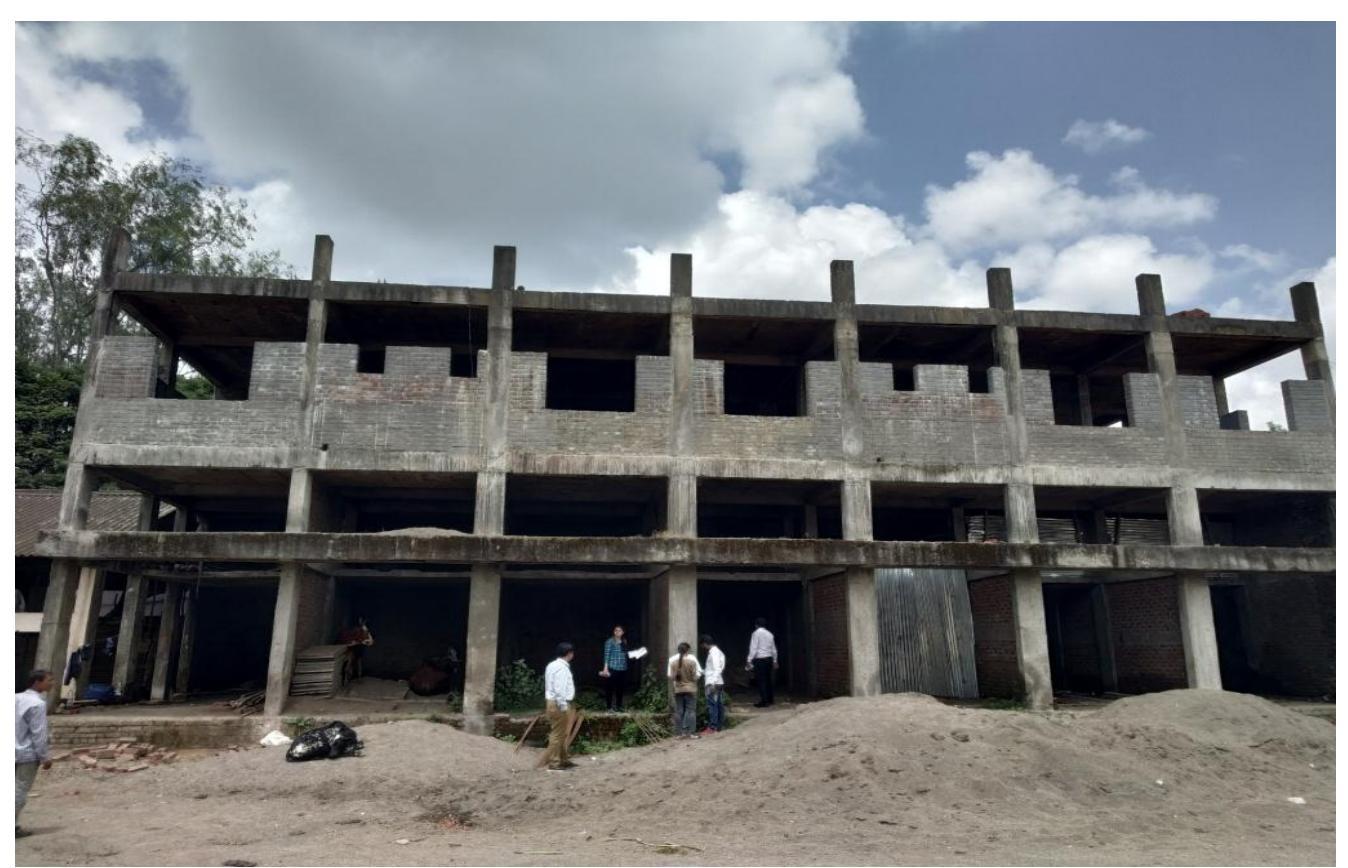
Figure 3.3: Building whose columns failed

After testing the columns using Rebound hammer, we found that most of the columns failed and were having compressive strength less than 20N/mm<sup>2</sup>. There were a few

columns whose compressive strength even came out to be less than  $10N/mm^2$ , and required urgent retrofitting.

We conducted a Non-Destructive Testing on the columns using a rebound hammer and recorded the failure of the columns. The site in-charge over there was generous enough to permit us to wrap a column using Carbon Fiber Reinforced Fabric.

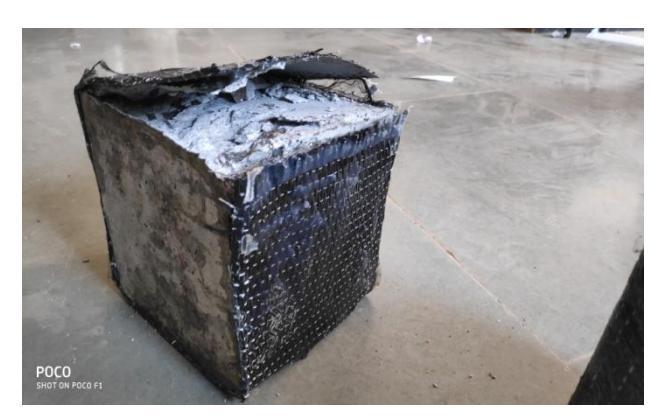
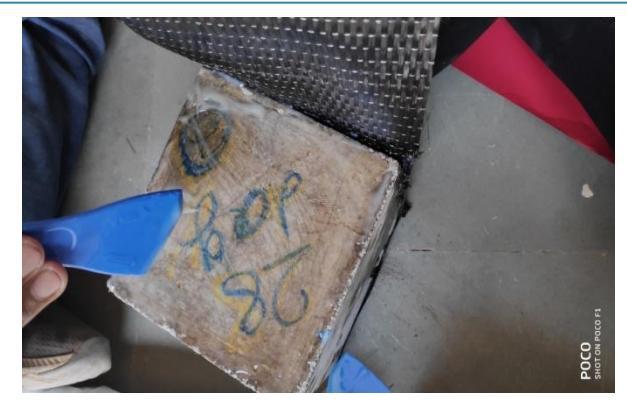
done. Later on compressive tests were carried out on these cubes using standard compression testing machine until the first crack appeared. The cubes were then wrapped with the carbon fiber fabric of 300 GSM 12k unidirectional. After wrapping the increase in the size of the cubes was negligible. For wrapping purpose the araldite solution was used. The araldite and hardener were mixed in the suitable proportion and applied on the surface of the cubes with the help of spatula. Immediately after applying the solution on four sides of the cube the carbon fiber fabric was applied and another coat of the araldite solution was applied over the fabric. The cubes were then allowed to dry and strengthen for two days and again the same compression test was carried out on the cubes. The test matrix is given in table no. 1 and 2. The parameters included in the test were specimen, compressive strength.
