Modified Negative Pressure Wound Therapy Using a Breast Pump Following Incision and Drainage of Lactational Breast Abscess: A Case Report

Dr Gunjan Jain

Senior Resident, Department of General Surgery, Indira Gandhi Medical College (IGMC), Shimla, Himachal Pradesh, India

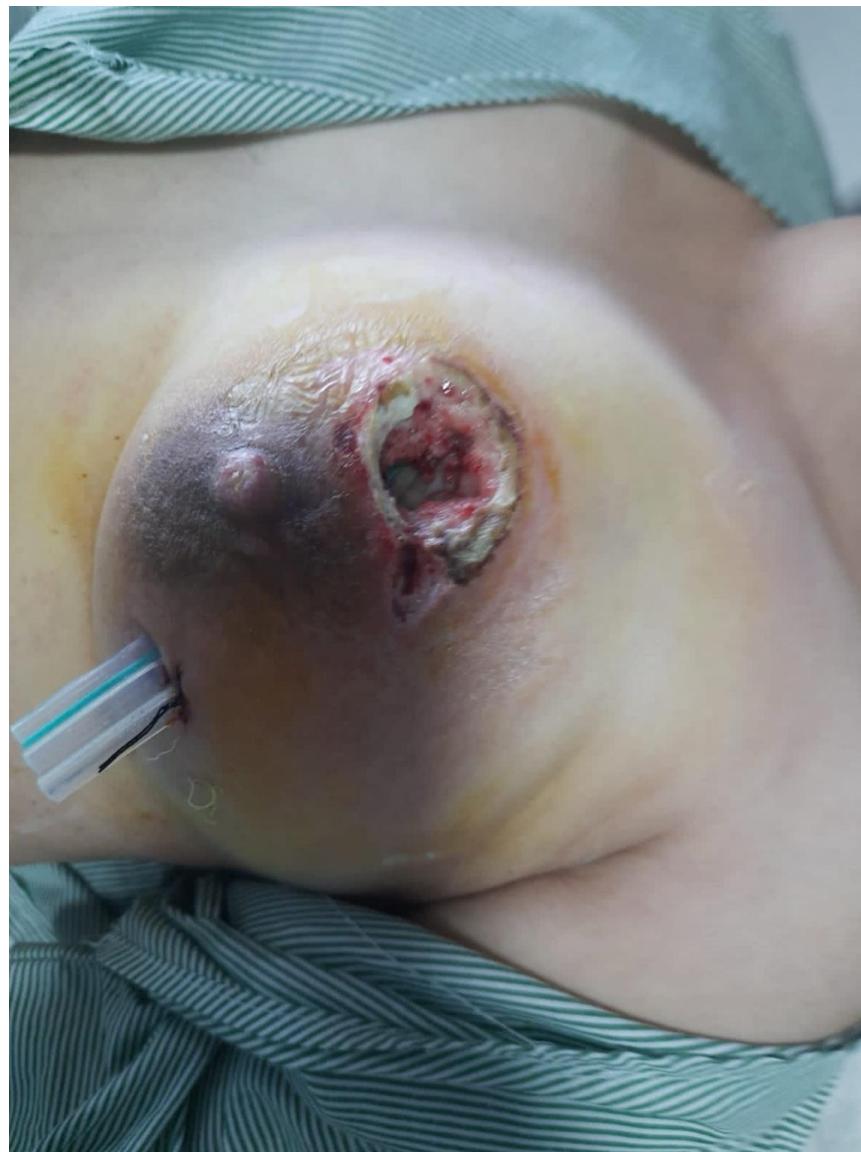
Figure 1: Post-incision and drainage status of breast abscess showing open cavity with residual slough.

A lactating female patient presented with pain, swelling, erythema, and fever involving one breast. Clinical examination and ultrasonography confirmed the presence of a localized breast abscess. The patient underwent incision and drainage under appropriate anesthesia. Postoperatively, an open cavity with residual slough was noted over the superior aspect of the breast, away from the nipple-areola complex.

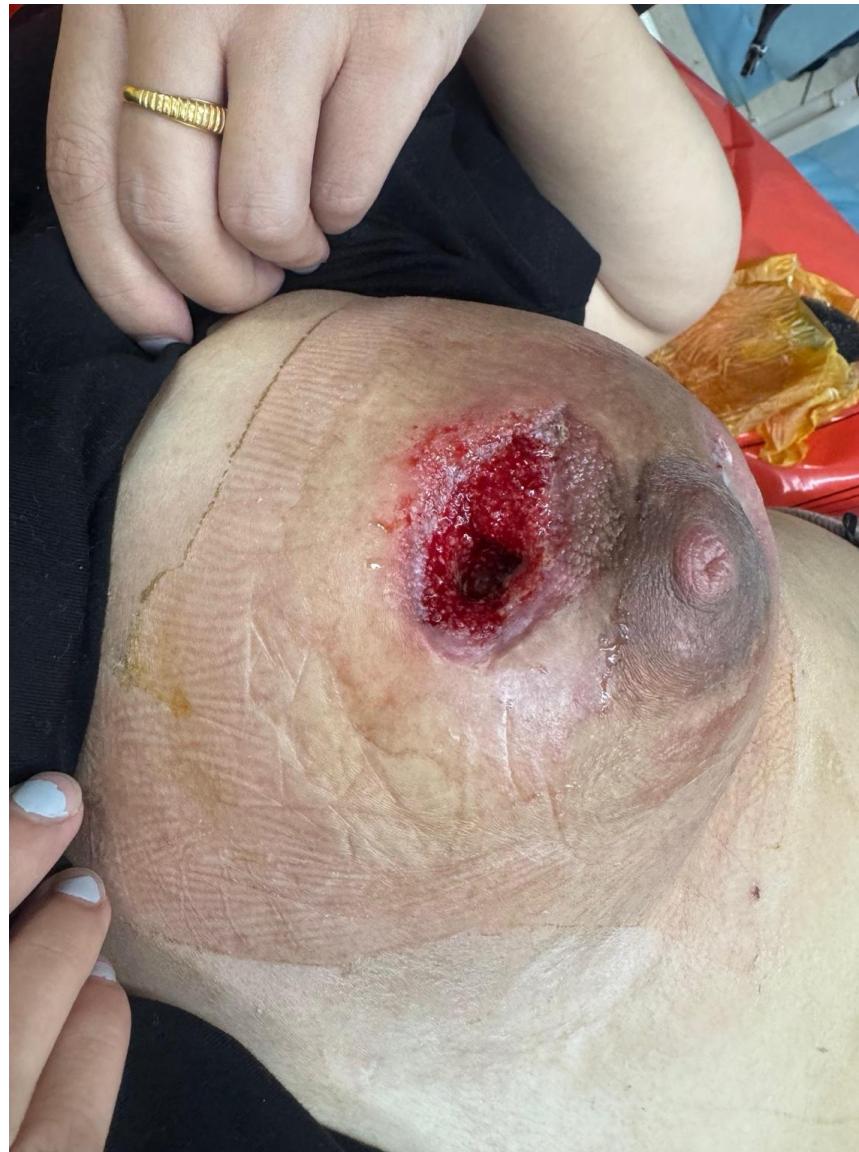
Figure 2: Wound appearance after 3 days of modified negative pressure wound therapy demonstrating healthy granulation tissue.

After three days of modified NPWT, the wound showed healthy granulation tissue with significant reduction in cavity size and absence of purulent discharge. The patient experienced improved comfort and was able to continue breastfeeding. No further surgical intervention or skin grafting was required.

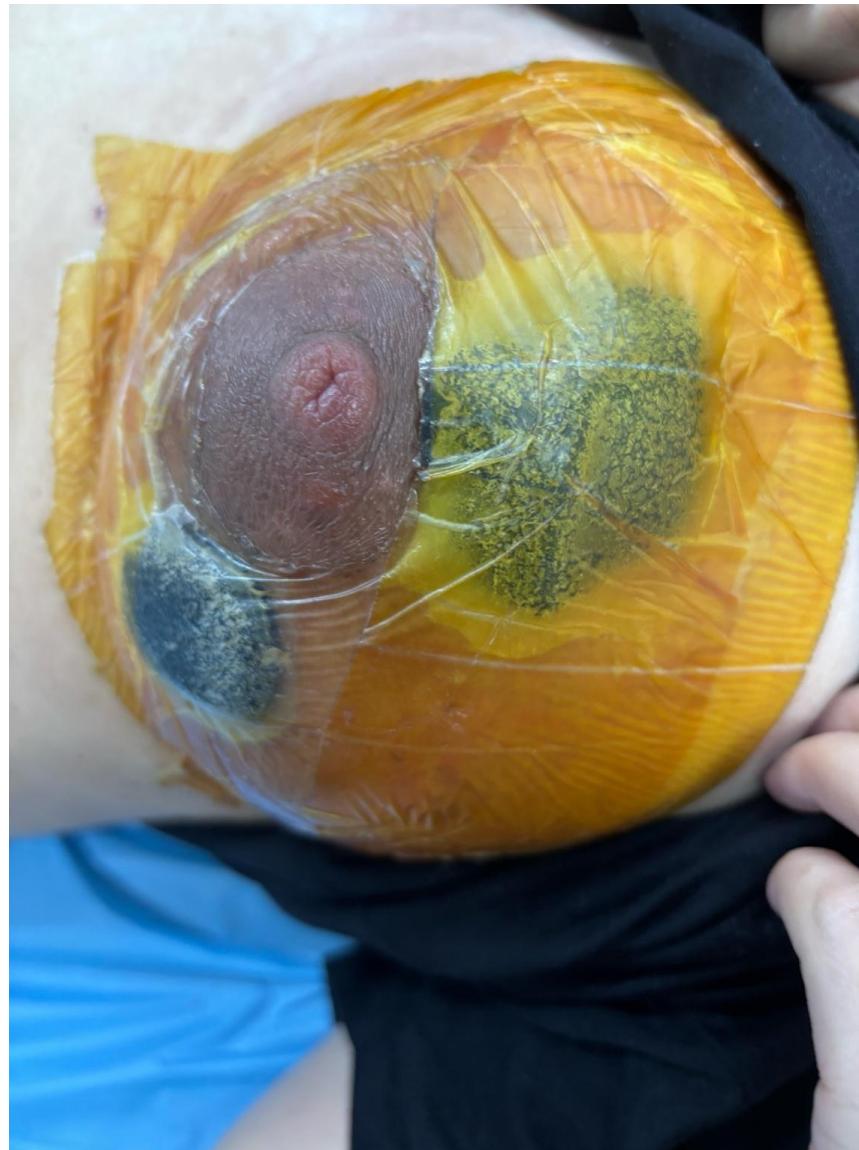
Figure 3: Application technique showing silver foam used to create a channel between the wound and suction system, facilitating wound drainage and milk expression.

A modified NPWT system was constructed using silver-impregnated foam, an adhesive transparent occlusive dressing, and a standard breast pump. The silver foam was placed within the abscess cavity and extended as a channel towards the suction interface. Care was taken to leave the nipple-areola complex uncovered to prevent ischemia. The dressing was sealed to create an airtight environment.

Controlled negative pressure was applied intermittently using the breast pump, allowing simultaneous wound drainage and milk expression.
