# Analysis of Wear Ring Wall Thickness and Integrity of Structural Strength

**Abstract:** This study evaluates the structural integrity of pump wear rings with locking screw configurations in accordance with API 610 requirements. The objective is to assess the adequacy of ligament thickness between the screw hole and outer surface. Visual inspection and geometric analysis were employed to identify localized wall thinning and stress concentration regions. The findings indicate that although the design satisfies hole diameter limits, insufficient ligament thickness may lead to elevated stress concentration, distortion, and fatigue risk. The study highlights the limitation of compliance based solely on dimensional criteria and emphasizes the need for structural assessment. It is recommended to optimize screw placement or adopt alternative anti rotation mechanisms to enhance reliability. These results contribute to improved design practices for rotating equipment components.

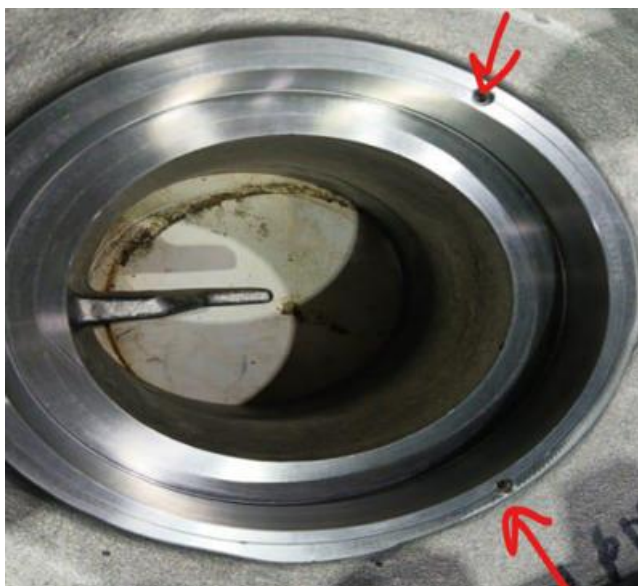
- The **locking screw hole** provided for anti-rotation is located **very close to the outer edge** of the wear ring.
- The **remaining ligament thickness** (material between screw hole and outer surface) appears **is insufficient based on geometric assessment**.
- Localized wall thinning is evident at the screw location (as highlighted in attached photograph).

**A reduction in structural integrity** due to insufficient ligament thickness

**High stress concentration** at the threaded hole location. This configuration increases the risk of the following failure modes:

- Crack initiation during tightening or operation
- Wear ring distortion affecting running clearance
- Fatigue failure under vibration and thermal loading

- 1) Verify ligament thickness at locking locations during inspection.
- 2) Alternative design configurations should be considered, including:
  - Relocating screw to thicker section
  - Using dowel pin arrangement
- 3) If the observation is repeating then verify the minimum thickness criteria on pattern /moulds.
