# Corrosion Behaviour of FLC Wire Ropes

**Abstract:** Steel wires are subject to corrosion when put in operation. It is important to analyze the wire rope condition time to time to prevent hazards in the work place. This paper reflects a process which can be applied in preventing wire rope failure by taking full locked coil sample of size 24 mm (in diameter).

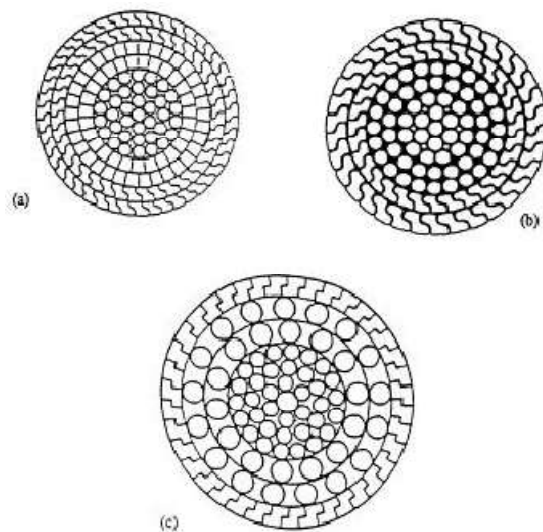
**Figure 1:** Full locked coil (FLC) wire ropes

According to shape, wire ropes are of following two types and shown in Figure 1 - Figure 3:

Locked coil wire ropes, by virtue of their unique design and construction have specialized applications in aerial ropeways, mine hoist installations, suspension bridge cables. In such specialty ropes, the outer layer is constructed with Z-profile wires that provide not only effective interlocking but also a continuous working surface for withstanding service wear.

The smooth outer surface of locked coil rope can withstand heavy wear, and because of the interlock, individual wire will not fly out of the rope if broken. The interlock also inhibits the ingress of moisture into the rope and the egress of lubricant from the rope, thus reducing the chances of internal corrosion. By virtue of their design, locked coil wire ropes have comparatively greater area of steel in proportion to their diameter than other types of wire ropes and hence have a higher breaking load-to-diameter ratio than any other construction.

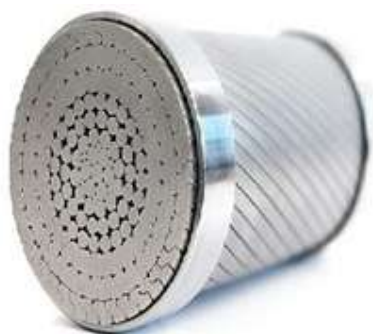
**Figure 2:** Cross section view of FLC

The samples of wire rope consist of five layers (outer, second, third, fourth and fifth) and the core. The common observations on each layer and core of five samples are given in Table 1.

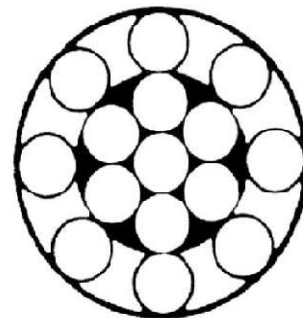
**Figure 3:** Half locked coil (HLC) wire rope
