An Investigation of Physico-Mechanical Properties of Some Chosen Concrete Mixtures by Ultrasonic Pulse Velocity (UPV) Techniques

P.Kuppuraj¹, S.Gunasekaran²

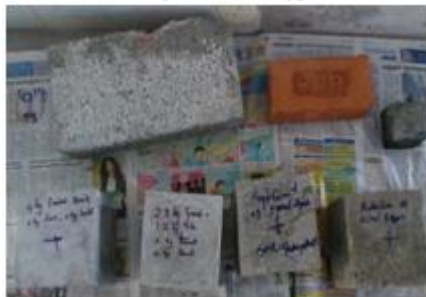
Figure 2.1: Chosen Specimens C1, C2, C3, C4 and C5

In this present study, we investigate the Physico-Chemical Properties for chosen five numbers of Concrete Specimens namely, C1, C2, C3, C4 and C5 shown in Fig.2.1. Test specimens were made of concrete cube of 150mmx150mmx150mm. The details of specimens along with their Mix proportions was made for Mix Design of M30 & M40 Grade of concrete as per IS 10262 [5] and the NDT Methods Ultrasonic Pulse Velocity (UPV) (Used Pandit lab model, Proceq Make Equipment was shown in Fig2.2) and Rebound Hammer Test (Used Schmidt model, Proceq Make Equipment shown in Fig 2.3) were carried out as per IS 13311(Part1) and (Part2) [6, 7]. The age of Concrete specimens is 28 days.

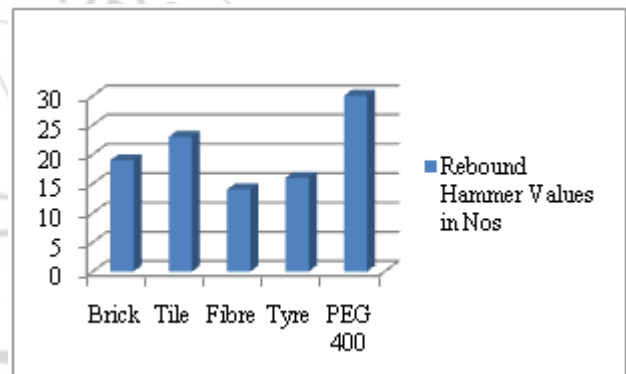
Figure 3.1: Comparisons of Average Rebound Hammer Values

The Prepared Specimens C1, C2, C3, C4 and C5 were taken and the Rebound Hammer Test was carried out at M/s.Hitech Concrete Solutions and the results are given in Table 3.1. The observed results are found satisfactory but the replacement of aggregates by fibre is very low 14 RH Value comparatively other Replacement Items and Aggregates Replaced by PEG400 is obtained Maximum of 30 RH Value. It gives authenticate results of PEG 400 is improve excellent physical Properties of Concrete.

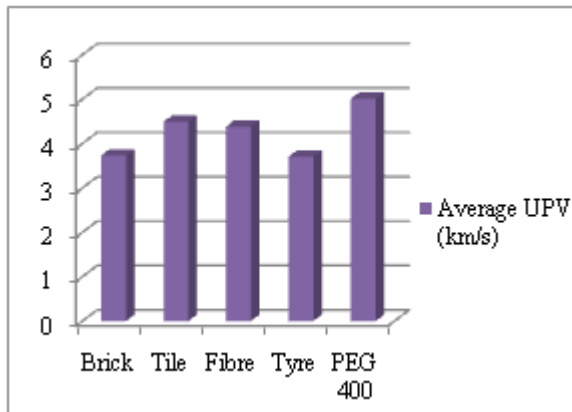
Figure 3.2: Comparisons of Ultrasonic Pulse Velocities

We are Prepared Specimens C1, C2, C3, C4 and C5 were taken and the Ultrasonic Pulse Velocity Test was carried out at M/s.Hitech Concrete Solutions. The observed results are found satisfactory but the direct and Semi Direct method of UPV supports PEG 400 has excellent for Concrete and bricks are Moderates remaining Tyre, Fibre, Tile are good for concrete. The Obtained results are tabulated in Table 3.2 and the table is given below also sketched graph for the same shown in Fig 3.2.
