Abnormal Changes in the Glenoid Cavity of the Scapula

Abstract: For frozen shoulder, the musculotendinous cuff & supraspinatus tendinitis were commonly thought about. The status of the scapula and the articular surface of the glenoid cavity also can contribute this condition. **Aim:** To study the articular surface of the glenoid cavity. **Materials & Methods:** 136 human scapulae (67 Right & 69 Left) from SSSMCRI, MGMCRI & Balaji Medical College were studied. The articular surface of the glenoid cavity and the vascular margins near its vicinity are studied. **Observation:** 14 right scapulae showed osteophytic changes, 17 left scapulae showed osteophytic changes. Two of them presented deep rough area other than the articular area. Two of them presented separate articular facet, in one the entire articular surface was rough. **Inference:** Increased vascularity and more number of nutrient foraminae were observed in Scapulae showing osteophytic changes

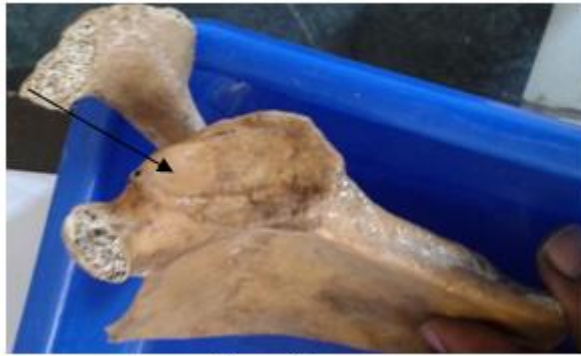
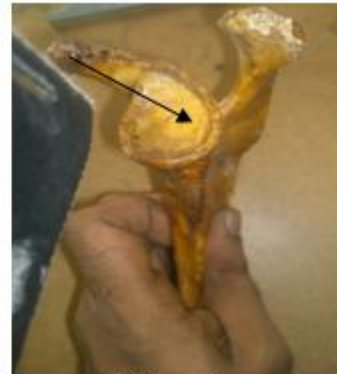
Figure 2a & 2b: Glenoid Cavity showing well defined articular facet within the articular area

17 right scapulae showed osteophytic changes, 14 left scapulae showed osteophytic changes. Two of them presented deep rough area (Fig: 1a & 1b) other than the articular area. Two of them presented separate articular facet (Fig 2a & 2b), in one the entire articular surface was rough (Fig 3). Maximum length & width of glenoid cavity observed was 38mm & 30 mm respectively (Fig:4). The smallest glenoid cavity had 27mm & 20mm of length & width respectively (Fig:5)

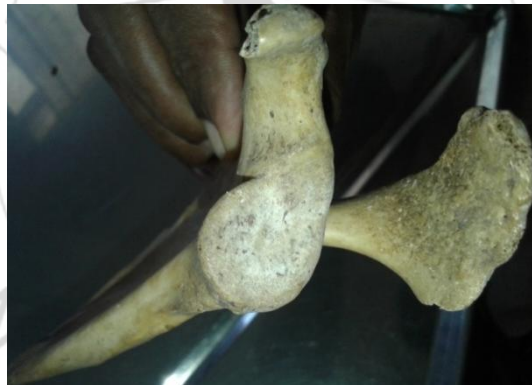
Figure 3: Entire Glenoid articular surface was rough not being lined by hyaline cartilage

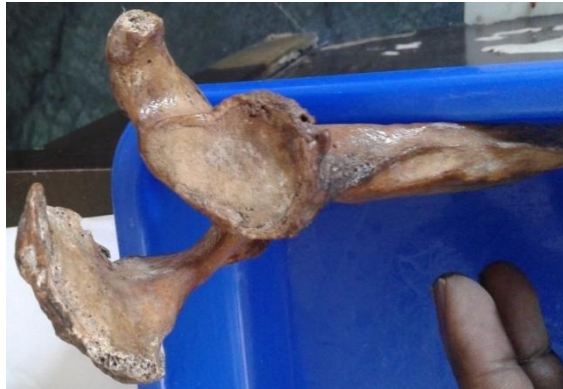
Figure 5: Showing Largest Glenoid Cavity
