Abnormal Changes in the Glenoid Cavity of the Scapula

Abstract: For frozen shoulder, the musculotendinous cuff & supraspinatus tendinitis were commonly thought about. The status of the scapula and the articular surface of the glenoid cavity also can contribute this condition. **Aim:** To study the articular surface of the glenoid cavity. **Materials & Methods:** 136 human scapulae (67 Right & 69 Left) from SSSMCRI, MGMCRI & Balaji Medical College were studied. The articular surface of the glenoid cavity and the vascular margins near its vicinity are studied. **Observation:** 14 right scapulae showed osteophytic changes, 17 left scapulae showed osteophytic changes. Two of them presented deep rough area other than the articular area. Two of them presented separate articular facet, in one the entire articular surface was rough. **Inference:** Increased vascularity and more number of nutrient foraminae were observed in Scapulae showing osteophytic changes

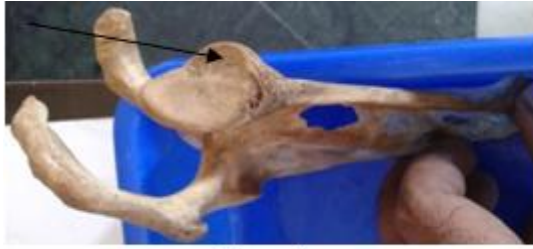
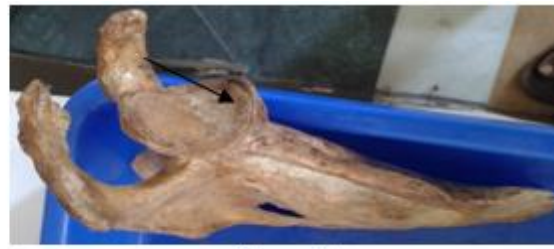
Figure 1a & 1b: Glenoid Cavity Showed deep rough non articular area

17 right scapulae showed osteophytic changes, 14 left scapulae showed osteophytic changes. Two of them presented deep rough area (Fig: 1a & 1b) other than the articular area. Two of them presented separate articular facet (Fig 2a & 2b), in one the entire articular surface was rough (Fig 3). Maximum length & width of glenoid cavity observed was 38mm & 30 mm respectively (Fig:4). The smallest glenoid cavity had 27mm & 20mm of length & width respectively (Fig:5)

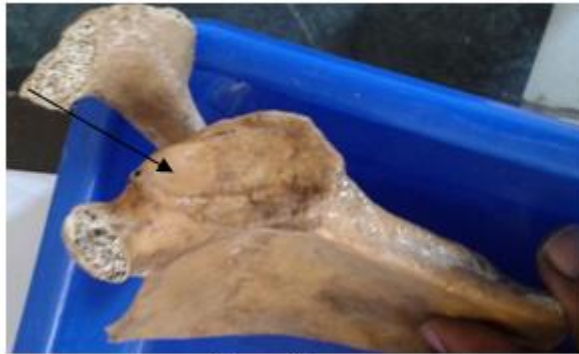
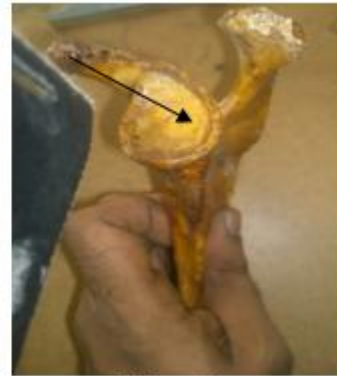
Figure 2a & 2b: Glenoid Cavity showing well defined articular facet within the articular area

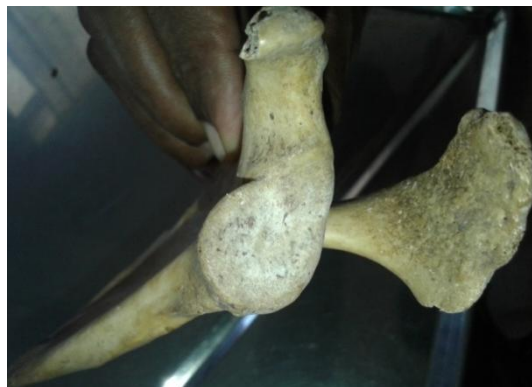
Figure 3: Entire Glenoid articular surface was rough not being lined by hyaline cartilage
