Development and Ultra Sonic Testing of Blast Resistant Sandwich Panel

Abstract: Composites are being used in many areas of ship construction to improve the performance and prepare the ships for the challenges of the future. Marine structures are to be stiffer, stronger and tolerant to corrosion and dynamic loads. Sandwich composites further enhances these advantages by using thin layers of GFRP or CFRP layers sandwiched with a low density foam or balsa wood core, effectively increasing strength and reducing the weight. The present study is to develop such sandwich structures with high specific strength and stiffness to withstand shock. These structures can be used for stealth application. Different types of sandwich panels are developed with cores made of foam and balsa wood with different skins and different thicknesses to get panels for multiple advantages. This paper presents development and ultrasonic test of one such sandwich panel. The results of dry scan method are presented which were used to find fitness after blast.

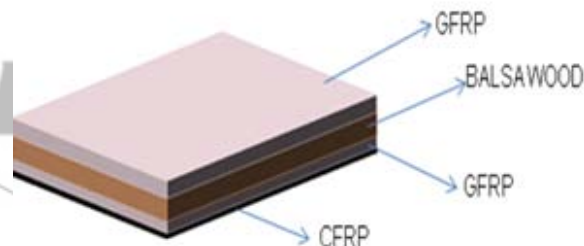
A sandwich panel is one which have high strength layer sandwiched with low dense and low strength material in the middle as a core as shown in Fig.1. These structures have to withstand for mechanical loads such as shock wave, ballistic impact loads caused by high explosions.

Figure 1: Schematic of Composite sandwich panel

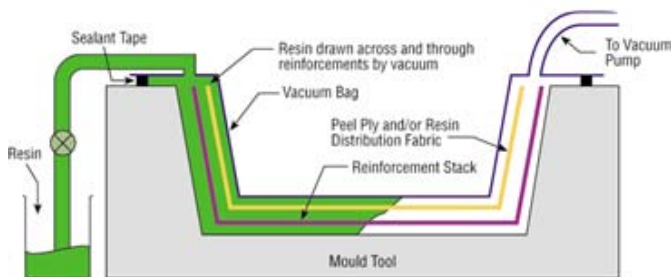
The material itself will not serve the purpose, proper fabrication process and curing is a must for achieving the desired properties of the hybrid composites. Vacuum Assisted Resin Transfer Moulding (VARTM) is used for fabrication as shown in Fig.2.

Figure 2: Schematic of VARTM setup

The Glass Fabric, Carbon Fabric and balsawood is laid as per the above schematic. The whole dry stack is then vacuum bagged, low Viscosity resin is allowed to flow into the layers of Hybrid Fibers at room Temperature. The resin distribution over the whole Fabrics are carried out by Using VARTM. For this process resins must be low in viscosity, thus comprising mechanical properties so generally epoxy, polyester and vinylester resins are used. Stitched materials work well in this process since the gaps allow rapid resin transport.

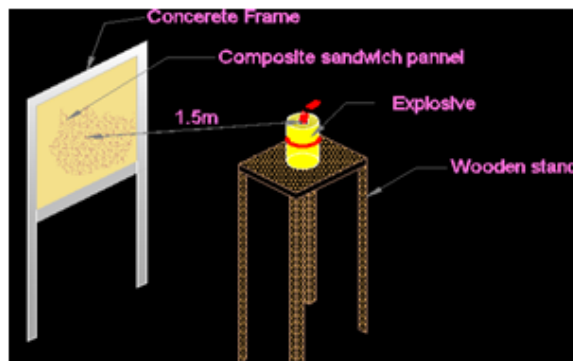
However the above are not sufficient, further tests are needed for critical application. The most important one being air blast test. In our study the panel is fixed at a distance of 1.5m from the explosive which gives shock wave and the intensity is increased from 400kpa to 2000kpa for different thickness panels. The panel withstood the air blast test successfully. The Non destructive Test (NDT) was carried out for the Composite Panel by using Ultra Sonic Flaw Detector in Dry scan Method with Through Transmission Mode as shown in Fig.3

Figure 3: Schematic of blast test

Both sides of the Sandwich Panels were marked in to a uniform grid. The distance between each nodal point of grid is 200 mm. The diameter of the Probe is 10 mm for both Transmitter and Receiver (T R) . The Ultra sonic signal was sent through probe and received the signal to scan the entire product as per the grid nodal points. By keeping both the transmitter and receiver exactly opposite to each other as per the Grid marked on sandwich panels, noted the gain value in terms of dB. These tests were carried out before and after blast tests of sandwich panels as a part of critical application for checking the integrity of Panel. Similar method was followed for graphite plates in our previous paper [4].

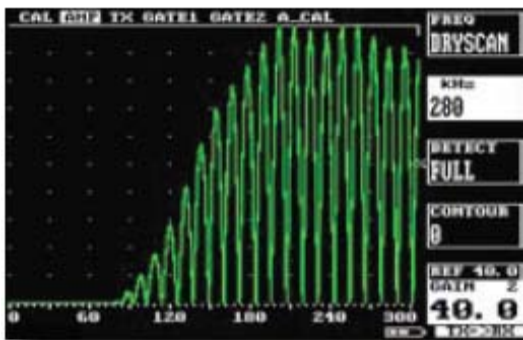
Maximum transmission of input signal is possible before blast test as there is no flaw. Table.1 shows the dB values of the panel tested for integrity before the blast test. F7 grid shows the minimum 45.8 dB value point and G6 shows the maximum value of 69.9 dB value. Fig.4 shows a cumulative signal without defect.

Figure 4: Cumulative signal without defect

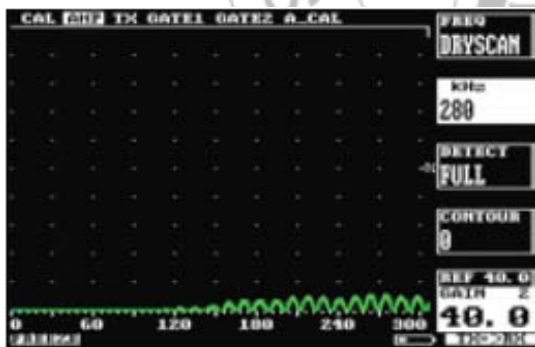
Typical spectrum obtained is show in Fig.5 the amplitudes diminish due to flaws.

Figure 5: Cumulative signal with severe flaw

In this test 6 dB difference may be considered as no defect and beyond 6 dB up to 10 dB may be considered as minor defect and between 10 dB and below 20 dB will represents the medium defect. The highest attenuation of ultrasonic signal shall represents the severe defect when it crosses 20 dB and above. However the cluster of defects as per the above dB ranges represents the internal damage as shown in Table.3.
